## 2023 Annual Formal Dam Safety Inspection

**RECIPIENT:** Mr Mike Herschmiller, CVRD  
**SENDER:** Mr Vincent Cormier, WSP Canada Inc.  
**COPY:** Mr David Daw, WSP Canada Inc.  
**DATE:** 27/10/2023  
**SUBJECT:** **Graham Lake Dam 2023 Annual Formal Dam Safety Inspection**  
**WSP Ref.: CA0007822.9373**

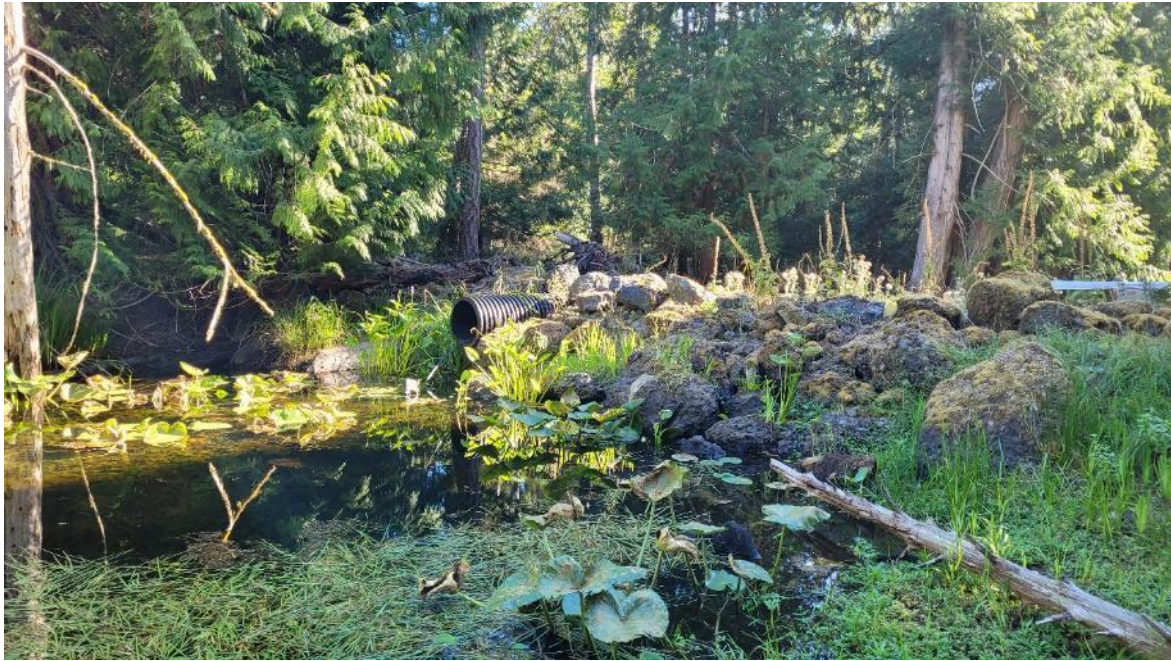
**Photo 1**

Minor vegetation on the upstream slope.

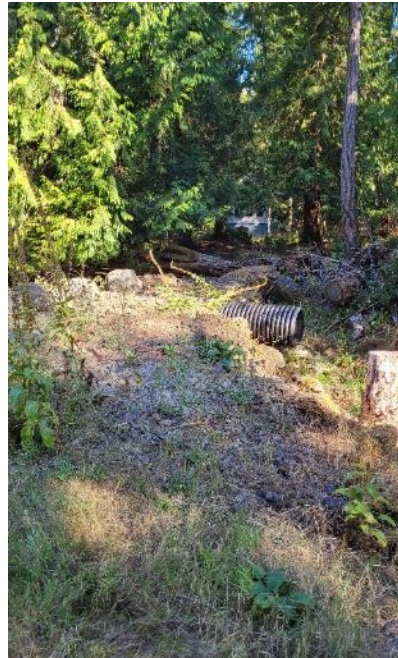
**Photo 2**

Dam's crest, looking towards the left abutment.

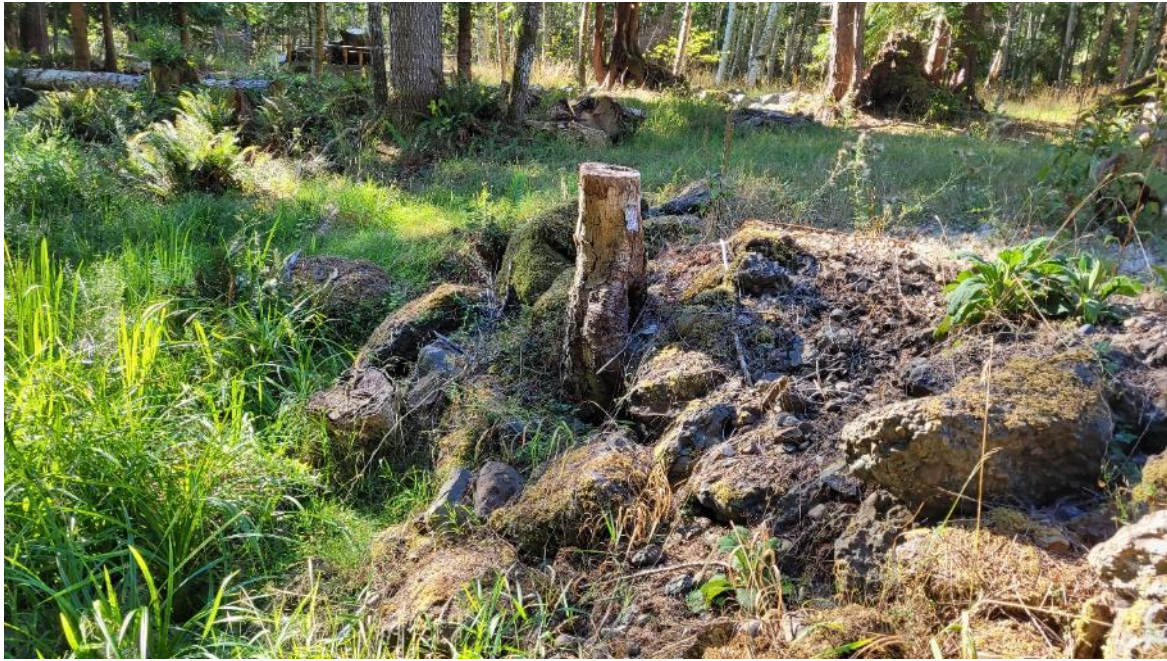
**Photo 3**

<b>VEGETATION</b>		<input checked="" type="checkbox"/>	<input type="checkbox"/>	<input type="checkbox"/>	<input type="checkbox"/>	<input type="checkbox"/>
<u>Trees</u>	<input checked="" type="radio"/> Yes <input type="radio"/> No Location Near the emergency spillway Notes <a href="#">Large stumps left in place after cutting down the trees.</a>					
<u>Brush</u>	<input checked="" type="radio"/> None <input type="radio"/> Sparse <input type="radio"/> Dense Location _____ Notes _____	<input checked="" type="checkbox"/>	<input type="checkbox"/>	<input type="checkbox"/>	<input type="checkbox"/>	<input type="checkbox"/>
<u>Ground Cover</u>	Bare <input checked="" type="radio"/> Grass <input type="radio"/> Other Notes _____	<input checked="" type="checkbox"/>	<input type="checkbox"/>	<input type="checkbox"/>	<input type="checkbox"/>	<input type="checkbox"/>
<b>SLOPE PROTECTION</b>		<input checked="" type="checkbox"/>	<input type="checkbox"/>	<input type="checkbox"/>	<input type="checkbox"/>	<input type="checkbox"/>

Tree stump on the downstream face.

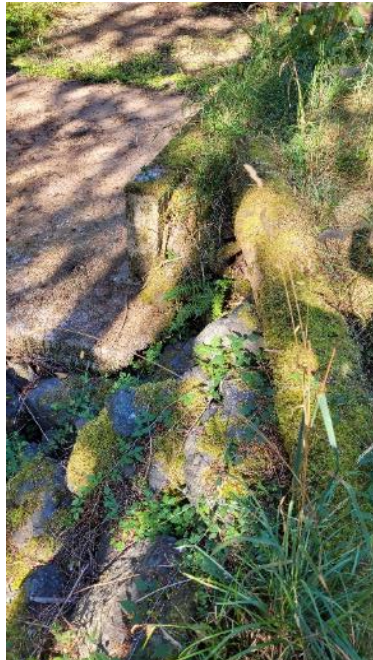
**Photo 4**

Damage Training walls do not extend into the embankment, potentially allowing bypass.

Location Upstream and downstream extremities of the training walls.

Gap and potential erosion between the training walls and the dam.

Issue Description	Recommendation	Cost estimate
behind the training walls. (see notes section of DSI checklist in attachment B.)	extended into the embankment to prevent any bypass flow that could erode the dam during spill events.	
There is no instrumentation at the dam.	Seepage at downstream toe of embankment in old stream bed location has been noted previously by MFLNRO. Monitoring of this seepage is recommended. See MFLNRO 2017 recommendation.	\$5,000 <sup>1</sup>
Dam Emergency Plan emergency contacts appear to be out of date.	Update DEP	NA <sup>1</sup>
Dried moss and vegetation covering the concrete slab making inspection difficult.	Clean the concrete spillway surface prior to the 2024 DSI.	NA <sup>1</sup>
Downstream scouring under the concrete spillway apron.	Fill the void below the spillway and within the riprap with a cement mixture.	\$15,000
The elevation difference between the spillway and the dam's crest appears to be low, indicating that the dam likely has little freeboard during a flood event.	Conduct a hydraulic review of the spillway to determine the available freeboard during the Inflow Design Flood and confirm that the dam would not overtop and fail during its design event.	\$10,000

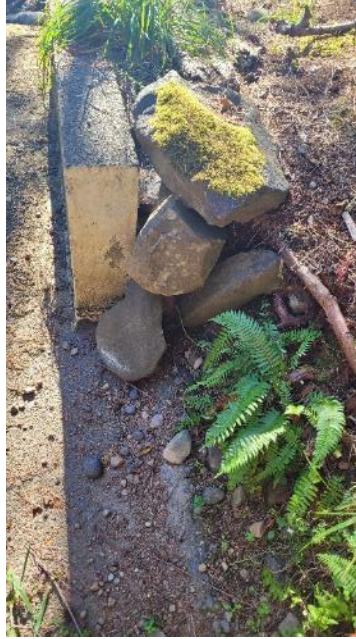
**Photo 5**

Gap and potential erosion behind riprap between the training walls and the dam.

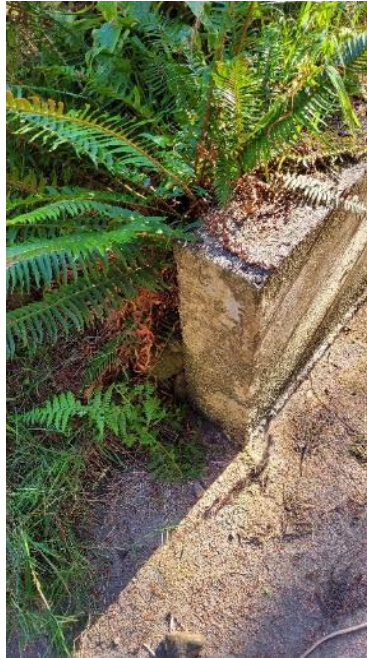
**Photo 6**

Notes Training walls inadequate.

Inadequate training wall configuration.

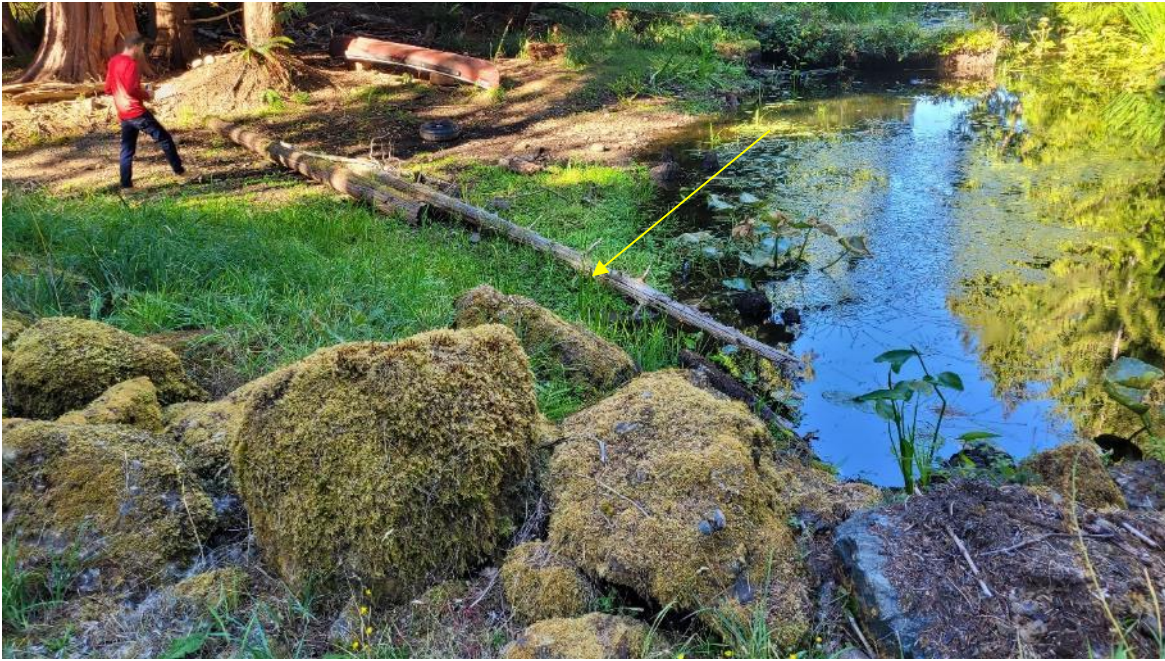
**Photo 7**

Condition: Logs poor Connections Fair Anchors Fair

Notes Logs at the left bank connection is undersize and in poor condition. Log boom efficiency to be reviewed during a spill event.

Undersize log boom towards the left bank (yellow arrow).

Issue Description	Recommendation	Cost estimate
The log-boom section located near the left bank appears undersize. It is unclear if the log-boom is efficient at intercepting floating debris. Water levels were too low during inspection to assess its efficiency.	Monitor log-boom at high water levels and replace deficient logs if required.	\$5,000 <sup>1</sup>
The spillway's training walls are too short and could potentially allow for flow by-pass	The training walls should be extended in both upstream and downstream direction. The training walls should be	\$75,000 <sup>2</sup>

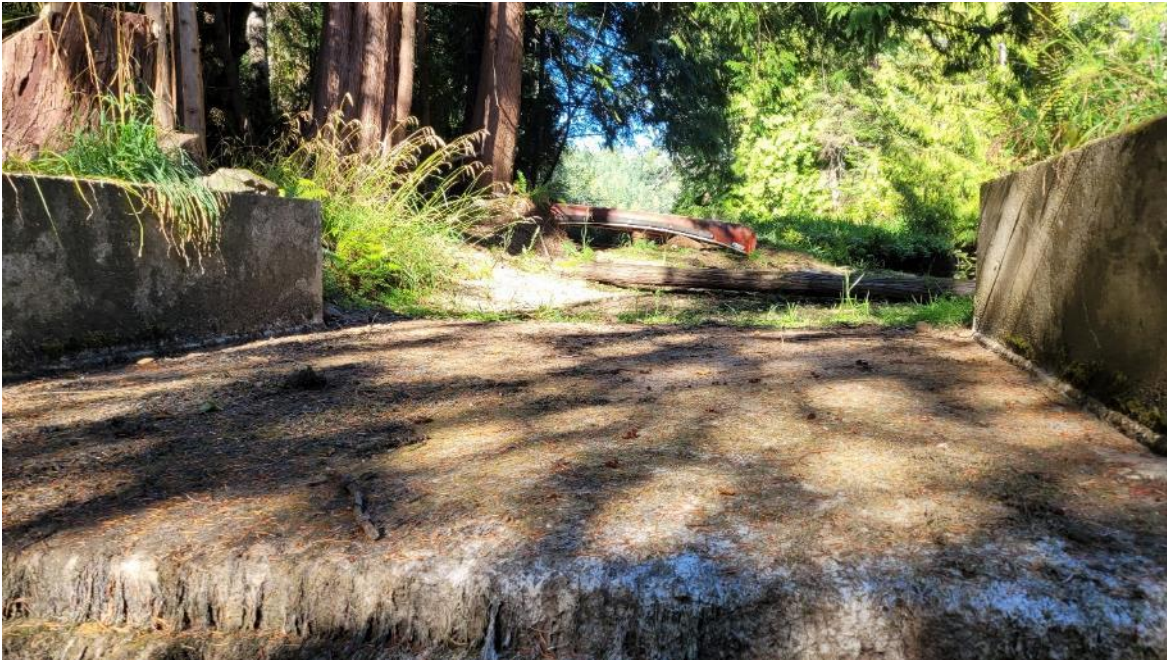
**Photo 8**

Notes Dried moss and vegetation covering the concrete slab making inspection difficult.

Dried moss and vegetation covering the spillway.

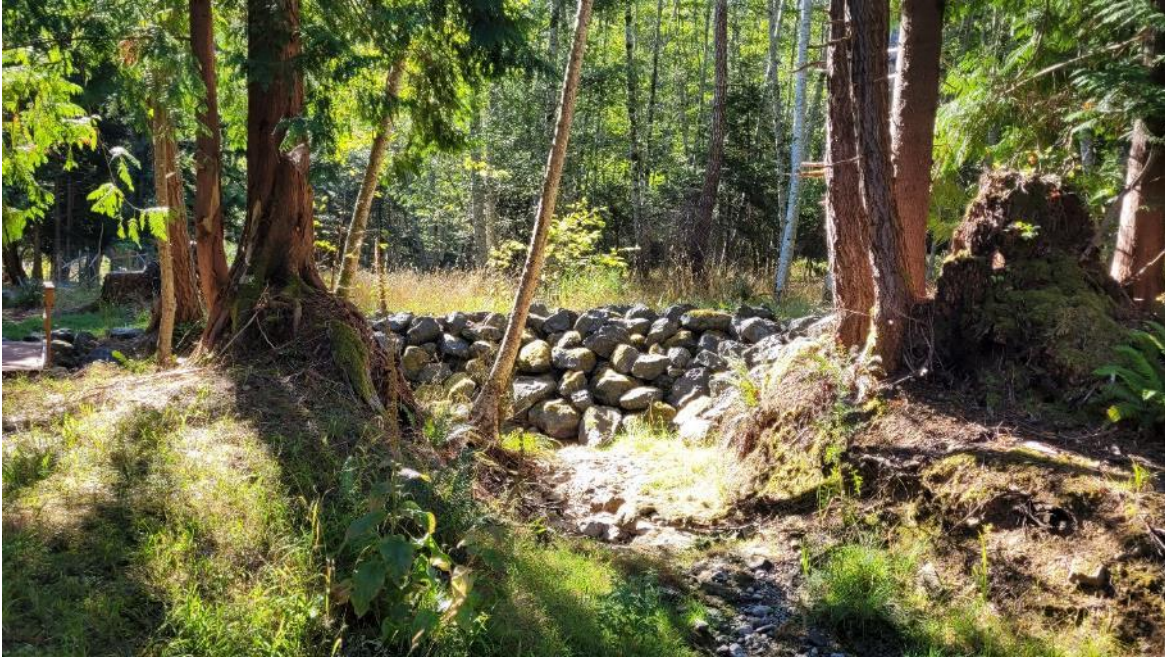
**Photo 9**

Notes Rockfill placed at the downstream end of the spillway and further down the channel, on the right bank.

Conveyance Channel located downstream of the spillway. Minor erosion upstream of the rock-lined bend.

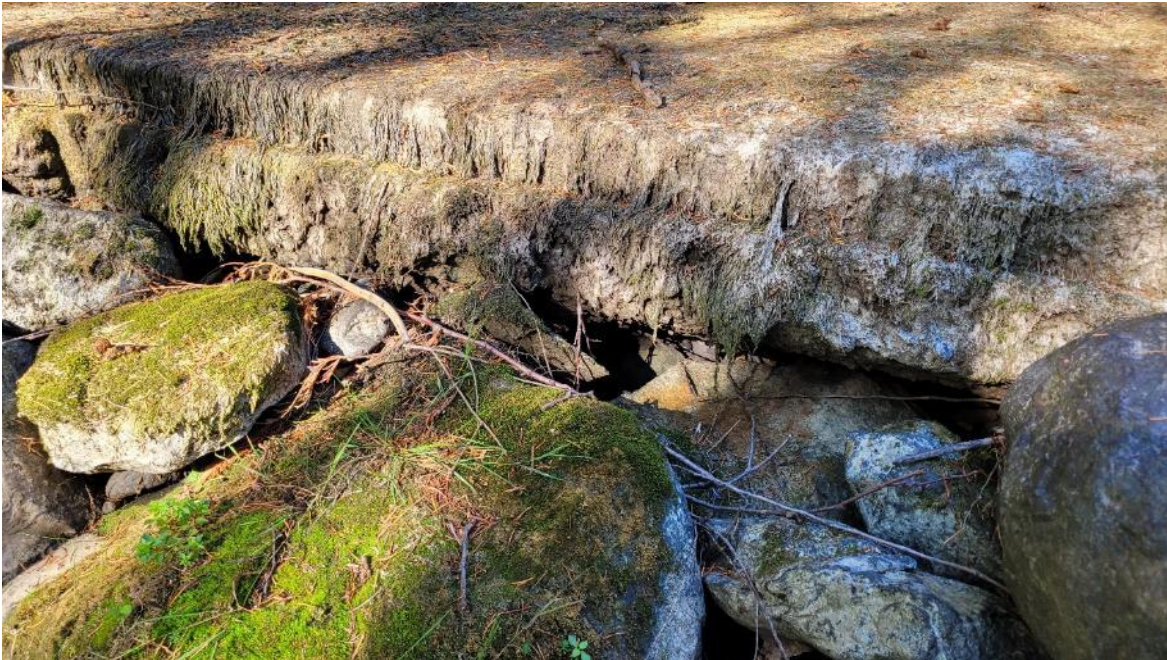
**Photo 10**

Notes Downstream scouring under the concrete spillway apron.

Scouring below concrete slab at spillway downstream end.
