# Perseverance Creek

## Fish Habitat and Proper Functioning Condition Assessment

January 24, 2019

Ecofish Research Ltd.

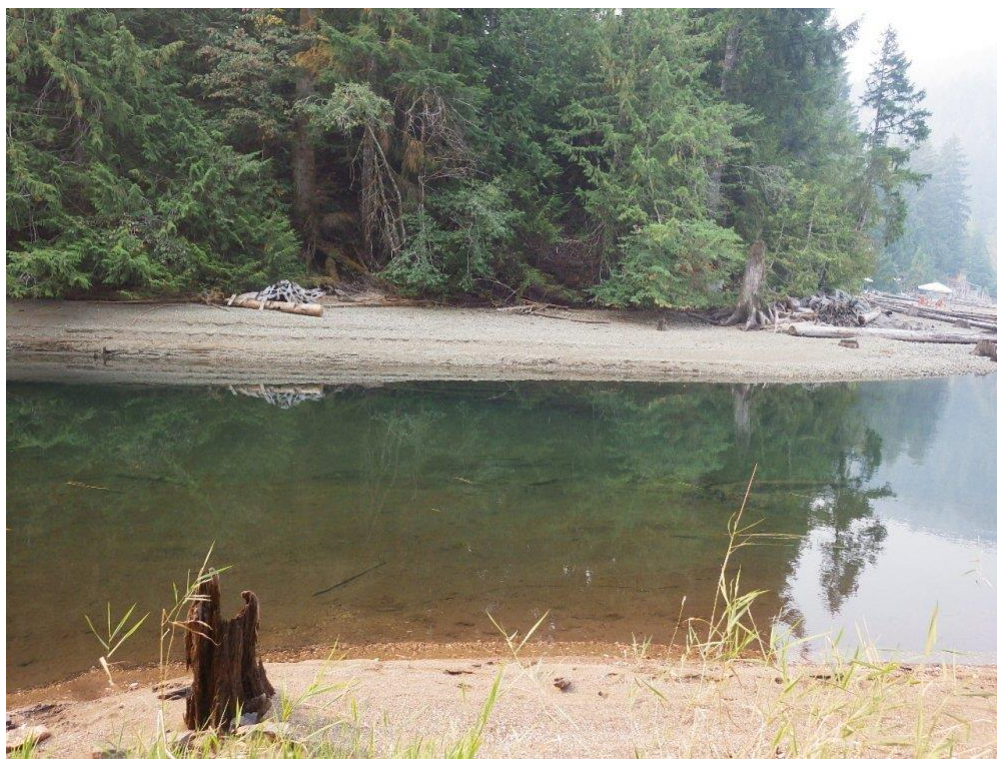
Figure 1. Start point at lake influenced reach of stream with warm water (19°C), August 21, 2018.

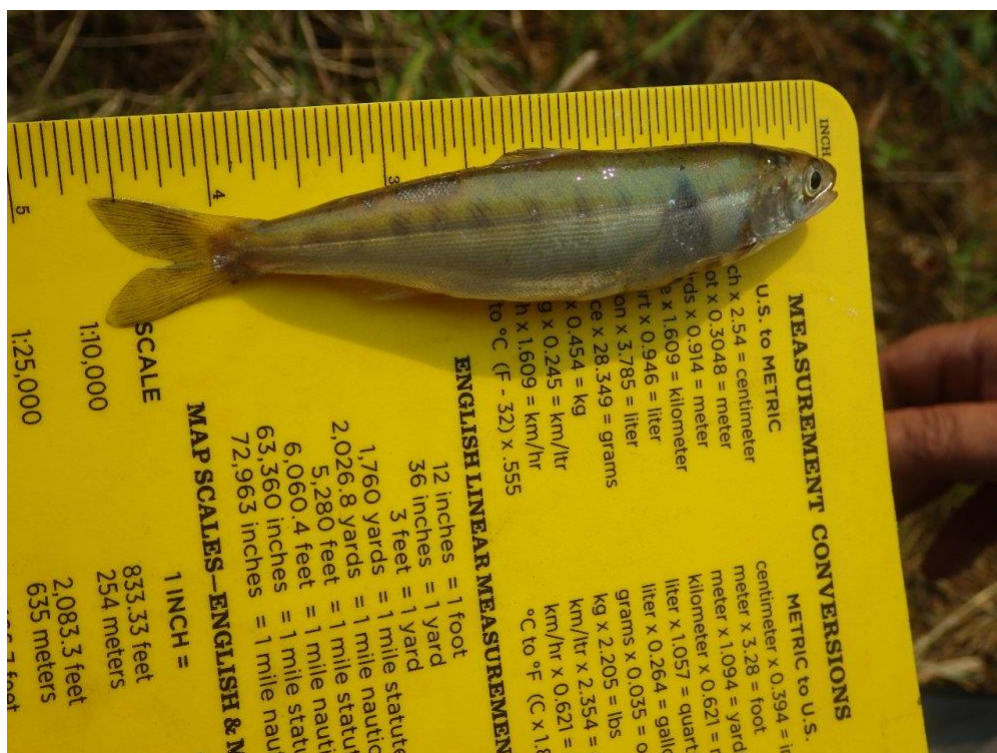
Figure 2. Dead salmonid smolt, August 21, 2018.

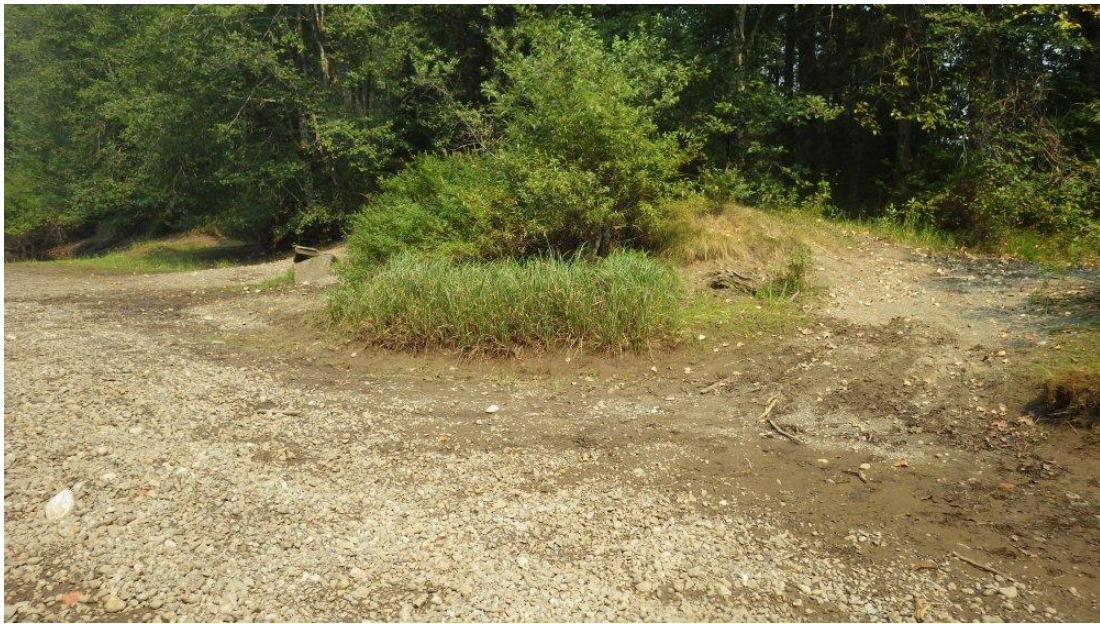
Figure 3.      ATV access and eroding banks, August 21, 2018.

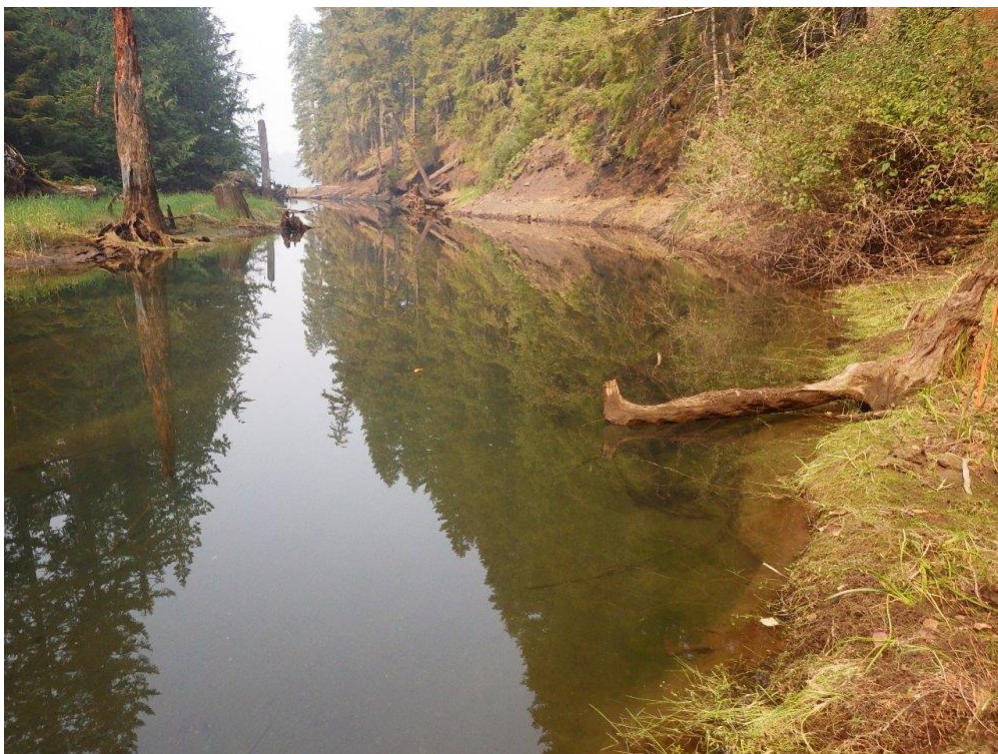
Figure 4.      Eroding banks on old coal slag piles, August 21, 2018.

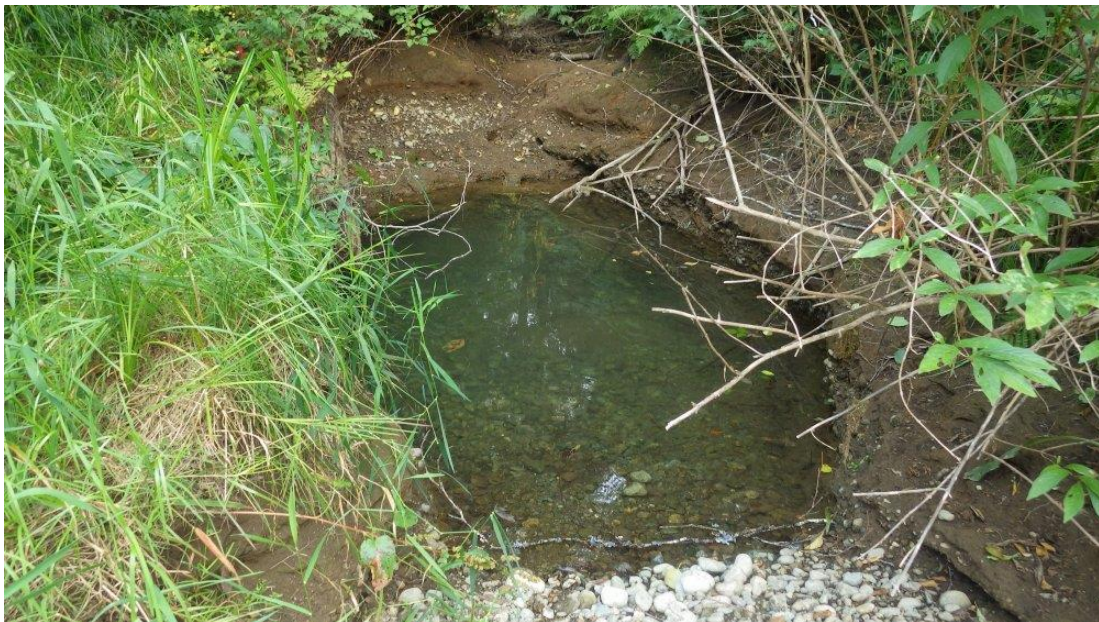
Figure 6. Isolated pool in back channel (possibly enhanced), August 21, 2018.

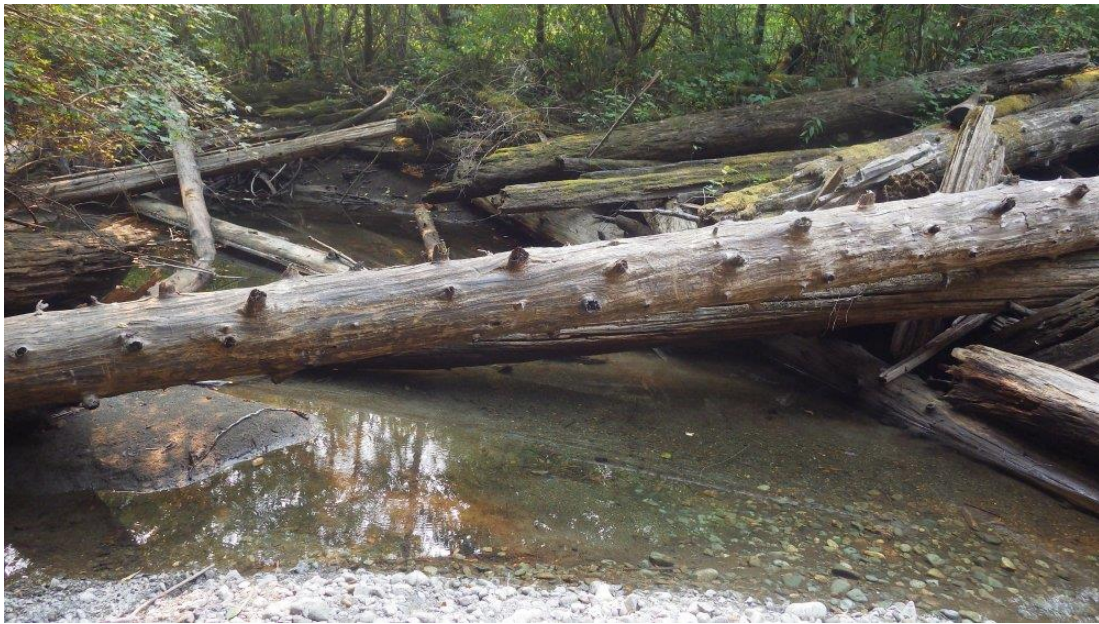
**Figure 7.** Log jam with sediment wedge behind it, August 21, 2018.

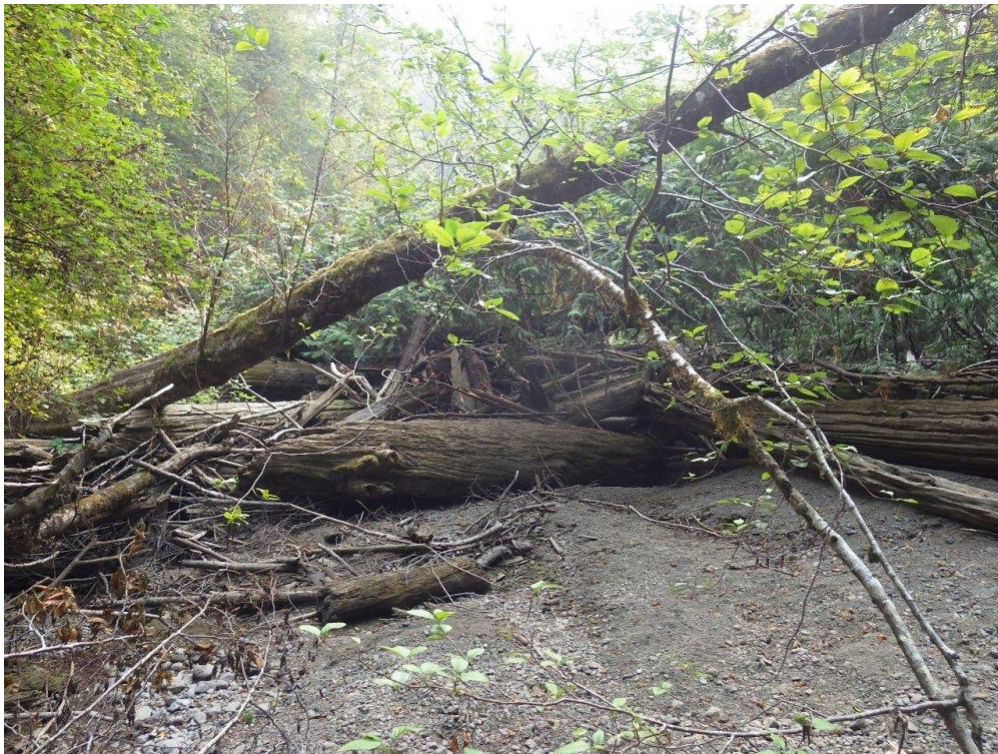
**Figure 11. Log jam barrier, August 21, 2018.**

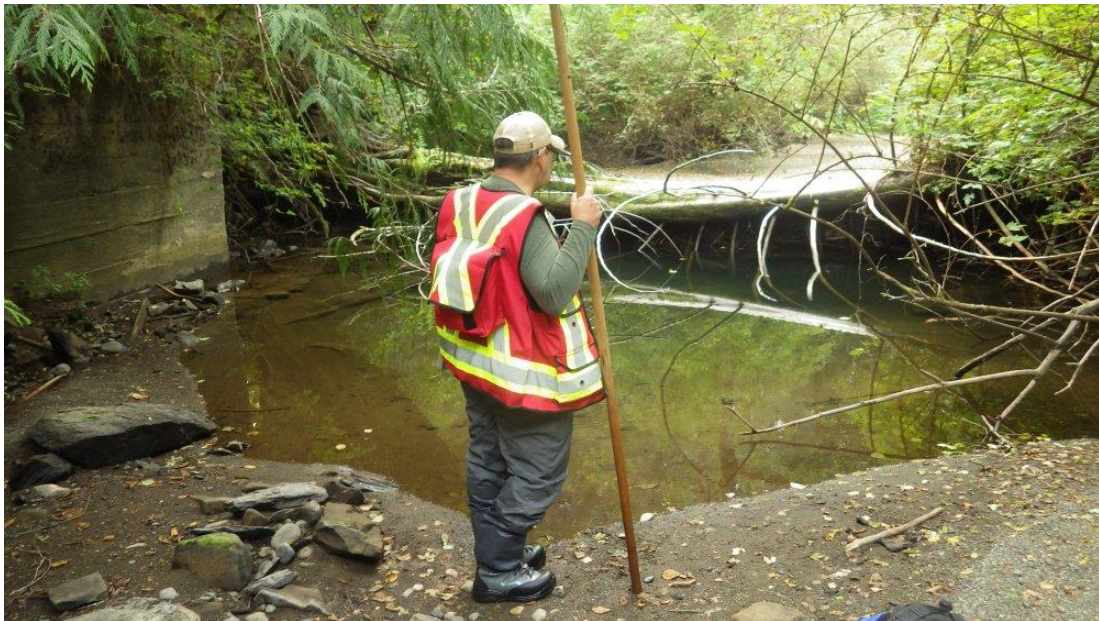
Figure 13. Several pools exist below large woody debris (LWD) jams with substrate aggradation above, August 22, 2018.

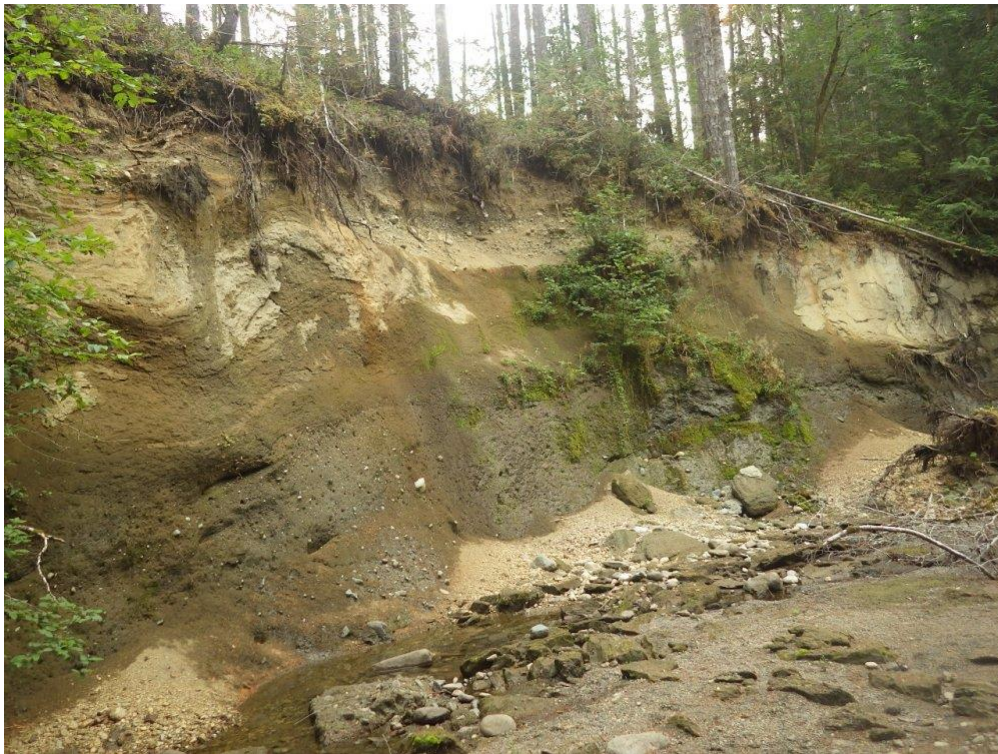
Figure 15. Eroding bank visible from Comox Lake Road, August 22, 2018.

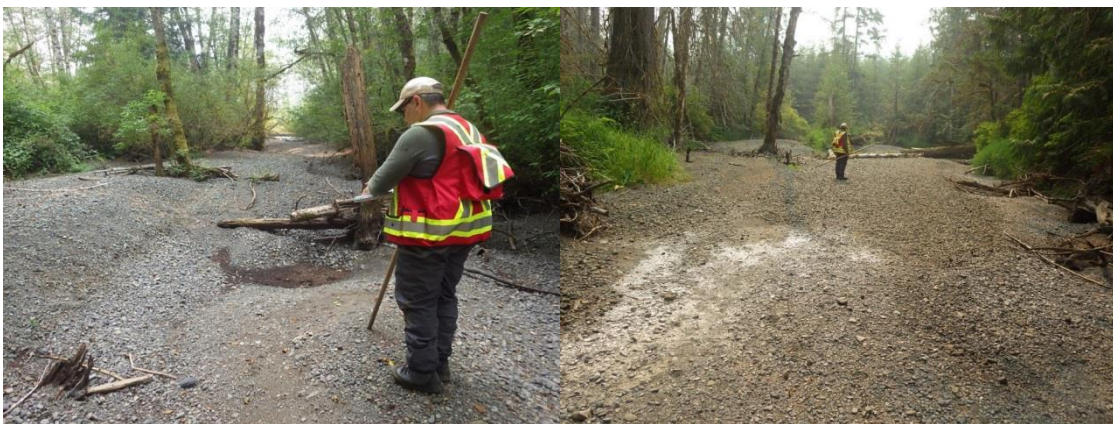
Figure 16. Mostly dewatered section of reach (subsurface flow present), August 22, 2018.

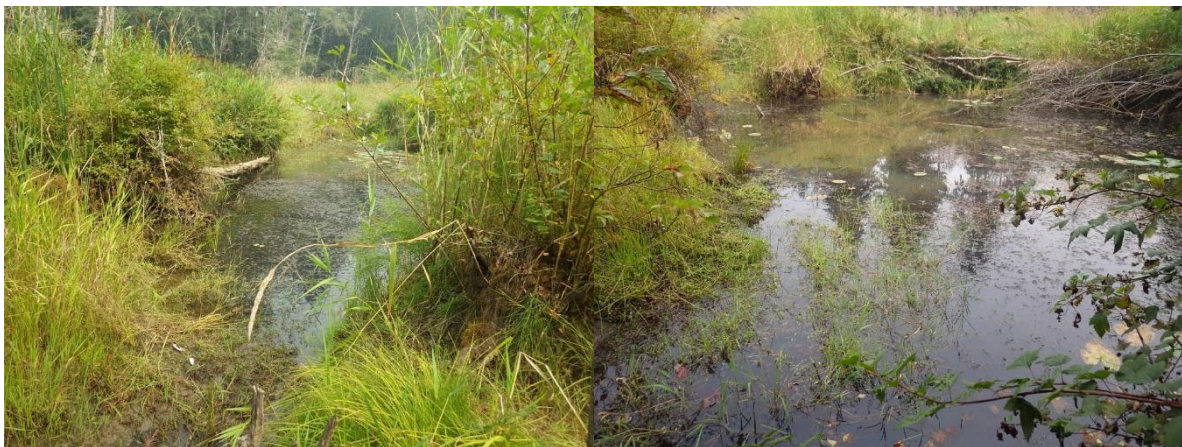
**Figure 18. Wetland beside creek with little shade and no low flow connectivity to Perseverance Creek, August 22, 2018.**

| PFC Site | Fish Habitat Site | Management/ Restoration Options | Future Studies |
|---|---|---|---|
| PRS-PFC04 | PRS-STC04 | Restore stream channel, groundwater hydrology and option to connect with wetlands once more shade is present and improved water quality conditions have been achieved. Plant coniferous trees where sparse in wetland environment to improve maintenance of cool water temperatures during summer. Improve year-round connection between wetland and main channel if water quality in wetlands is suitable. Other improvements to wetlands may be beneficial such as excavating deep pools that provide refuge for fish and that are too deep to be populated by reed canary grass. Note that a beaver baffle may be required to maintain connection. Disperse LWD, stabilize upstream erosion and control flooding. | Assess and monitor water quality in the wetlands to determine suitability for fish habitat and risks in connecting to Perseverance Creek. |

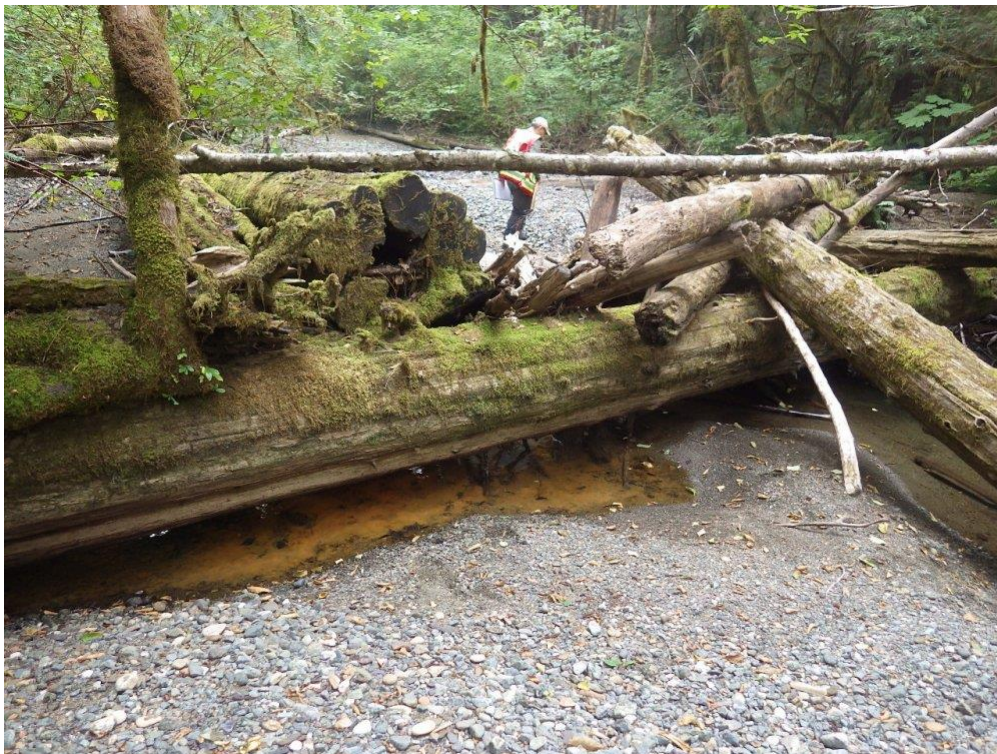
Figure 20. LWD jam; August 22, 2018.

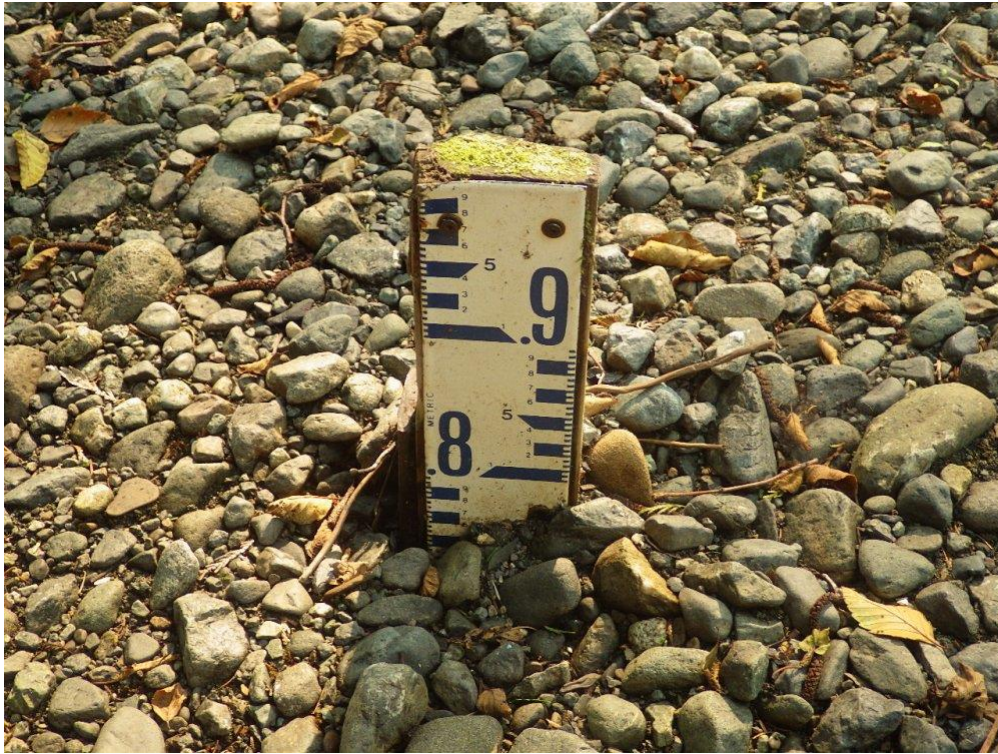
**Figure 21.** Buried staff gauge (installed ~ 2001) behind log jam demonstrates recent aggradation, August 22, 2018.

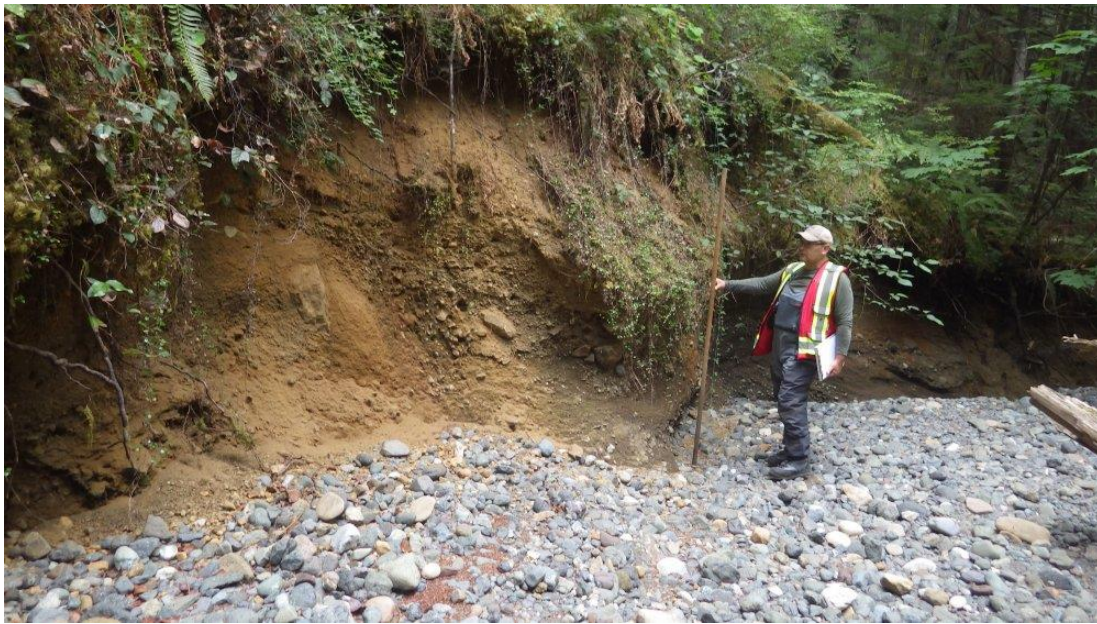
**Figure 23. Eroding bank; August 22, 2018.**

High flows are contributing to extensive bank erosion. Banks can be armored with boulders, LWD, and planted with vegetation, among other treatments, to reduce the rate of erosion. However, armoring of banks requires careful site planning and consideration of alternate energy pathways and potential downstream impacts. Also, as erosion is occurring in many areas, any bank stabilization should be prioritized in consideration of the watershed as a whole. Undersized culverts can be replaced with appropriately sized (e.g., to accommodate up to 100-year sized floods) and styled culverts (e.g., open bottom culverts or clear-span bridges) to reduce erosion, as well as facilitate fish passage.

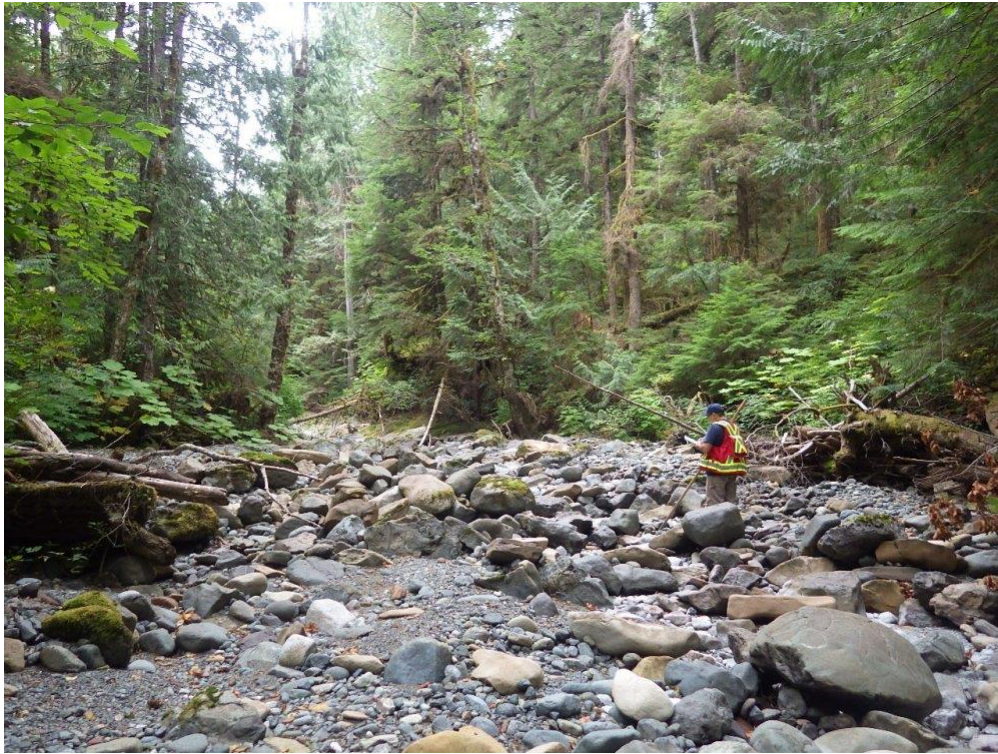
Figure 25. Excess bedload aggradation, including large substrates; dry with few pools, August 23, 2018.

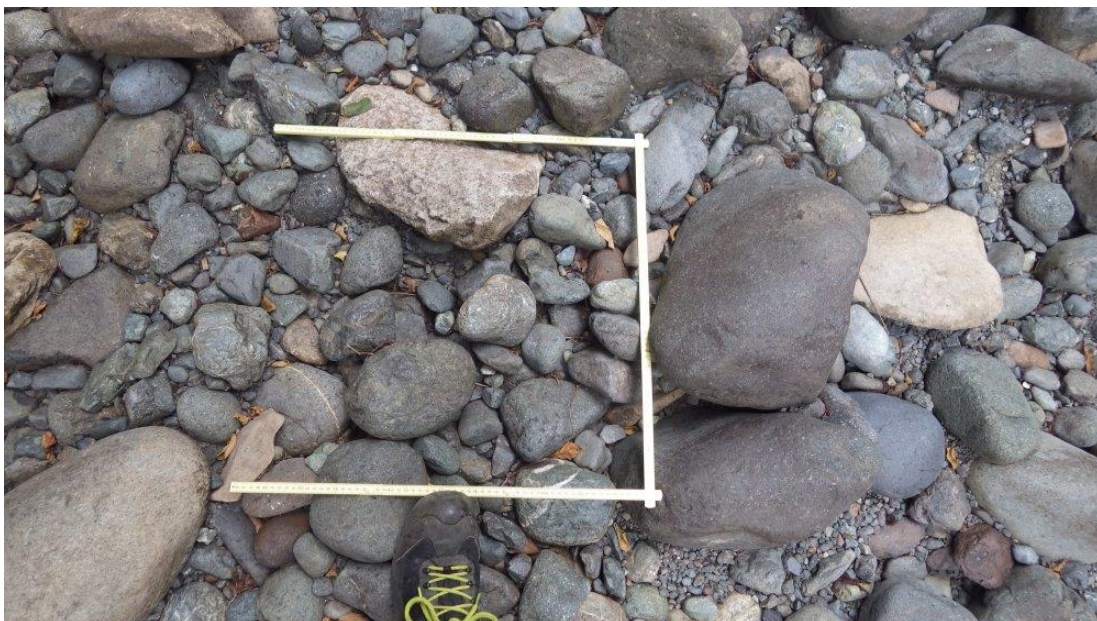
Figure 26. Excess bedload aggradation, August 23, 2018.

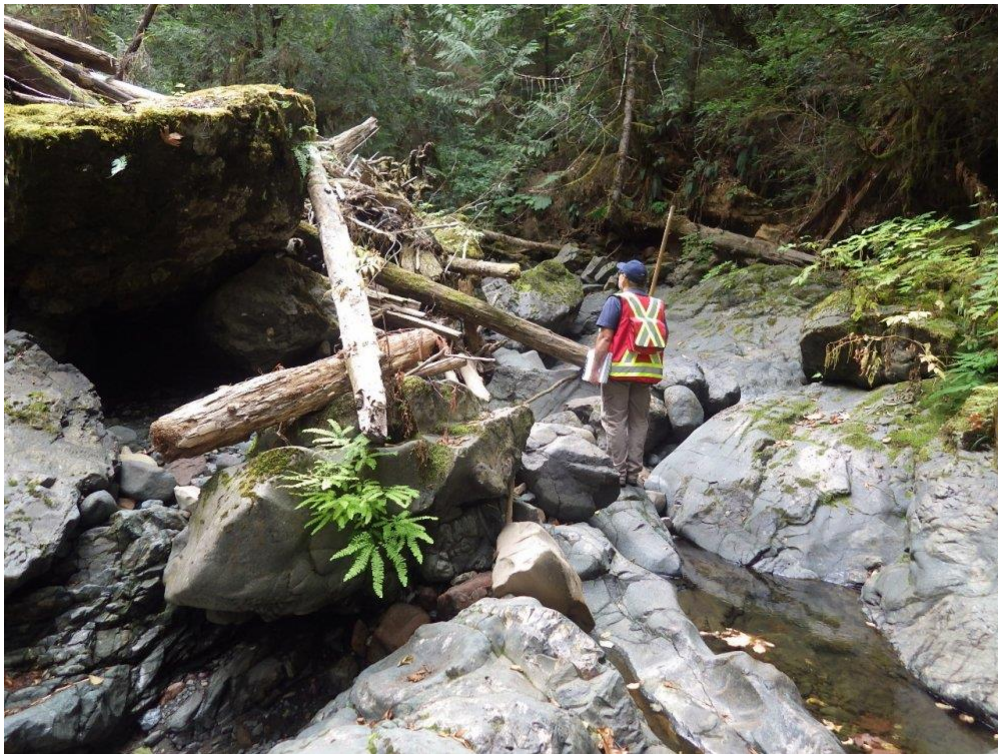
Figure 29. LWD jam, boulders and constricted channel, August 23, 2018.

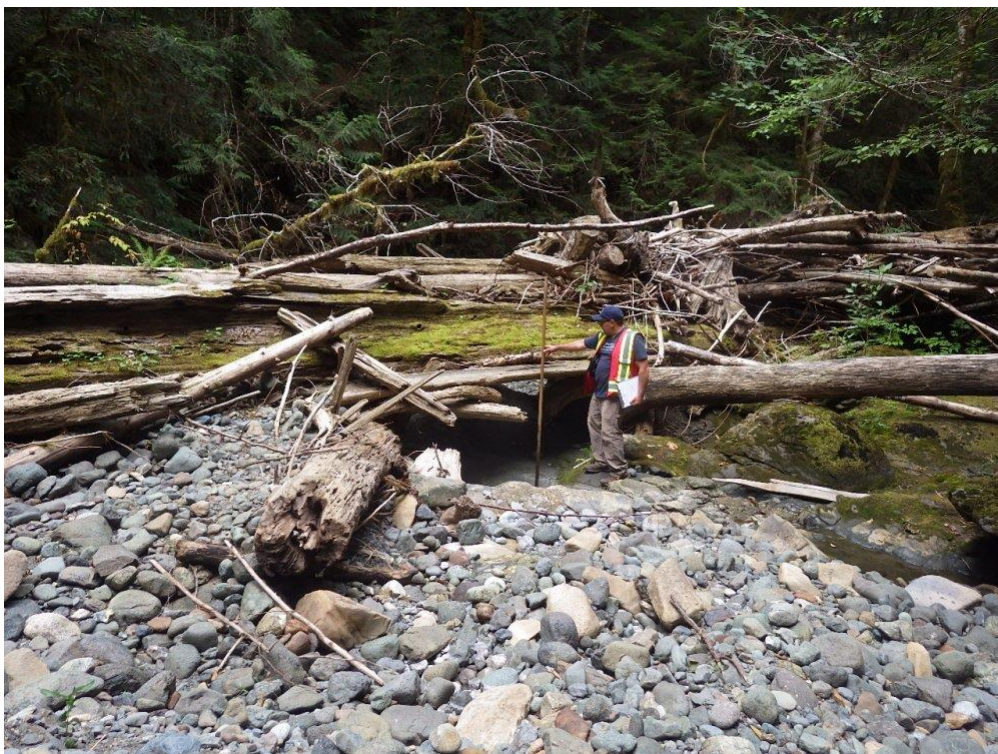
Figure 30. LWD jam supporting substrate aggradation, August 23, 2018.

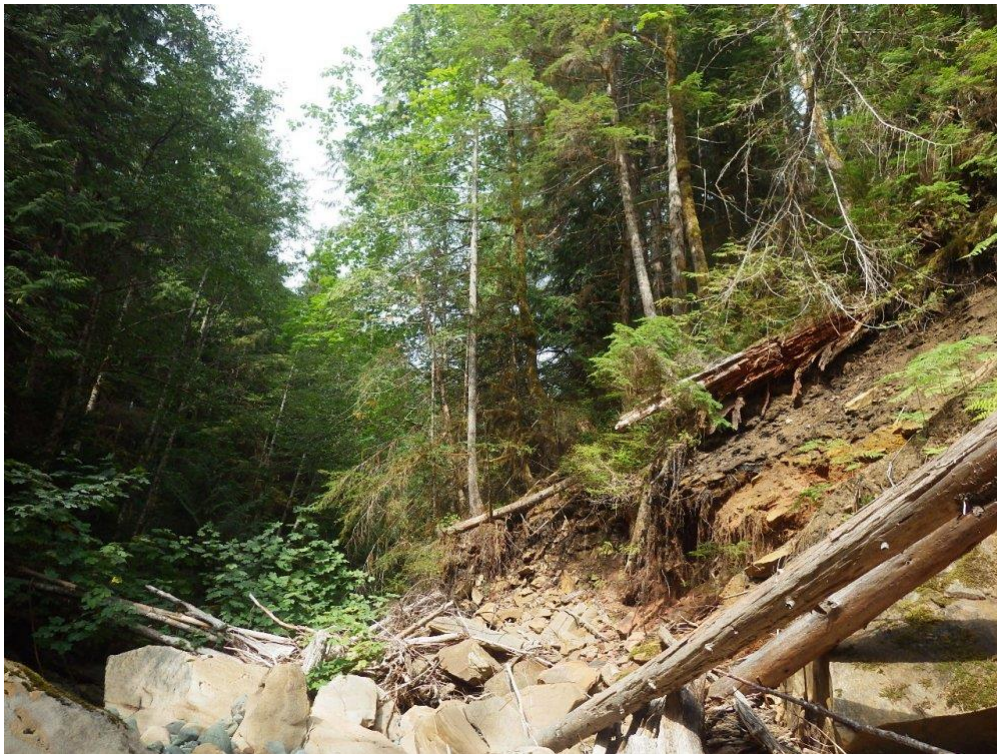
Figure 33. Eroding banks, August 23, 2018.

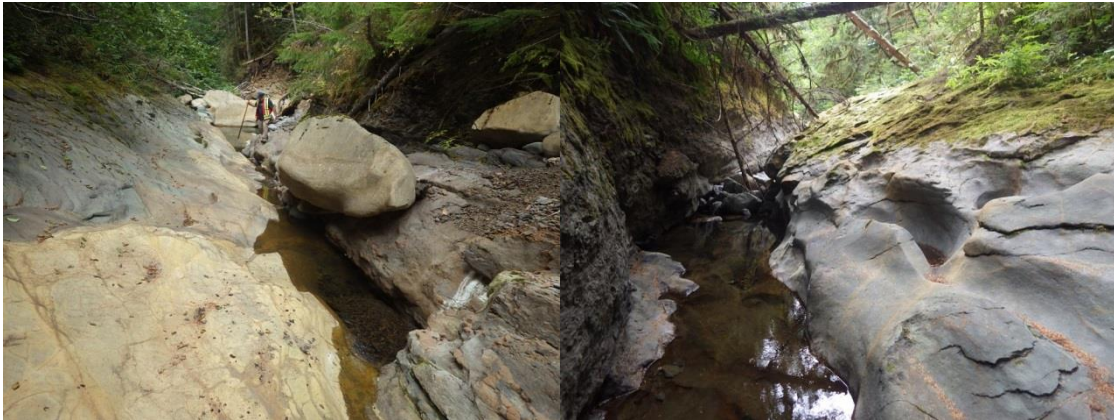
Figure 35. Constricted canyon, August 23, 2018.

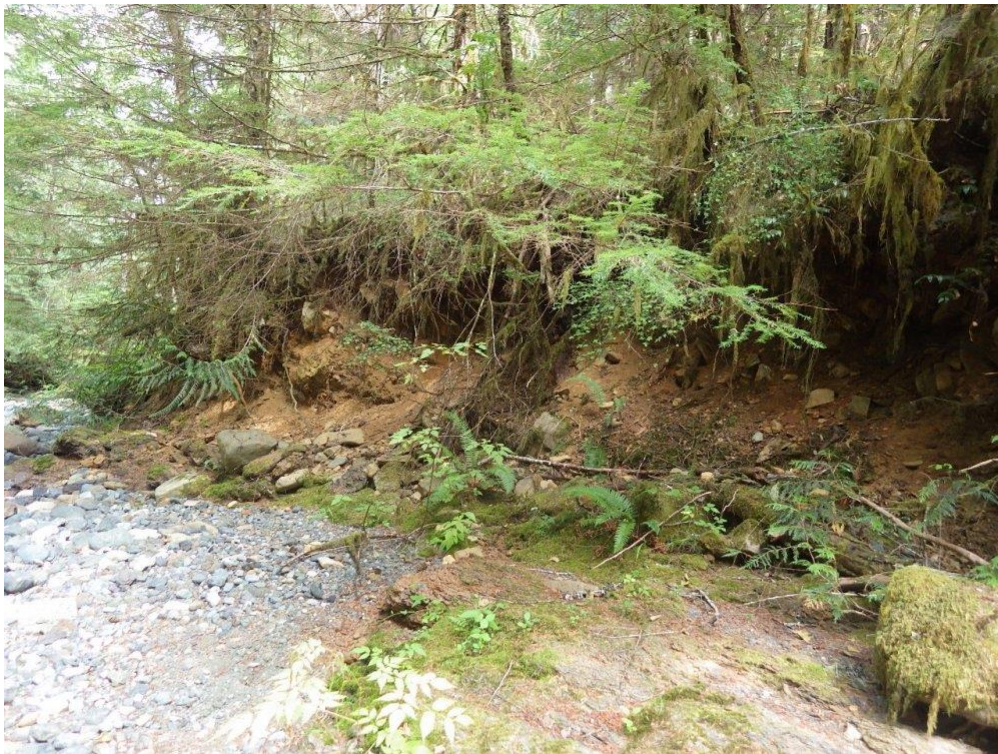
Figure 37. Eroding bank (3m high x 20m wide), August 23, 2018.

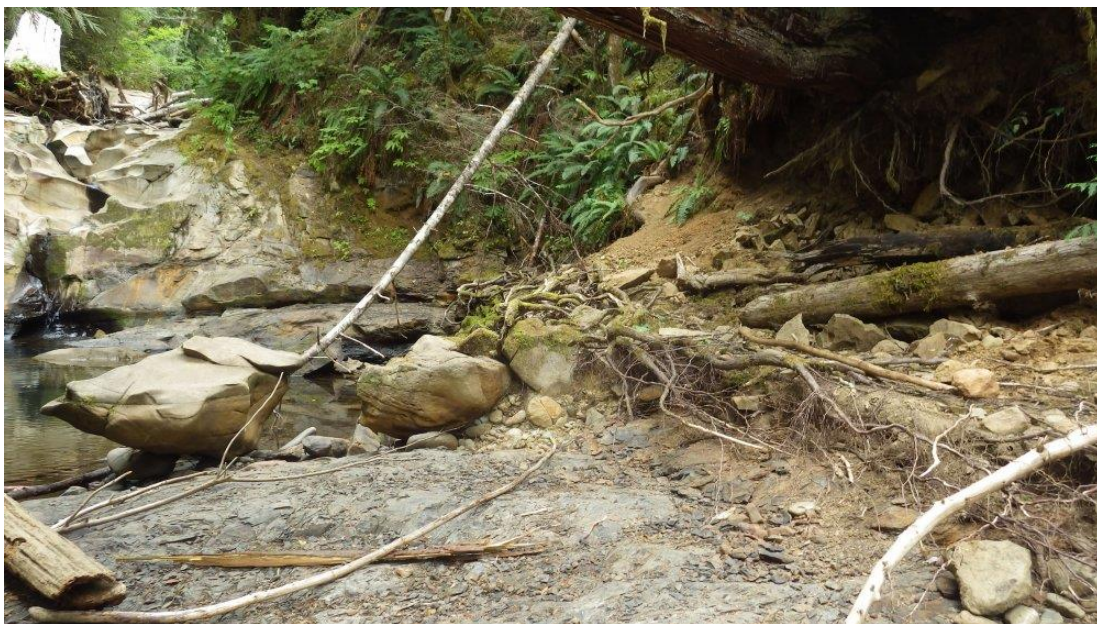
Figure 38. Eroding band below falls on river left, August 23, 2018.

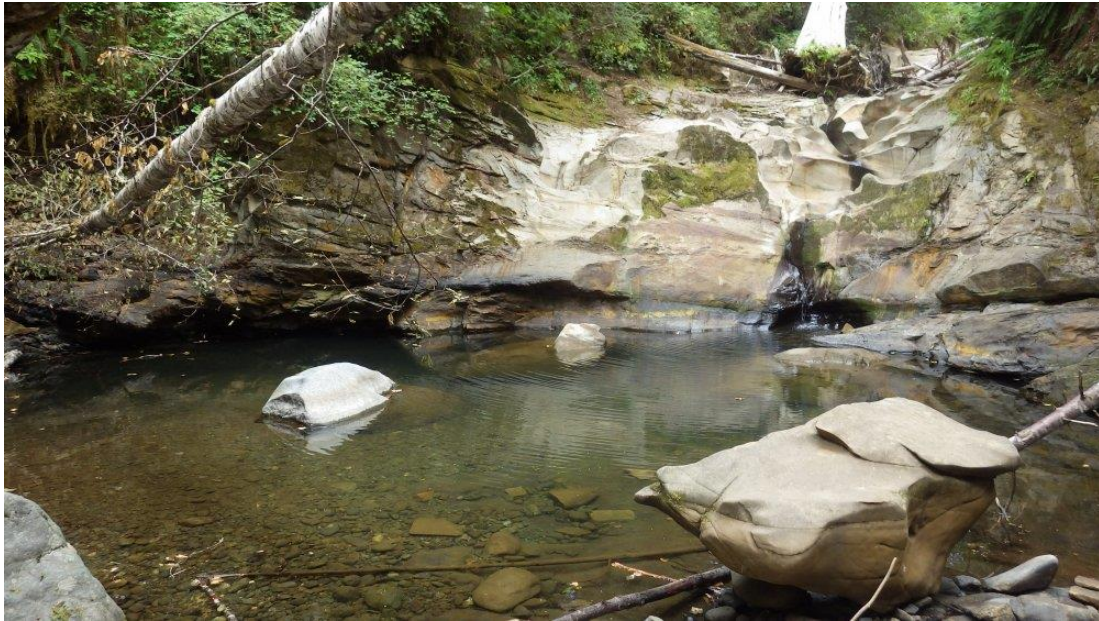
Figure 39. Pool below 5 m high barrier falls; two 200 mm long trout observed, August 23, 2018.

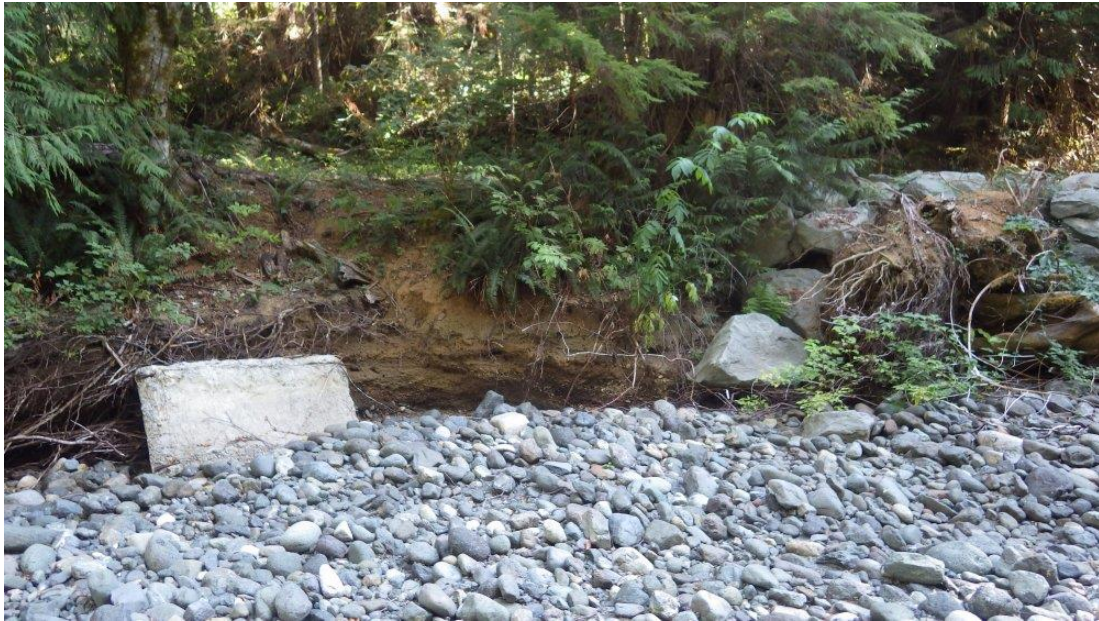
Figure 47. Eroding bank (left) and bank armouring with pavement (right), August 24, 2018.

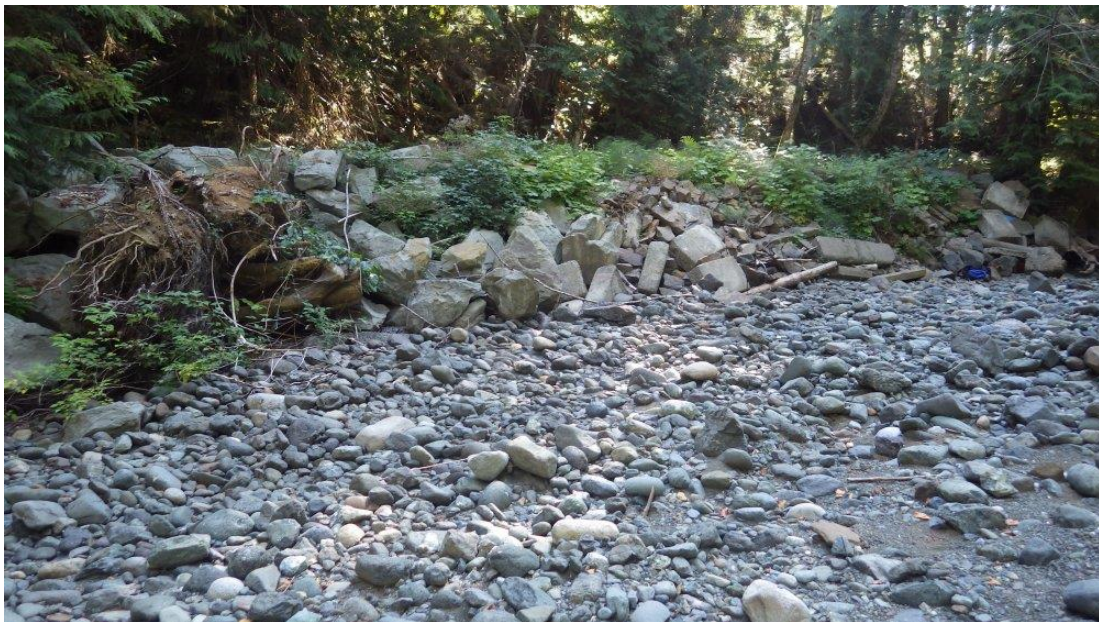
Figure 48. Bank armouring, August 24, 2018.

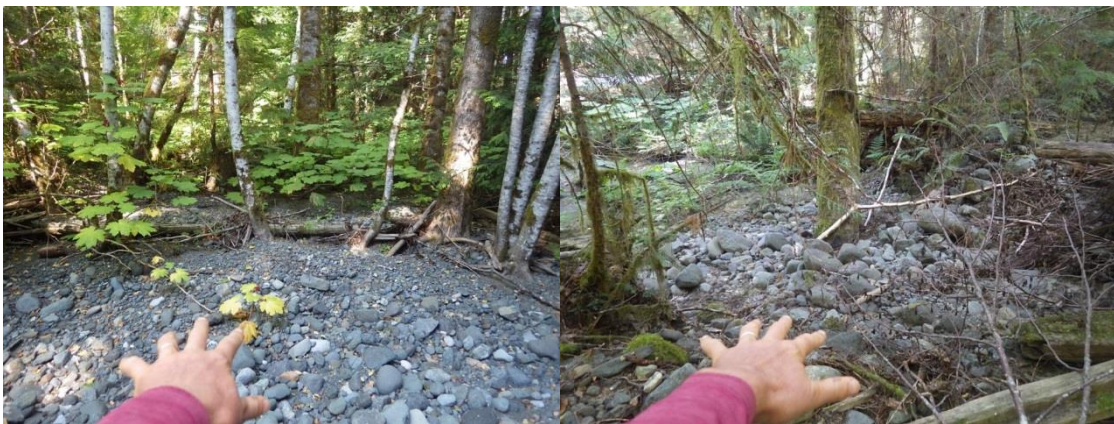
| Site | Overview |
|---|---|
| PRS-STC08 | Channel is mostly dewatered due to extensive aggradation that has filled channel with bedload and spread into the forest in many places. The channel is comprised of coarse cobble and bedrock substrates and a moderate gradient (up to 6%). A few trout exist in bedrock pools. Some extensive erosion noted. |

Figure 50. Channel filled; bedload extends into forest, August 24, 2018.

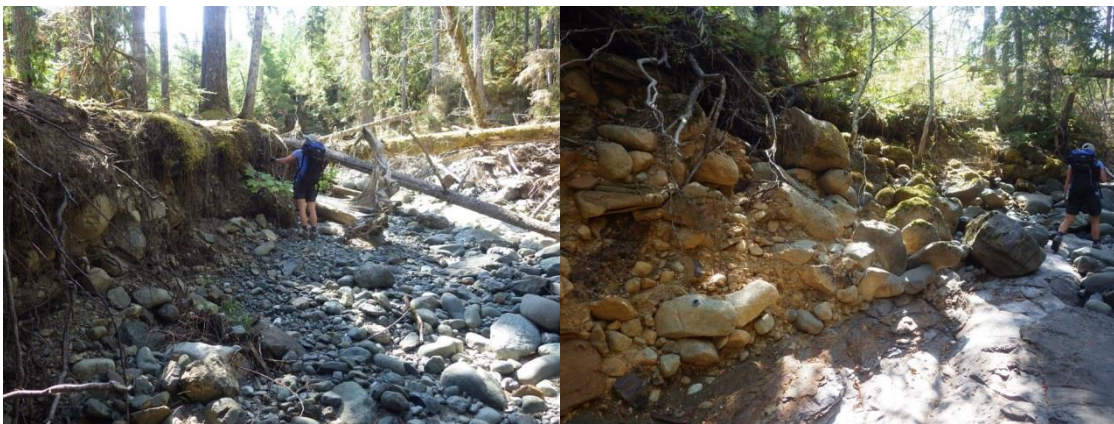
Figure 51. Eroding bank; clear-cut close to stream bank, August 24, 2018.

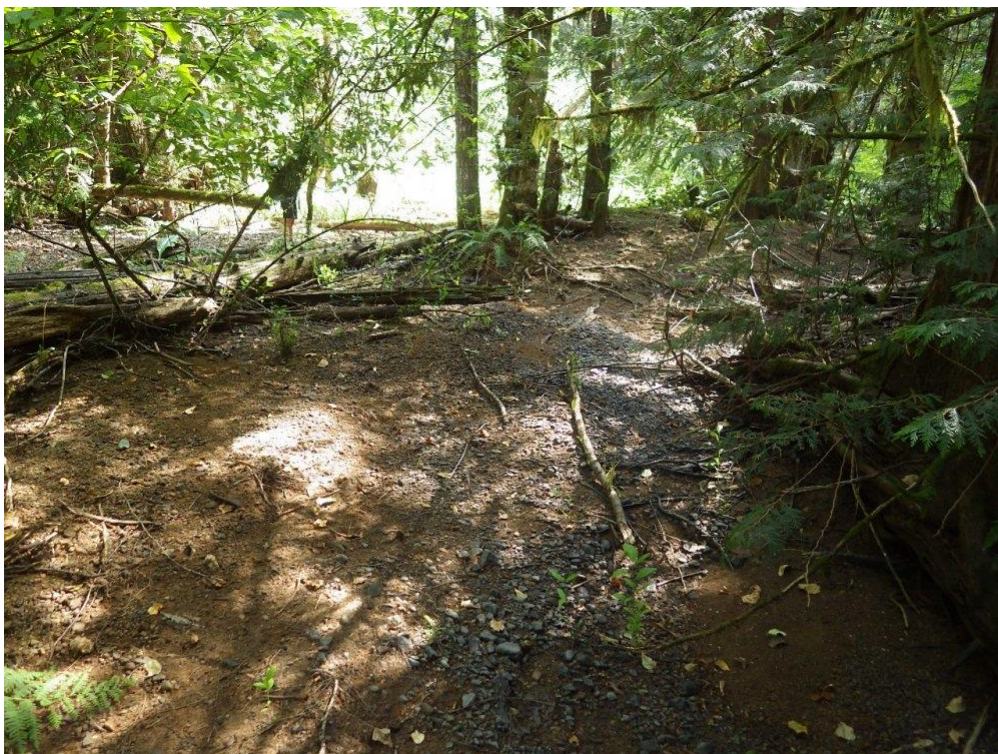
Figure 55. Sediment through forest, August 24, 2018.

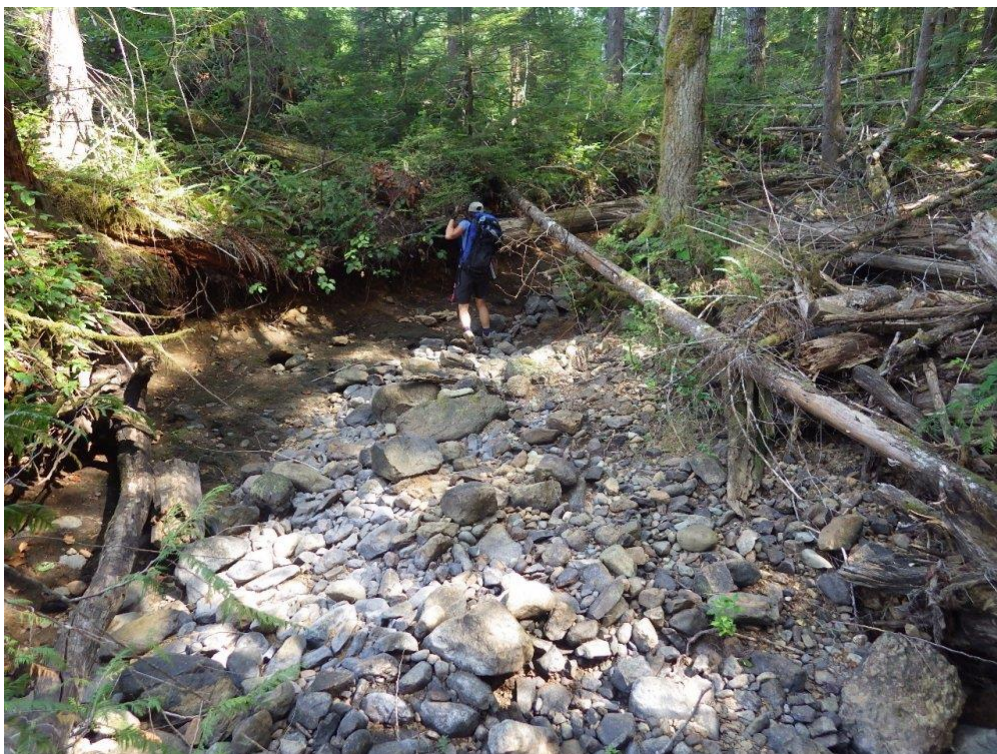
Figure 57. Severe erosion over 50 m x 2.5 m area, August 24, 2018.

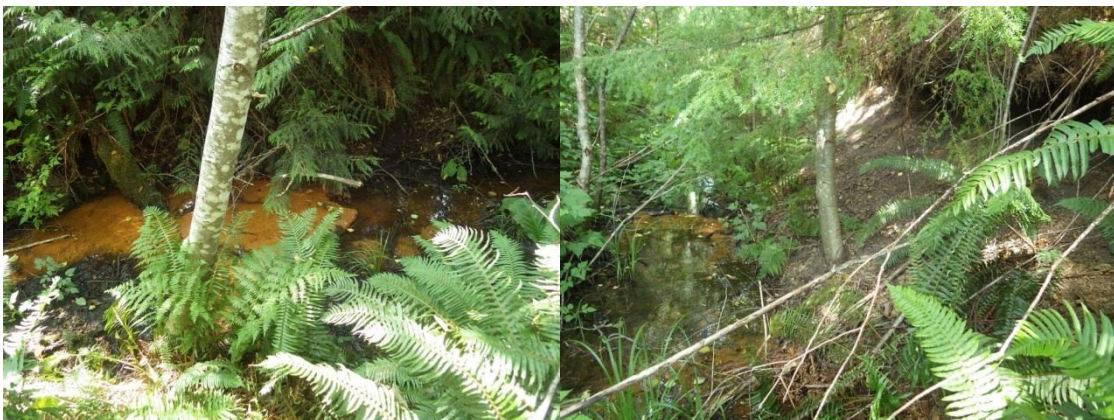
**Figure 60.** Seepage flow from East dam; iron algae blooms August 24, 2018.
