# Goose Spit Coastal Recreation Park: Proposed Enhancements

## Project Report

Prepared for the Comox Valley Regional District by:  
Outlook Land Design Inc.,  
northwest hydraulic consultants and  
Rupert Wong Consulting.

## GOOSE SPIT COASTAL PROCESSES

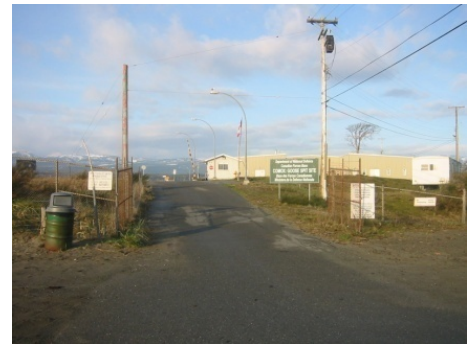
Entry to HMCS Quadra cadet training facility.  
Note over head power lines above.

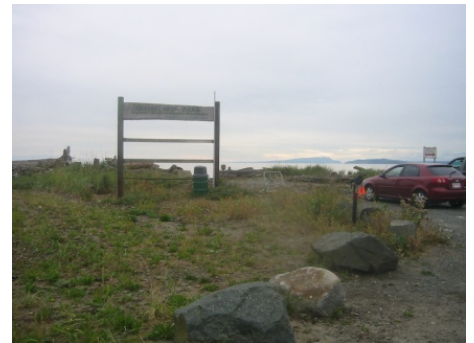
Proposed location for North Interpretive Area.

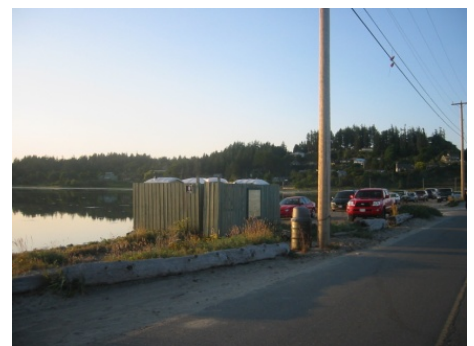
Proposed location for South Interpretive Area. Toilet area will be relocated.

### 2.4 South Interpretive Area

The South Interpretive Area replaces the toilets in their current location. This location is adjacent to and complements the Verbena Interpretive Area. Like the North Interpretive Area this area will include picnic tables, and will accommodate small groups.

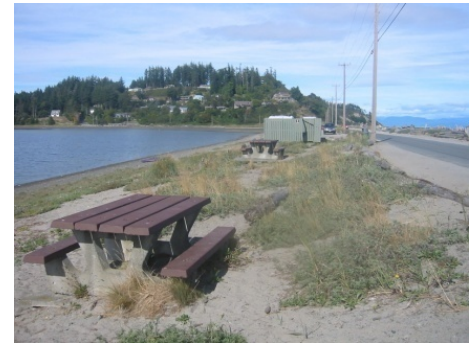
Proposed location for Verbena Interpretive area. Picnic table will be removed. Careful planning is required to ensure this is a net ecological benefit.

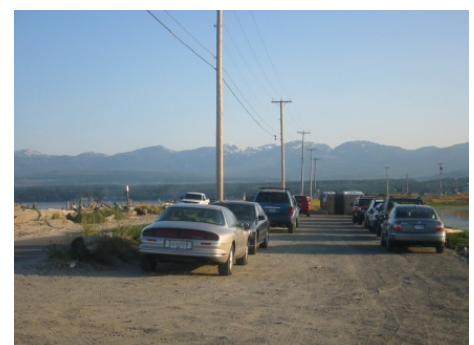
Existing parking area to be retained. Toilets will be relocated into the centre of this area.

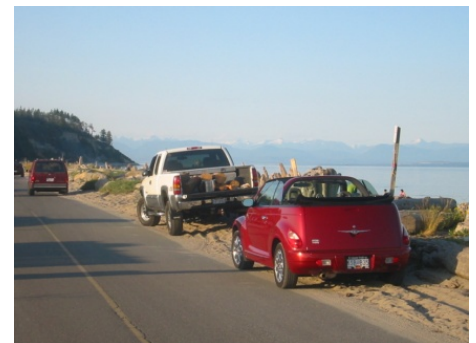
Unauthorized parking adjacent sandy beaches to south. Log barriers are to be installed to control this problem.

The highest demand beach areas are at the south end of the spit where there is the least parking. As a result, unauthorized parking on Hawkins Road frequently occurs. This is a concern to HMCS Quadra as it can impede traffic flow. Shifting log barriers closer to the pavement and stepping up enforcement are two approaches that should help reduce this problem.

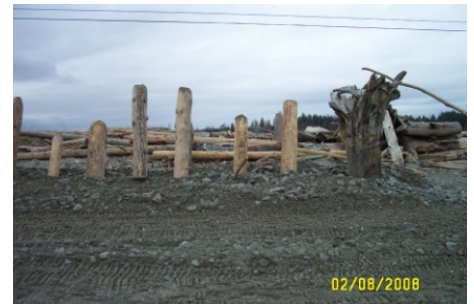
Newly installed log structures. The line of widely spaced logs will be further reviewed for their effectiveness and potentially be removed in favour of other techniques and locations.

Erosion and reduced sand supply are key concerns. The current program of log structures to control erosion is recommended for continuation. These are described in the appended northwest hydraulics' report. These structures will primarily benefit dune and road stability. It is expected that these structures will perform adequately except in the most extreme events and therefore prevent or delay harsher erosion control methods. Most park users do not object to log structures and see them as a necessary measure. Ideally, these structures should be kept low enough to allow water views from parked vehicles.

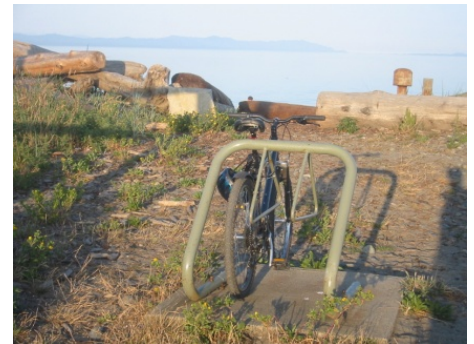
New site furnishings should conform to a design theme. The existing bike rack has an appropriate colour but the crude concrete base detracts from the natural setting.

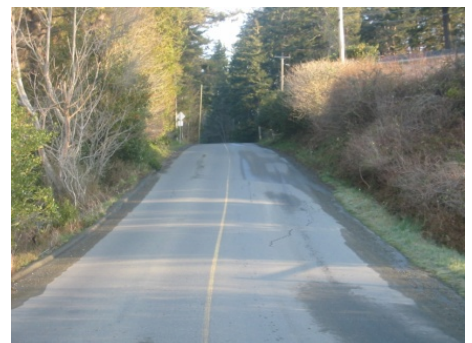
Dangerous hill on Hawkins Road. This is the main walking and cycling access to the Park. A separated trail would be a safety benefit.

Continuing south from the Yates Road intersection, Hawkins descends a steep hill while turning a sharp corner. Without shoulders pedestrians are forced onto the narrow pavement, thus making this portion of Hawkins unsafe and unpleasant for most people. This portion of Hawkins does not meet road safety conventions or the expectations of residents. A parallel separated route is strongly recommended. A conceptual section is provided on Section 2, Drawing L08. A topographic survey is required to confirm feasibility and to which side of the road it is preferred. Construction on either side will have extensive tree impacts.

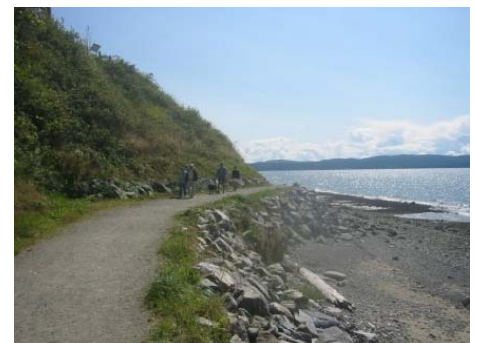
A shoreline trail recently constructed in Powell River in an exposed ocean environment.

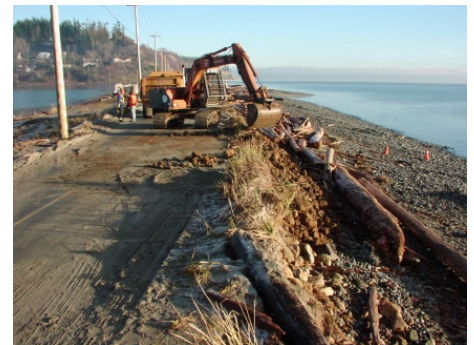
Ministry of Transportation contractor repairing erosion along Hawkins Road. Goose Spit Park is located on both sides of Hawkins Road.

The Ministry of Transportation is responsible for Hawkins Road. Their contractor maintains the roadway which typically consists of removal of windblown sand from the roadway as well as erosion repairs as required.

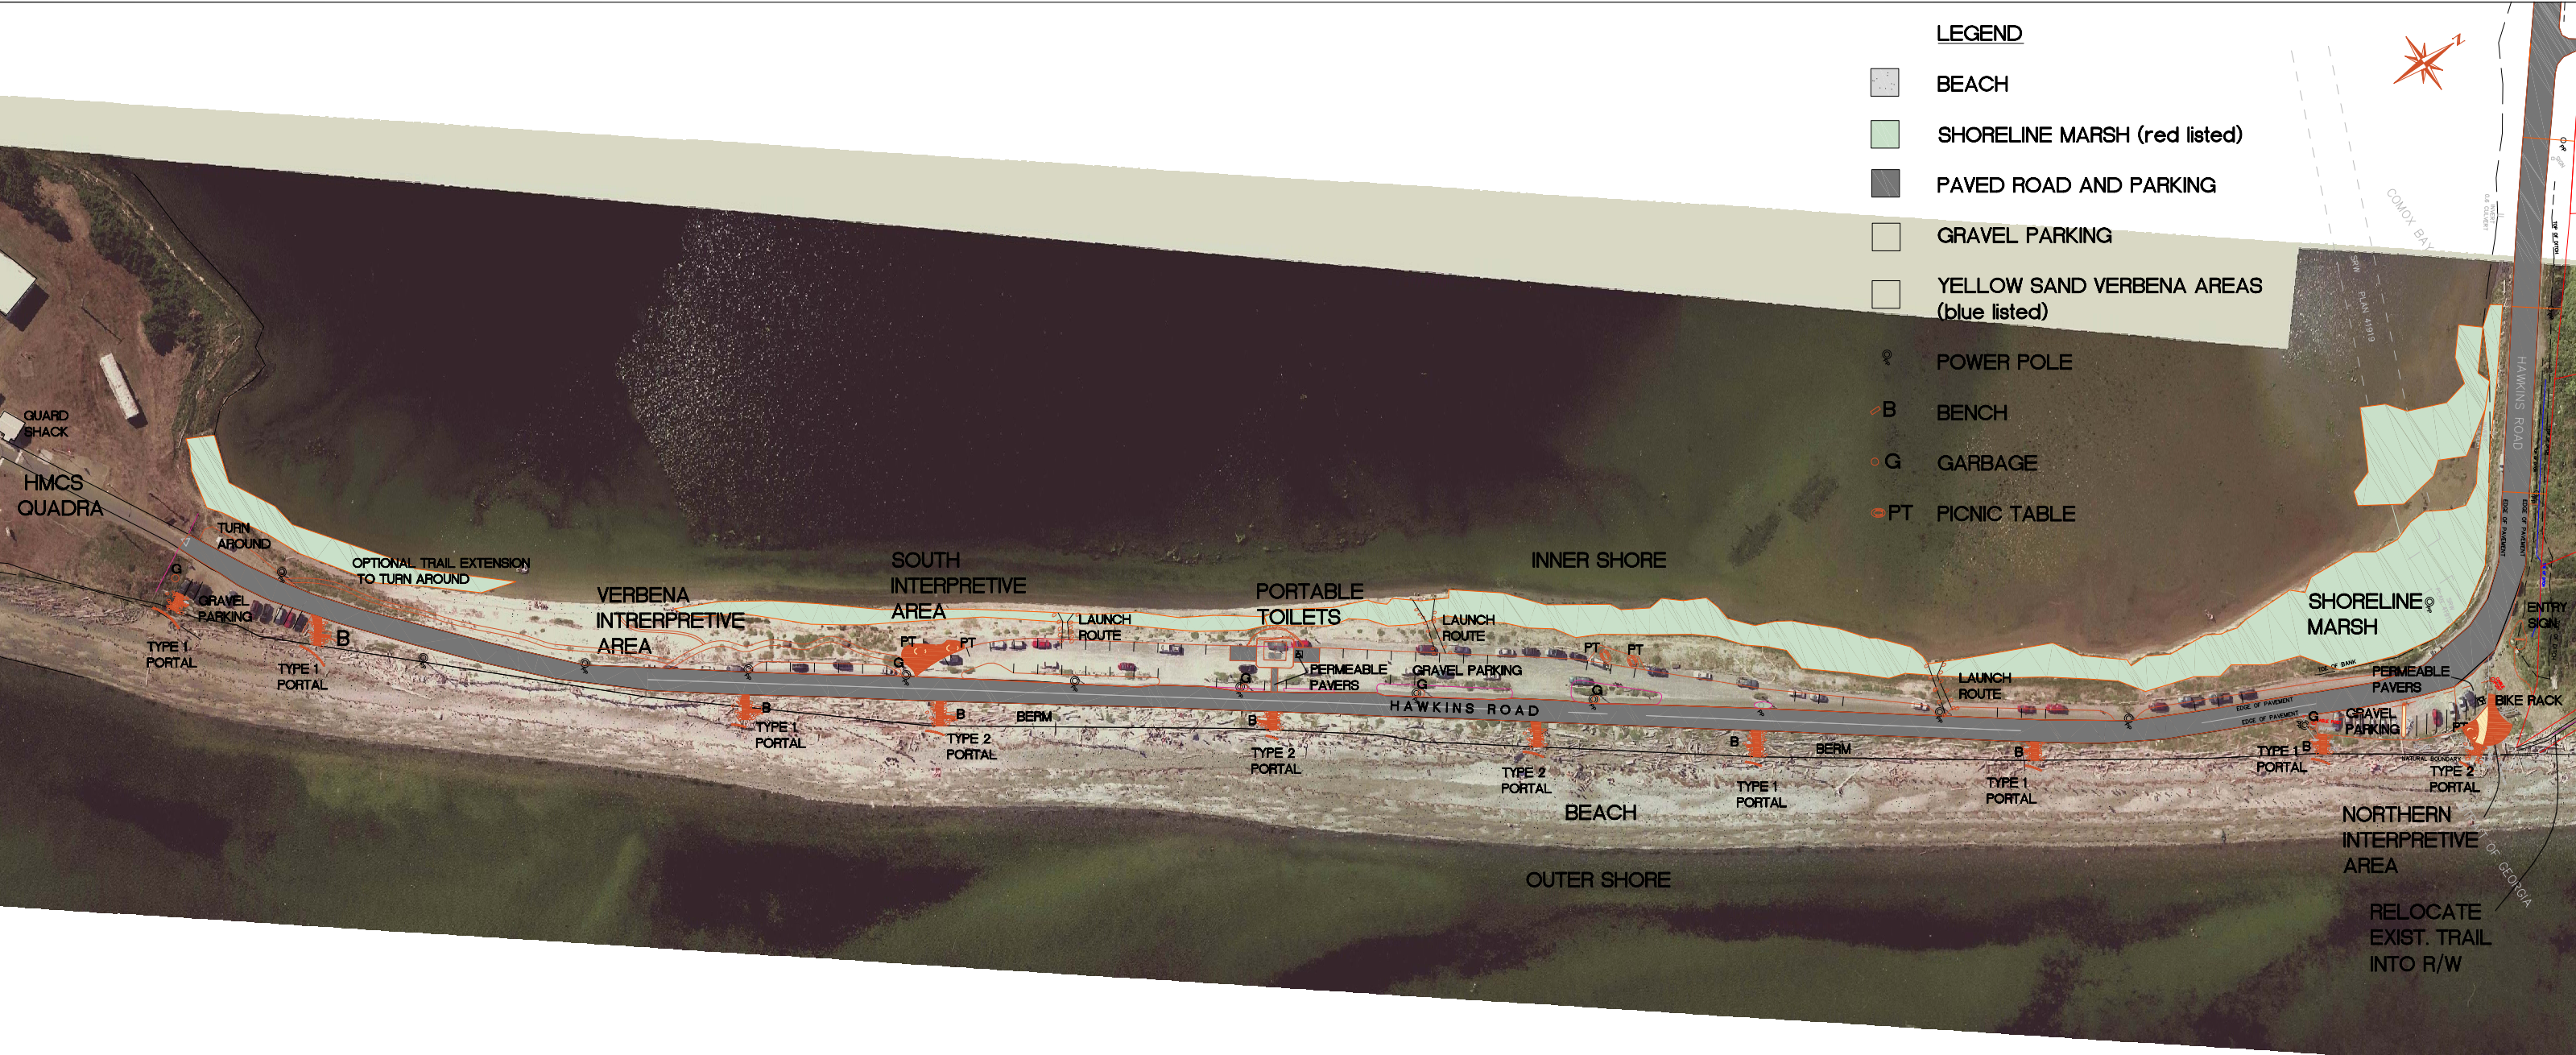
SITE PLAN AERIAL OVERLAY

*Goose Spit Park*

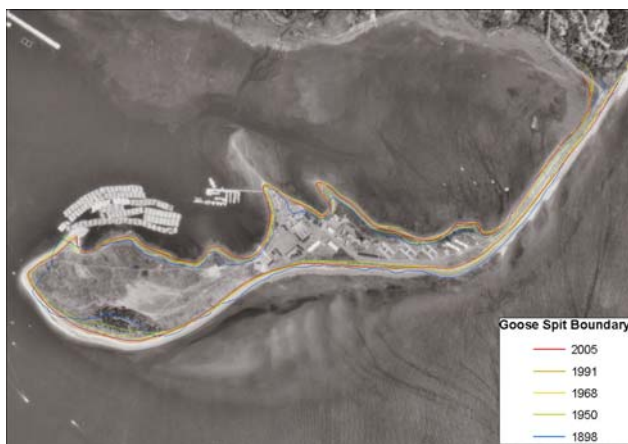
The southern portion of this area has experienced significant deposition over time, increasing by approximately 2 ha from 1898 to 1991. There is some evidence the vegetation boundary in this area has retreated by roughly 10 m between 1991 and 2005 although this is difficult to determine due to the relatively low resolution of the available 2005 imagery. Deposition has also occurred on the western edge of the spit with the overall shape of this area changing between the 1898 survey and the 1950 aerial photography, remaining relatively constant for the remainder of record.

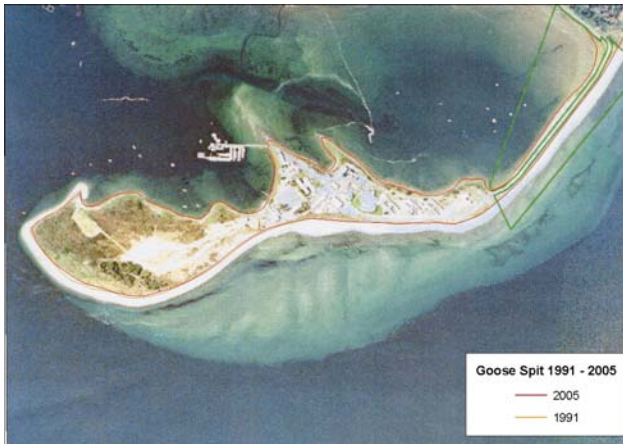
1991 – 2005 (2005 scanned ortho copy)

The unvegetated portion of the spur does not extend as far out in 2005 (may be differing tides) and more sediment appears to be deposited on the leeward side by 2005 ;

The vegetation boundary on the south edge of the west spit end may have retreated but it is difficult to say for sure with the scan resolution/overexposure in the 2005 image;

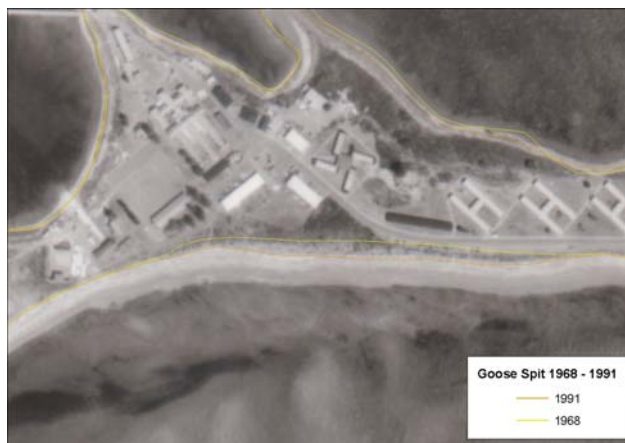
1968 to 1991 (1991 Photo)

The neck of the spit has remained stable throughout this time period.

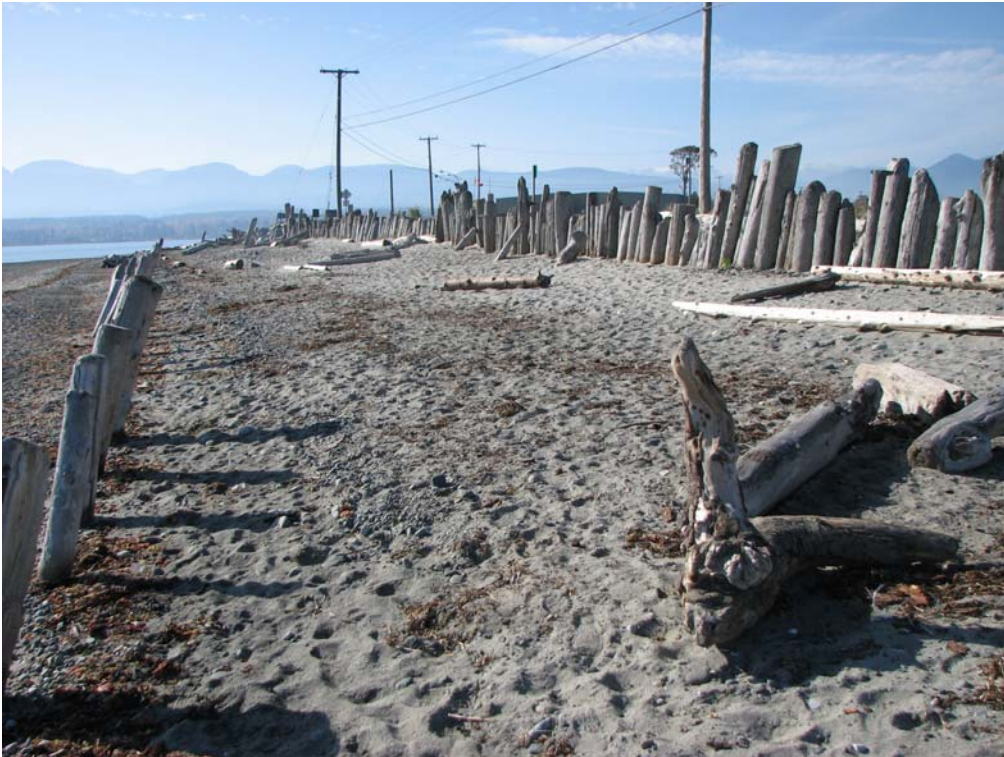
Photo 1: Viewing southwest, Type 1 log protection near SW end of park

This type of structure is found mainly along the south-west end of the park towards the entrance to the Department of National Defence base and is illustrated in Photo 1. The structure consists of a row of closely spaced logs embedded in the beach to form a continuous wall near the edge of the road. The wall promotes wind-blown sand to deposit directly behind it, which probably reduces sand accumulation on the road. A second row of logs spaced around 2 m apart has been embedded in the beach approximately 9 m further down the slope. It appears these logs do not have much effect on the beach profile (Photo 1), although they may help to retain driftwood on the higher elevation portions of the beach.

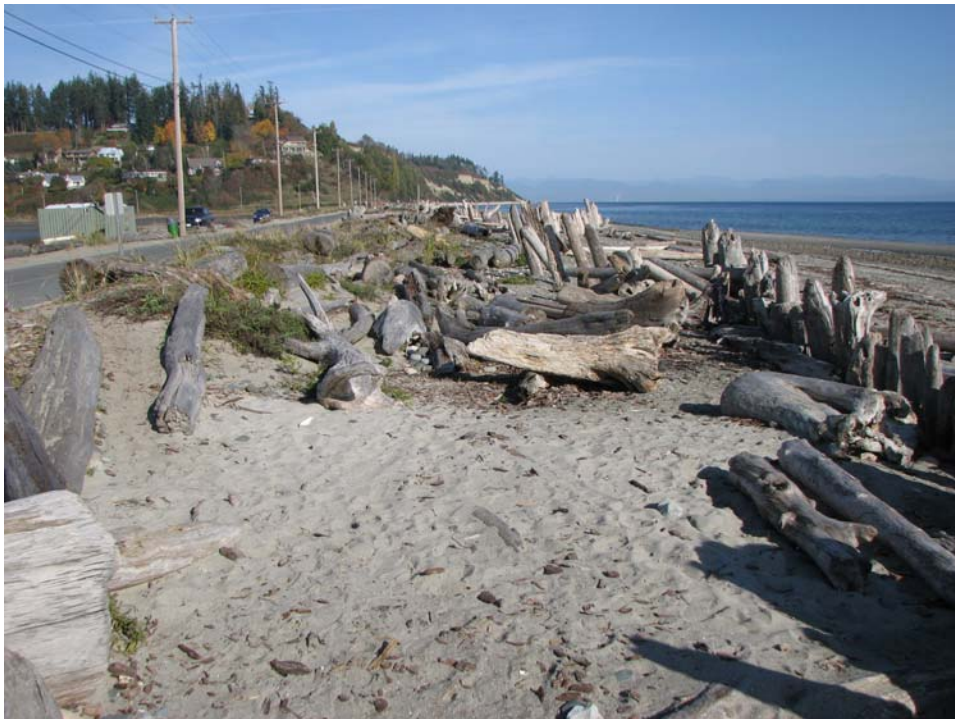
Photo 2: Viewing north east Type 2 log protection

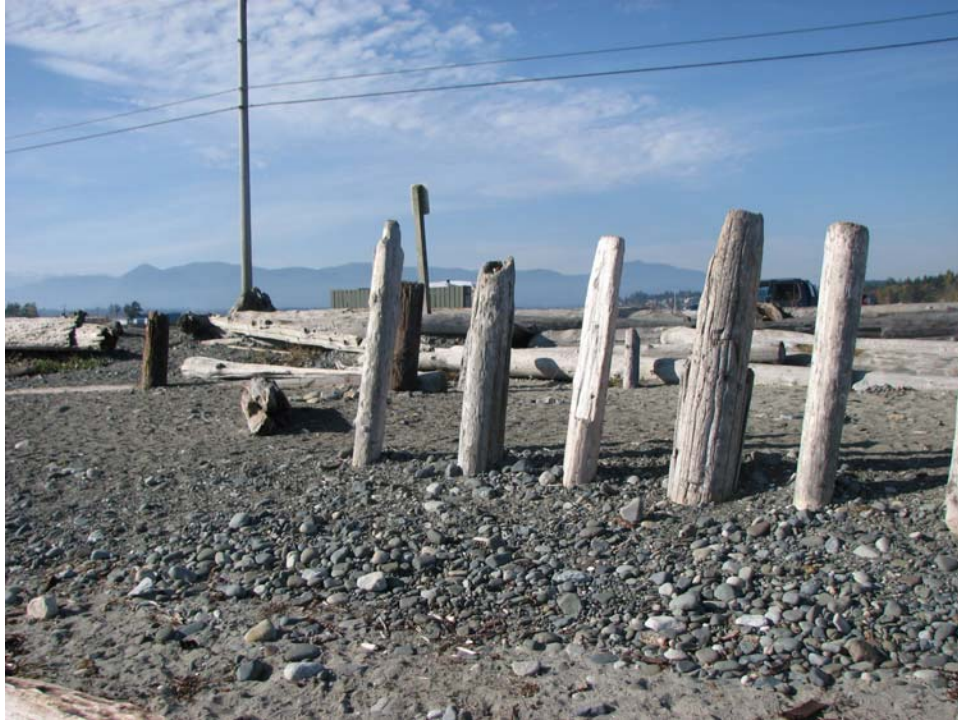
Photo 3: Type 3 Protection

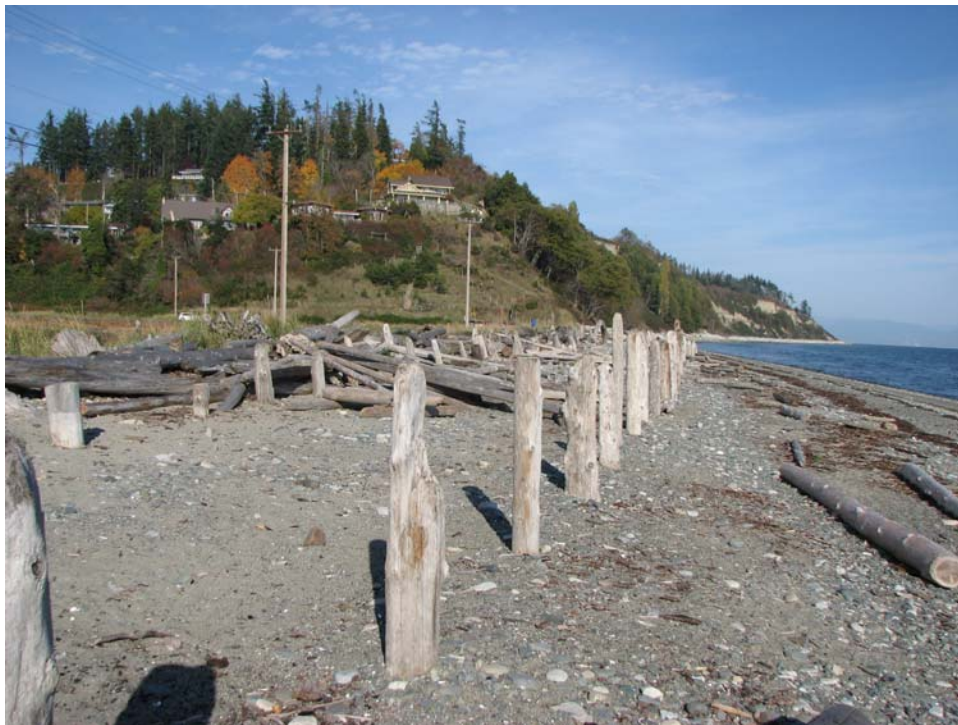
Photo 4: Type 4 Log Protection

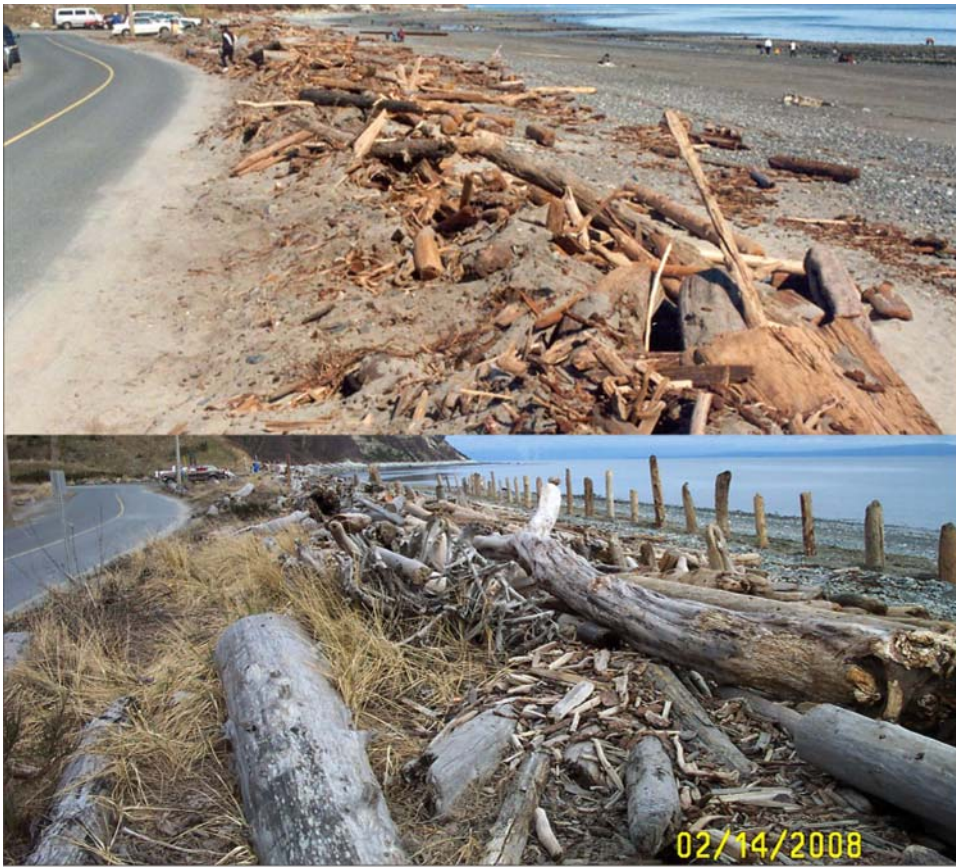
Photo 5: Changes on Berm 1999 to 2008

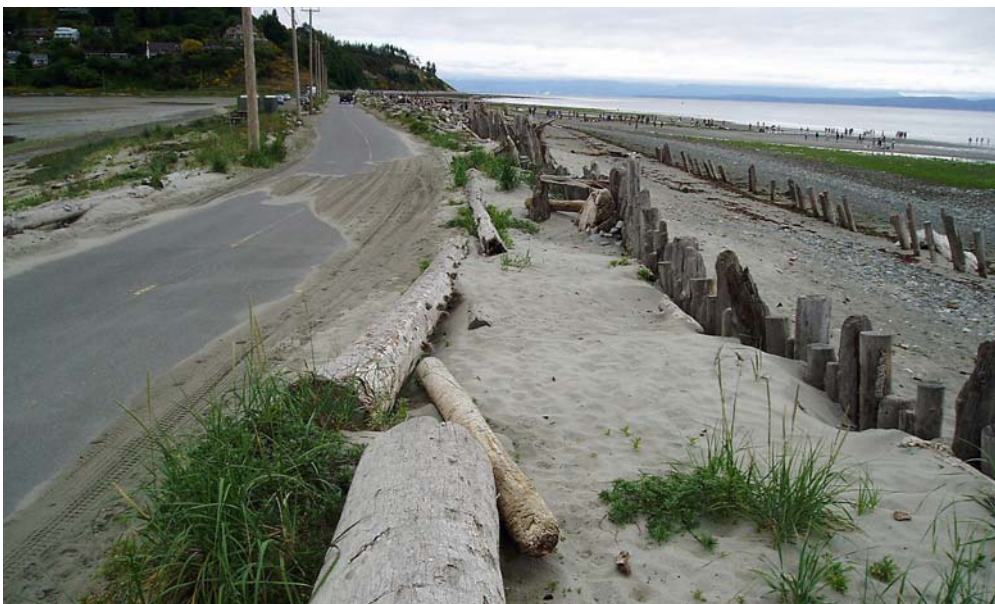
Photo 6: Sand Deposition on Road

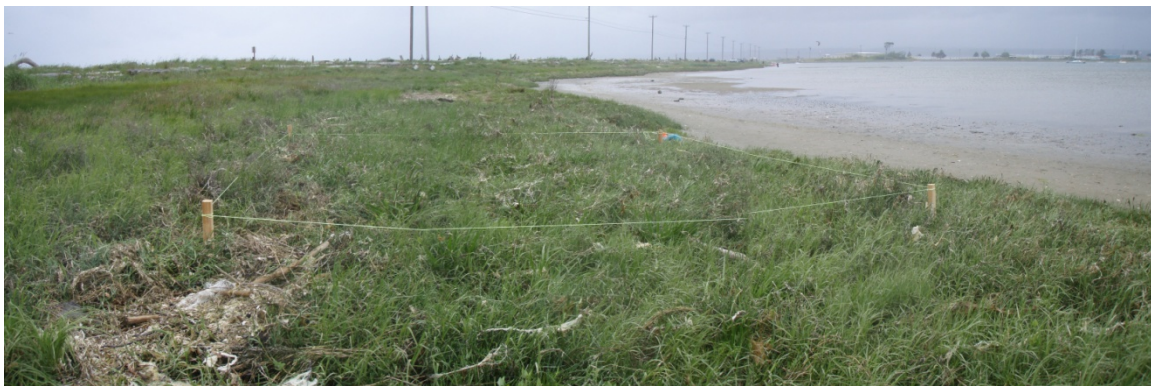
**Photo 6. Southwest view of 5 m x 5 m quadrat located in northeast corner of Marshland planning unit showing typical complex between CDFmm/Em03 and CDFmm/Em02 (May 2008).**

recognized as important habitat for aquatic wildlife. *Distichlis spicata* is dominant with subdominant coverage of *Salicornia virginica* and scattered coverage of *Glaux maritima* and *Atriplex patula* (Photo 5). Margins of this community are poorly defined with Em02 as these two communities are occurring in complex with one another (Photo 6).

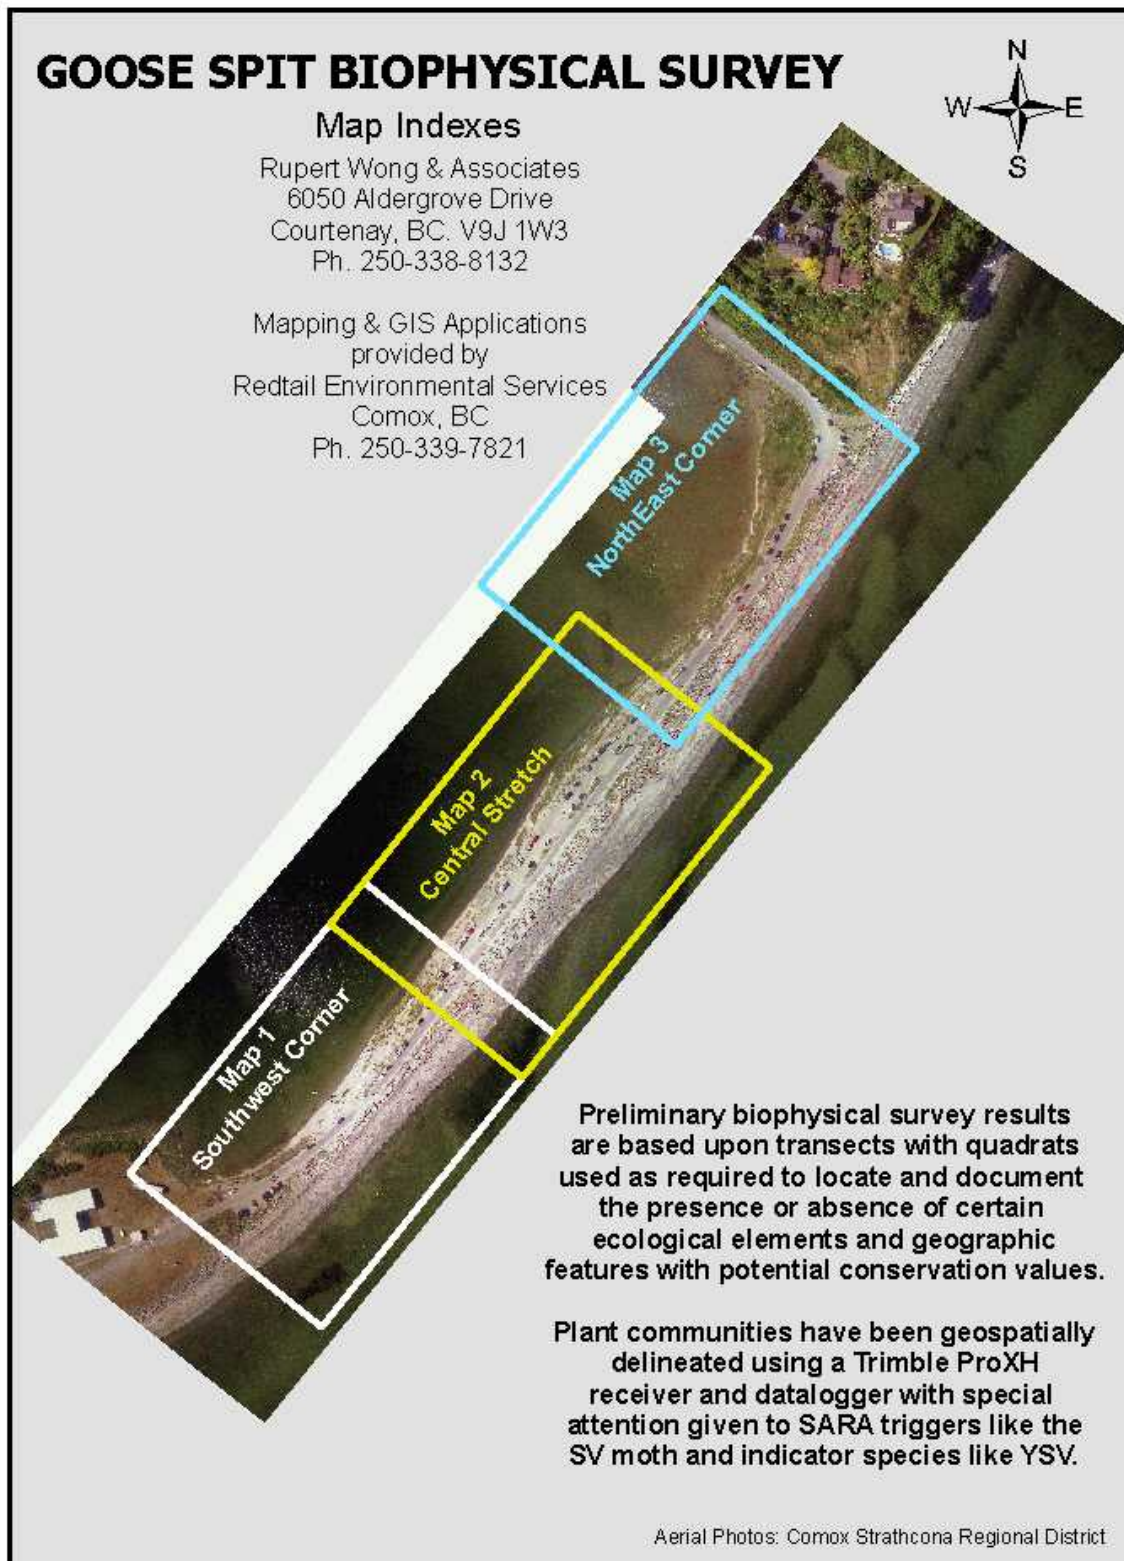
**Figure 5. Overview map showing distribution of map indexes used to delineate occurrences of rare plant communities.**

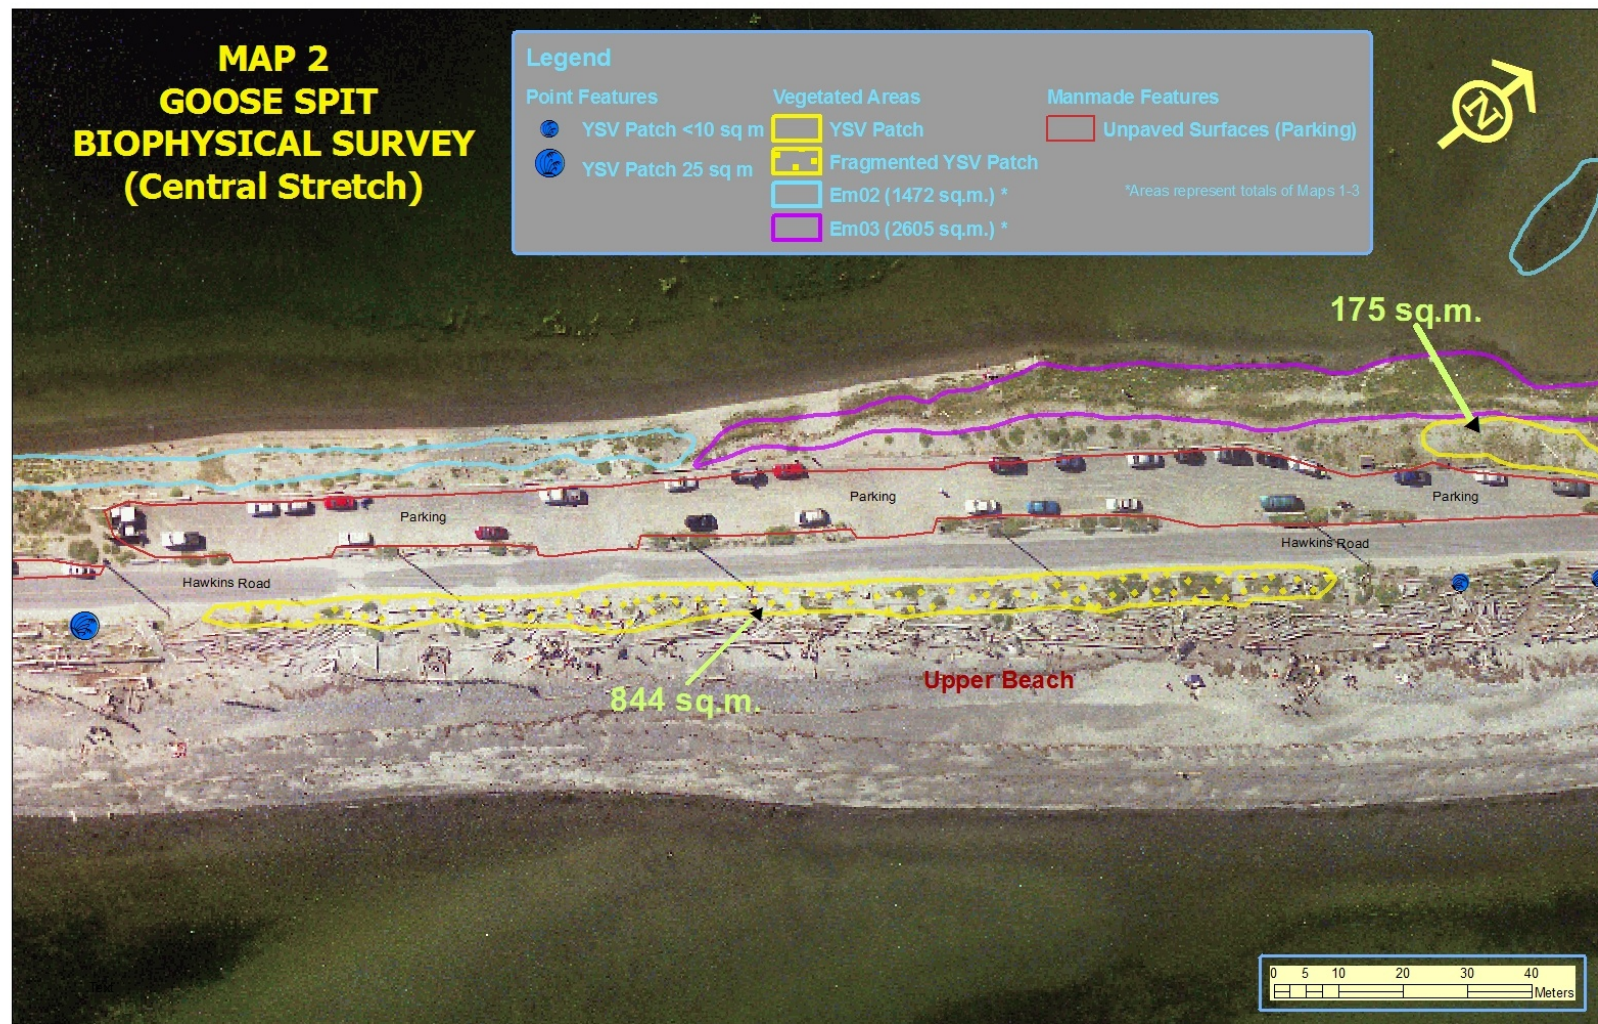
Figure 7. Index map 2 showing geospatial delineation of salt marsh and sand dune ecosystems within the central portion of the Study Area.

The Glasswort - Sea-milkwort community occupies an estimated area of 0.15 ha along the southeast margin of the Marshland planning unit where soils are mainly fine textured with some coarse fragments (Figure 4, 7 & 8). Em03 and Em02 dominate a nearly continuous margin of vegetation along the high intertidal zone of Comox Harbour that extends into the Marshland planning unit. The complex of both plant communities were mapped and identified as Polygon S1170 in 1998 by Environment Canada. The site

The Sparsely Vegetated Herbaceous Sand Dune site association occurs in different sized patches over an estimated 0.20 ha within the Study Area (Figures 4, 6, 7 & 8). The site is located along the upper beach and is typically fragmented or impaired by human-made features, frequent disturbance, and stabilization of sand by coarse wood accumulations and establishment of invasive plant species. Substrate in this site is dominated by exposed sand, which is regularly transported by way of wind and wave energy. Species diversity in the Sand Dune community is characteristically low and consists of scattered cover of rare and provincially listed *Abronia latifolia*, *Polygonum*

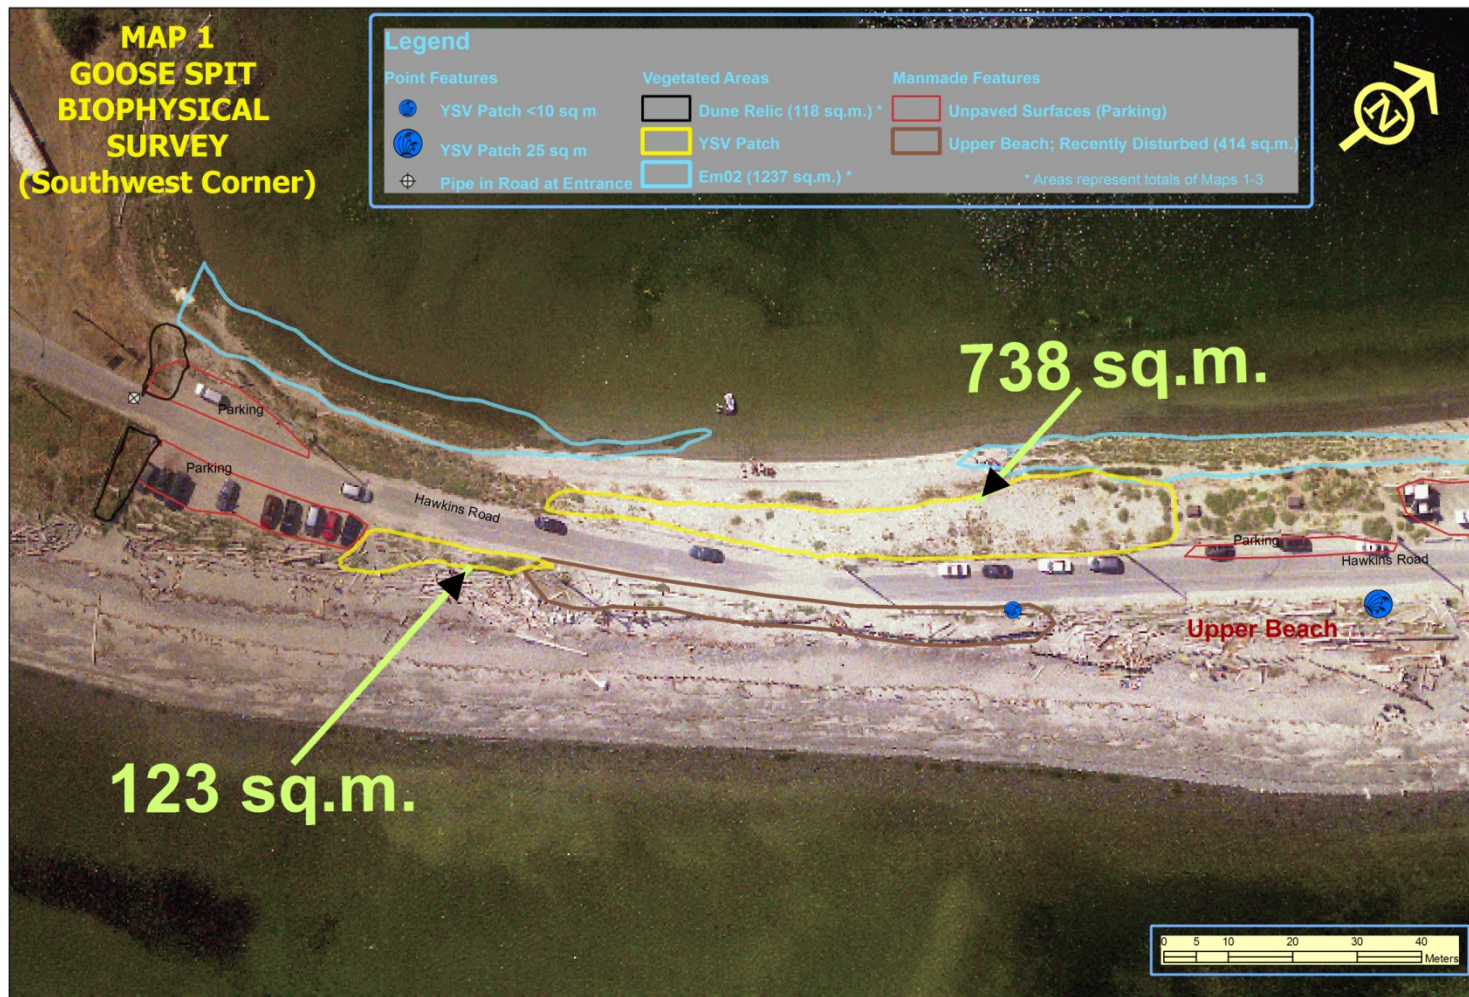
Figure 8. Index map 1 showing geospatial delineation of salt marsh and sand dune ecosystems within the southwest corner of the Study Area.

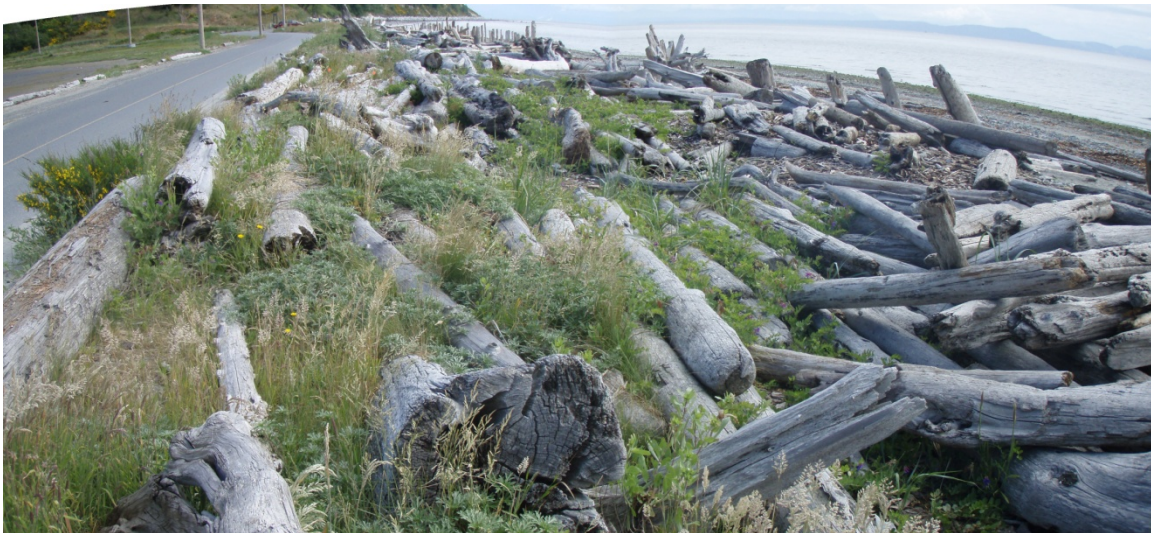
Photo 20. Northeast end of the outer shore showing dense log and coarse woody debris accumulations over the upper beach where opportunity for log removal and Sand-verbena Moth Recovery exist (May 2008).

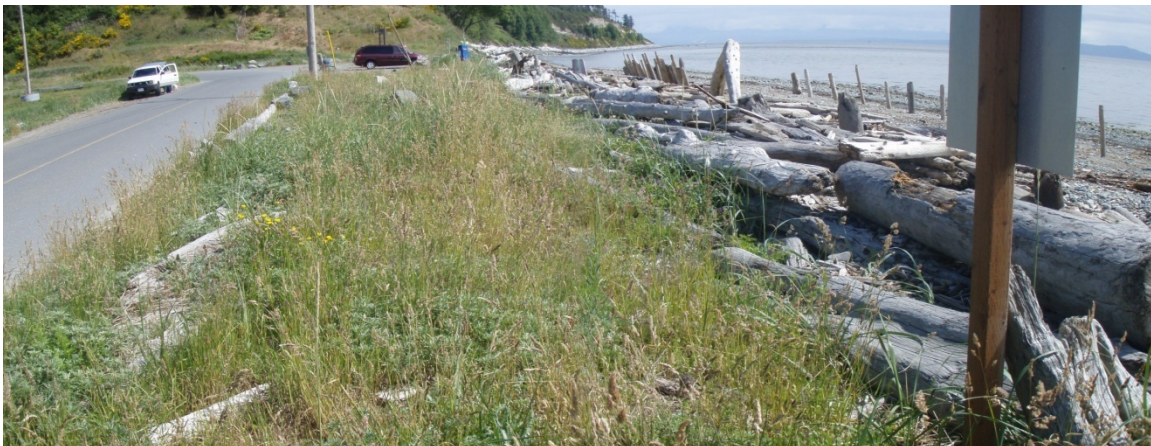
Photo 21. Northeast end of the outer shore showing dense log accumulations and proliferation of invasive plant species over the upper beach where opportunity for log removal and Sand-verbena Moth Recovery exist (May 2008).

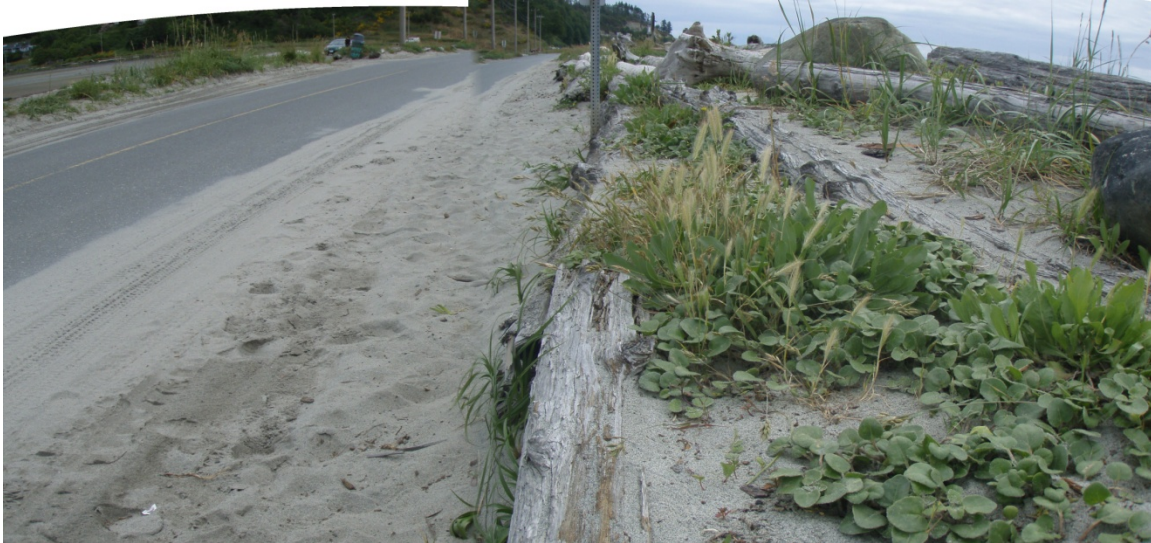
**Photo 22. Northeast view of 844 m<sup>2</sup> patch of Yellow sand-verbena located along southeast side of Hawkins Road across from the main parking area with other patches not shown (May 2008).**

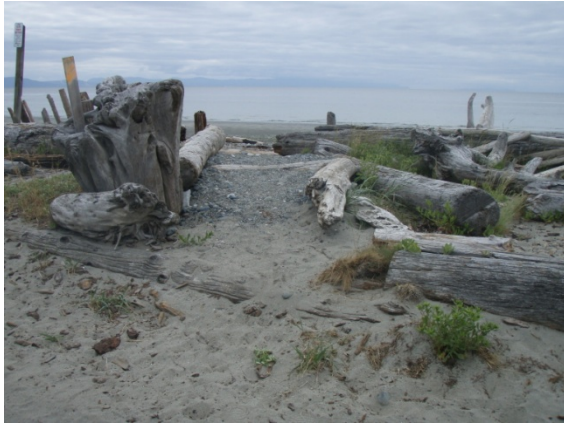
**Photo 23. Typical existing beach access achieved by maneuvering and placing beach logs (May 2008).**

Part of the strategy to address conflicts between recreational use and sensitive Dune ecosystem is to localize and concentrate disturbance to constructed and maintained beach access sites described as Portals by Outlook Land Design Inc (2008). While existing beach access sites provide some measure of mitigation the 10 proposed portals are distributed along the outer beach to enhance existing access locations and create additional suitable sites (Photo 23). Depending on the location, type and quantity of portals constructed a range of harmful alterations will occur to the Dune ecosystem including direct impacts to Yellow Sand –verbena and Sand-verbena moth. To avoid environmental impacts careful consideration should be given to locating portals between existing Yellow Sand-verbena patches and providing an adequate

buffer to allow for stand growth where habitat criteria is met. Careful consideration should also be given to evaluating the need for impermeable surfaces proposed for type 2 portals as the cumulative effect of such permanent features can impose a significant footprint that will potentially impair natural dune processes and opportunities for

ecosystem recovery. Where impacts to Yellow Sand-verbena and Sand-verbena moth habitat are unavoidable suitable compensation strategies such as Yellow Sand –verbena propagation and habitat construction are expected to be feasible for the scale of the beach portal project.
