## Technical Memorandum #2

**RE:** Coastal Flood Mapping Project  
Technical Memorandum #2 – Fluvial and Coastal Geomorphology  
Our File 2623.014-300

This technical memorandum (#2) documents the fluvial (river migration corridor) and coastal (shoreline erodibility) geomorphic assessment components of the project. Other technical memoranda will document the remaining project components.

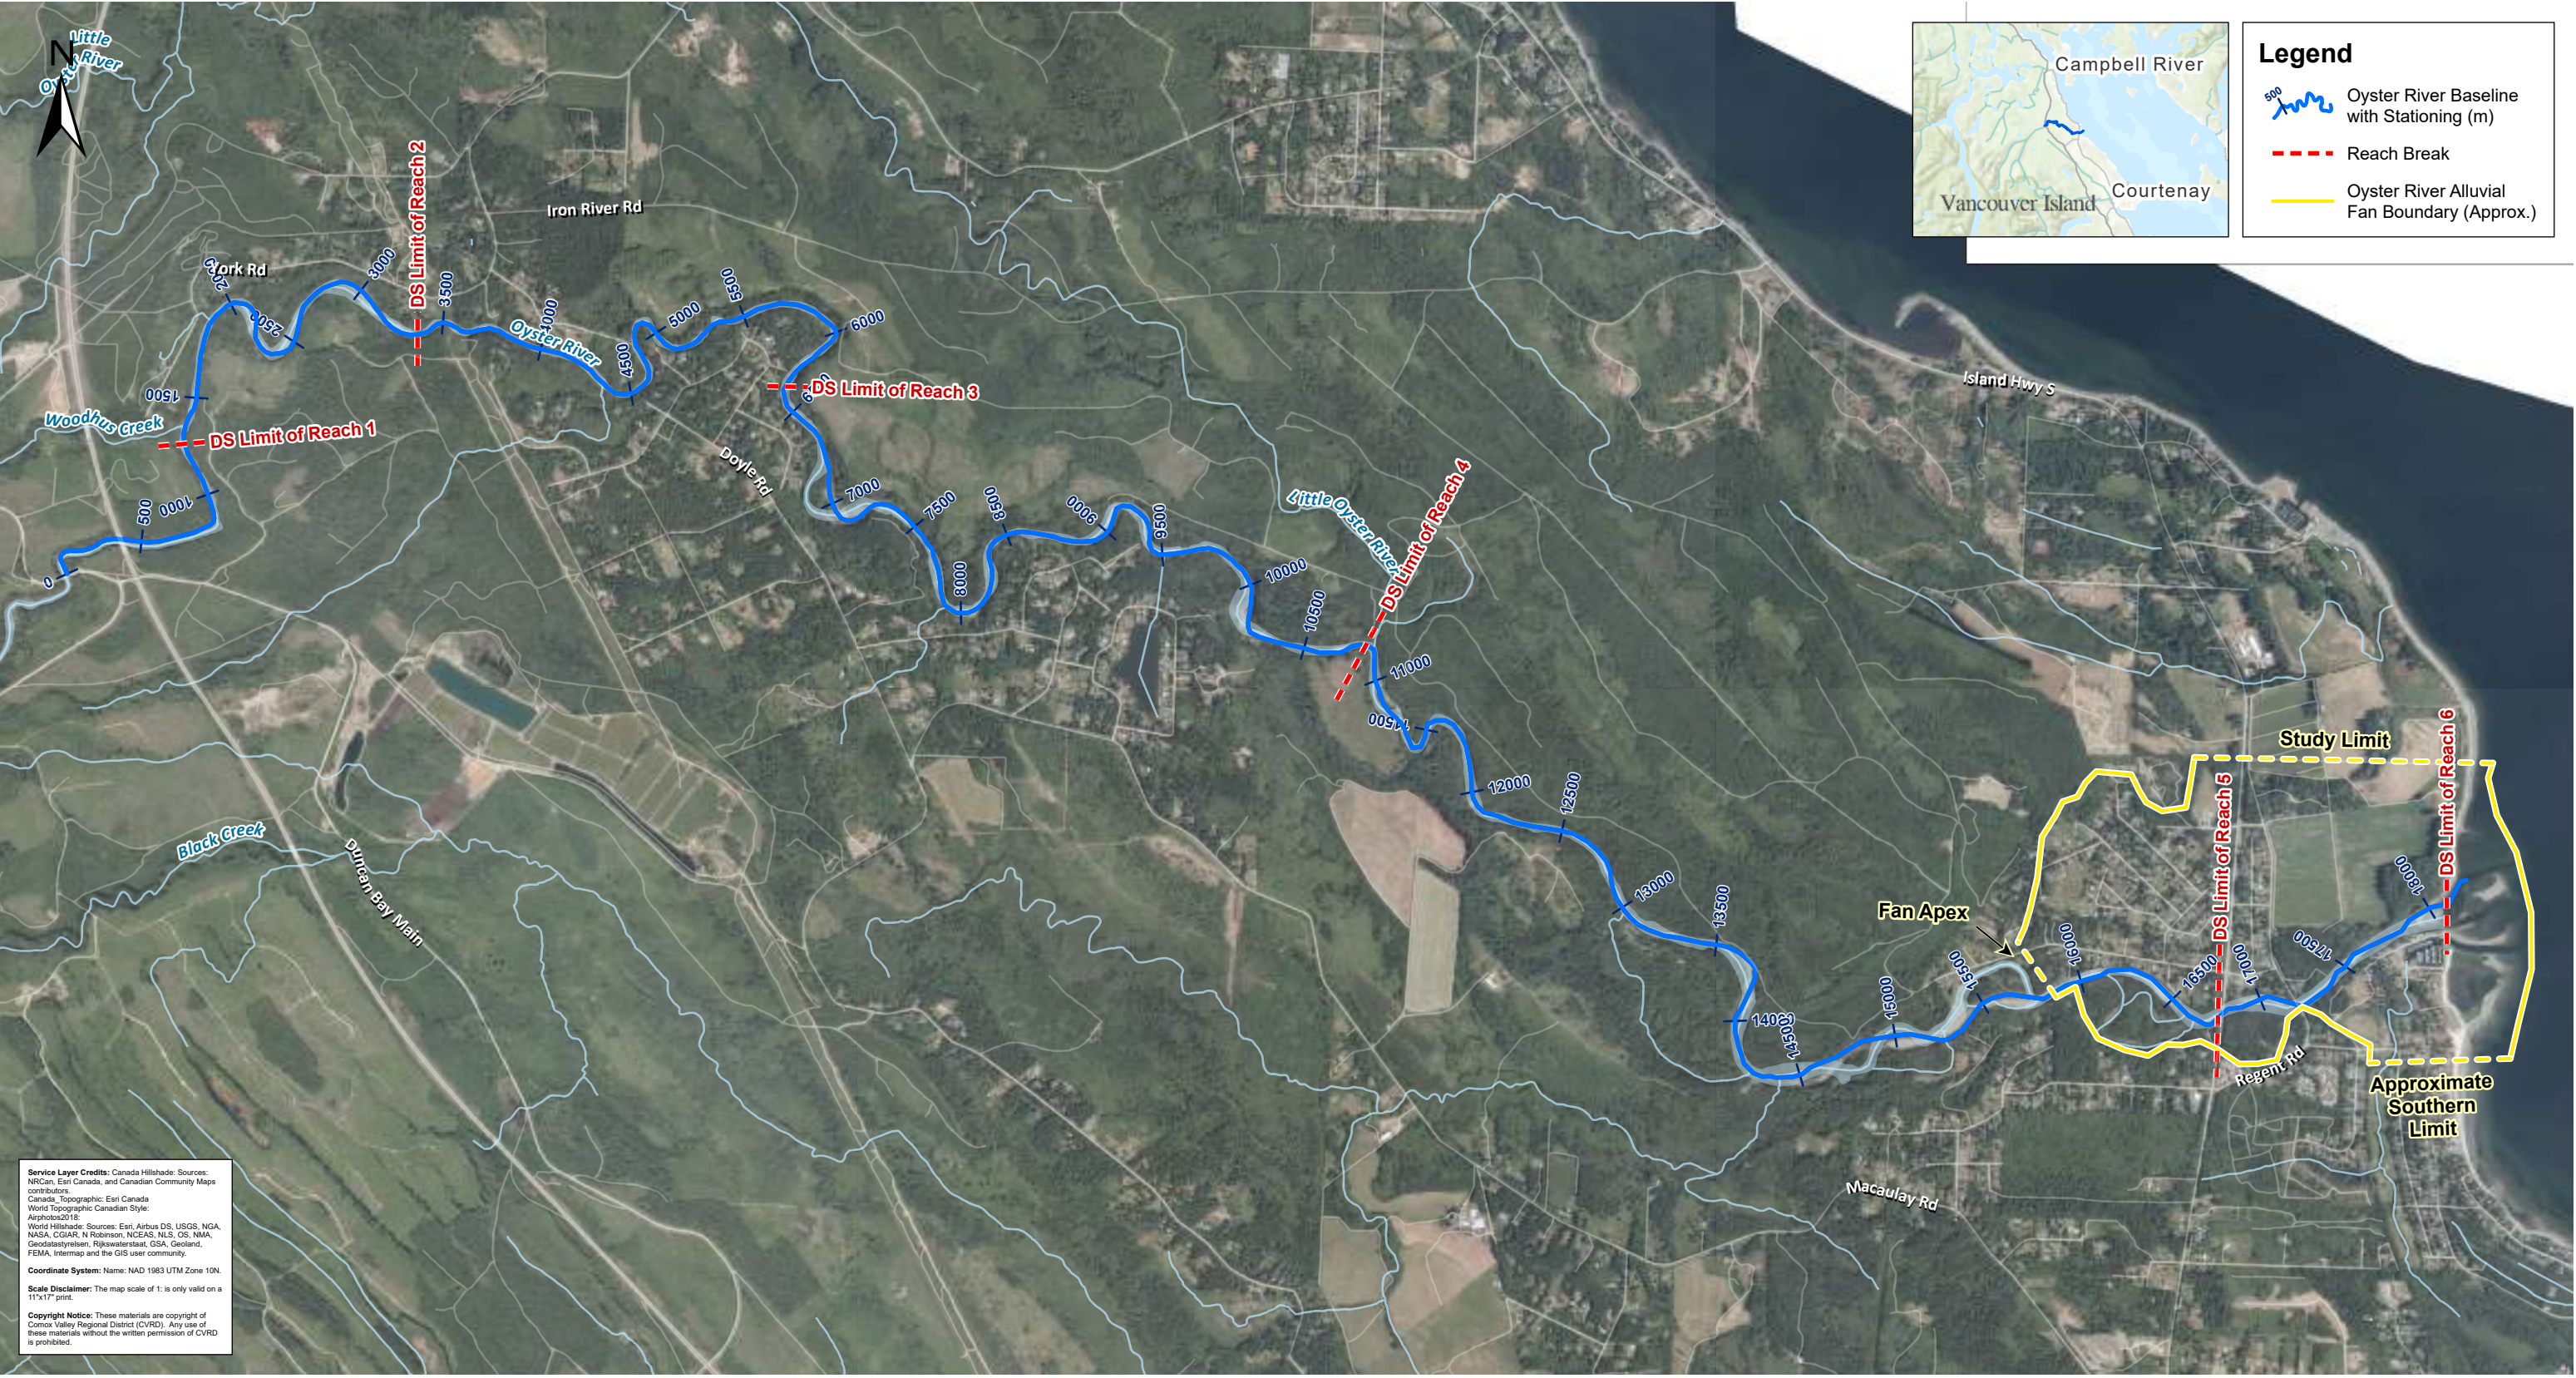
Oyster River Fluvial Geomorphic Assessment – Study Area

The study area consists of river reaches downstream of the Highway 19 bridge crossing (Figure 1). In the upper portion of the study area the river channel is locally constrained by bedrock outcrops and is underlain by valley alluvium. Over time, the Oyster River has eroded into the coastal plain feature forming a valley comprised of terraced fluvial deposits (Capilano sediments) (Fyles, 1959). Further downstream in the study area there is a decreasing occurrence of bedrock outcrops. In addition, the Oyster River encounters a mix of fluvial, deltaic, and shore deposits (Salish sediments) (Fyles, 1959), situated approximately at the downstream limit of Reach 3 (Figure 1). In the lower section of Reach 5, the valley widens considerably as the Oyster River flows onto its alluvial fan (delineation of fan boundaries were guided by geology data from Fyles, 1959, see Figure 1). At the river mouth, a small deltaic feature is evident in the foreshore area, having been formed from fluvial processes as a result of river flooding as well as coastal transport processes.

This section describes the methods used in the geomorphic assessment that was conducted for the Oyster River (see study area in Figure 1), and to assess the erodibility of the CVRD shoreline (see study area in Figure 2).

8. The four meander cut-offs identified above (see Figure 6 and Figure 7) are avulsion<sup>2</sup> events that have all occurred within the Oyster River alluvial fan (approximate boundaries shown in Figure 1). Due to the depositional nature of alluvial fans, the risk of avulsions is higher. In addition to localised avulsion events (e.g., meander cut-offs) larger scale channel avulsions can also occur along alluvial fans (e.g., abandonment of entire migration corridor). The alluvial fan boundary illustrated in Figure 1 represents the avulsion hazard area for the lower Oyster River.

7. The four meander cut-offs identified have all occurred within the Oyster River alluvial fan (approximate boundaries shown in Figure 1). The alluvial fan boundary represents the avulsion hazard area for the lower Oyster River.

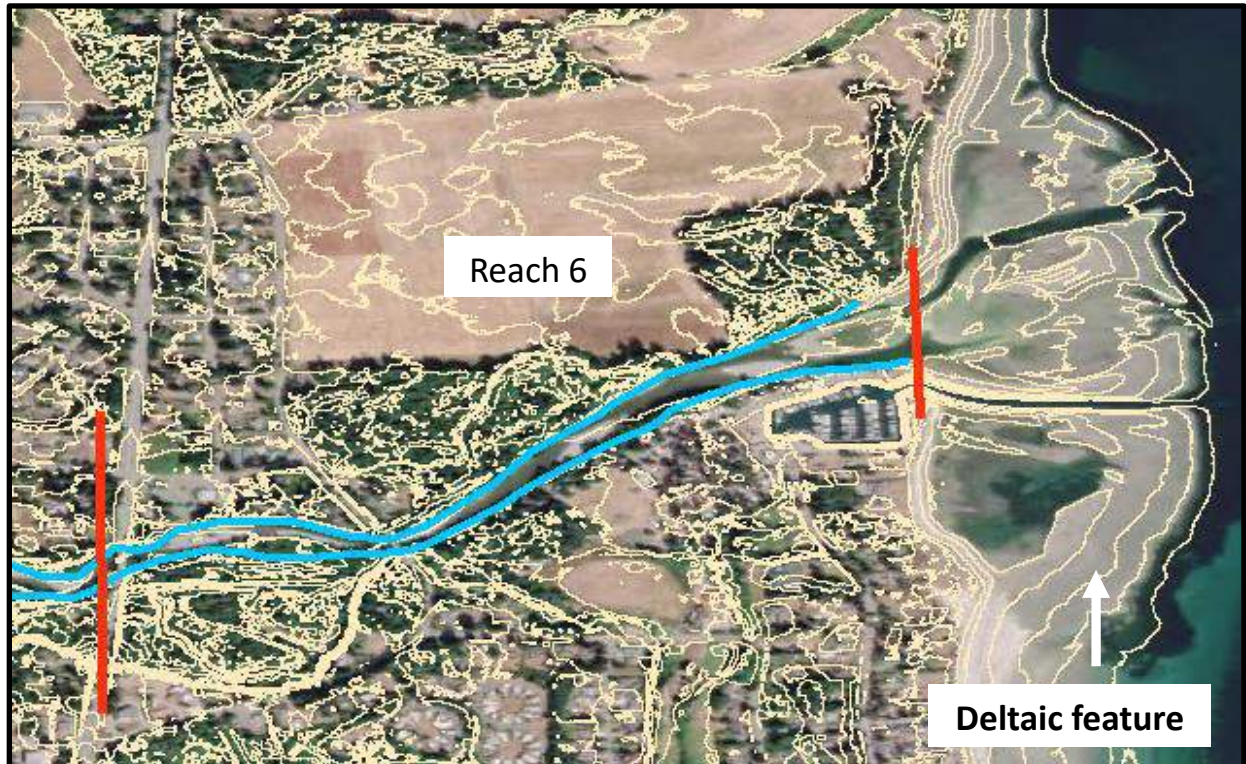
**Figure 5: Reach 6 is Located Near the Mouth of the Oyster River. Yellow Lines Represent 1 m Contours and Blue Lines are the 2018 Oyster River Bank Position.**

6. **Reach 6** is ~ 1.1 km in length, starts upstream at the bridge crossing at the Old Island Highway (Highway 19A), and extends downstream to the confluence with the Strait of Georgia as shown in Figure 5. This reach is situated along the Oyster River fan and is tidally controlled, and only includes the section of channel exhibiting a meandering morphology (i.e., the deltaic feature, where the channel becomes multi-thread or braided, is not included in the reach).

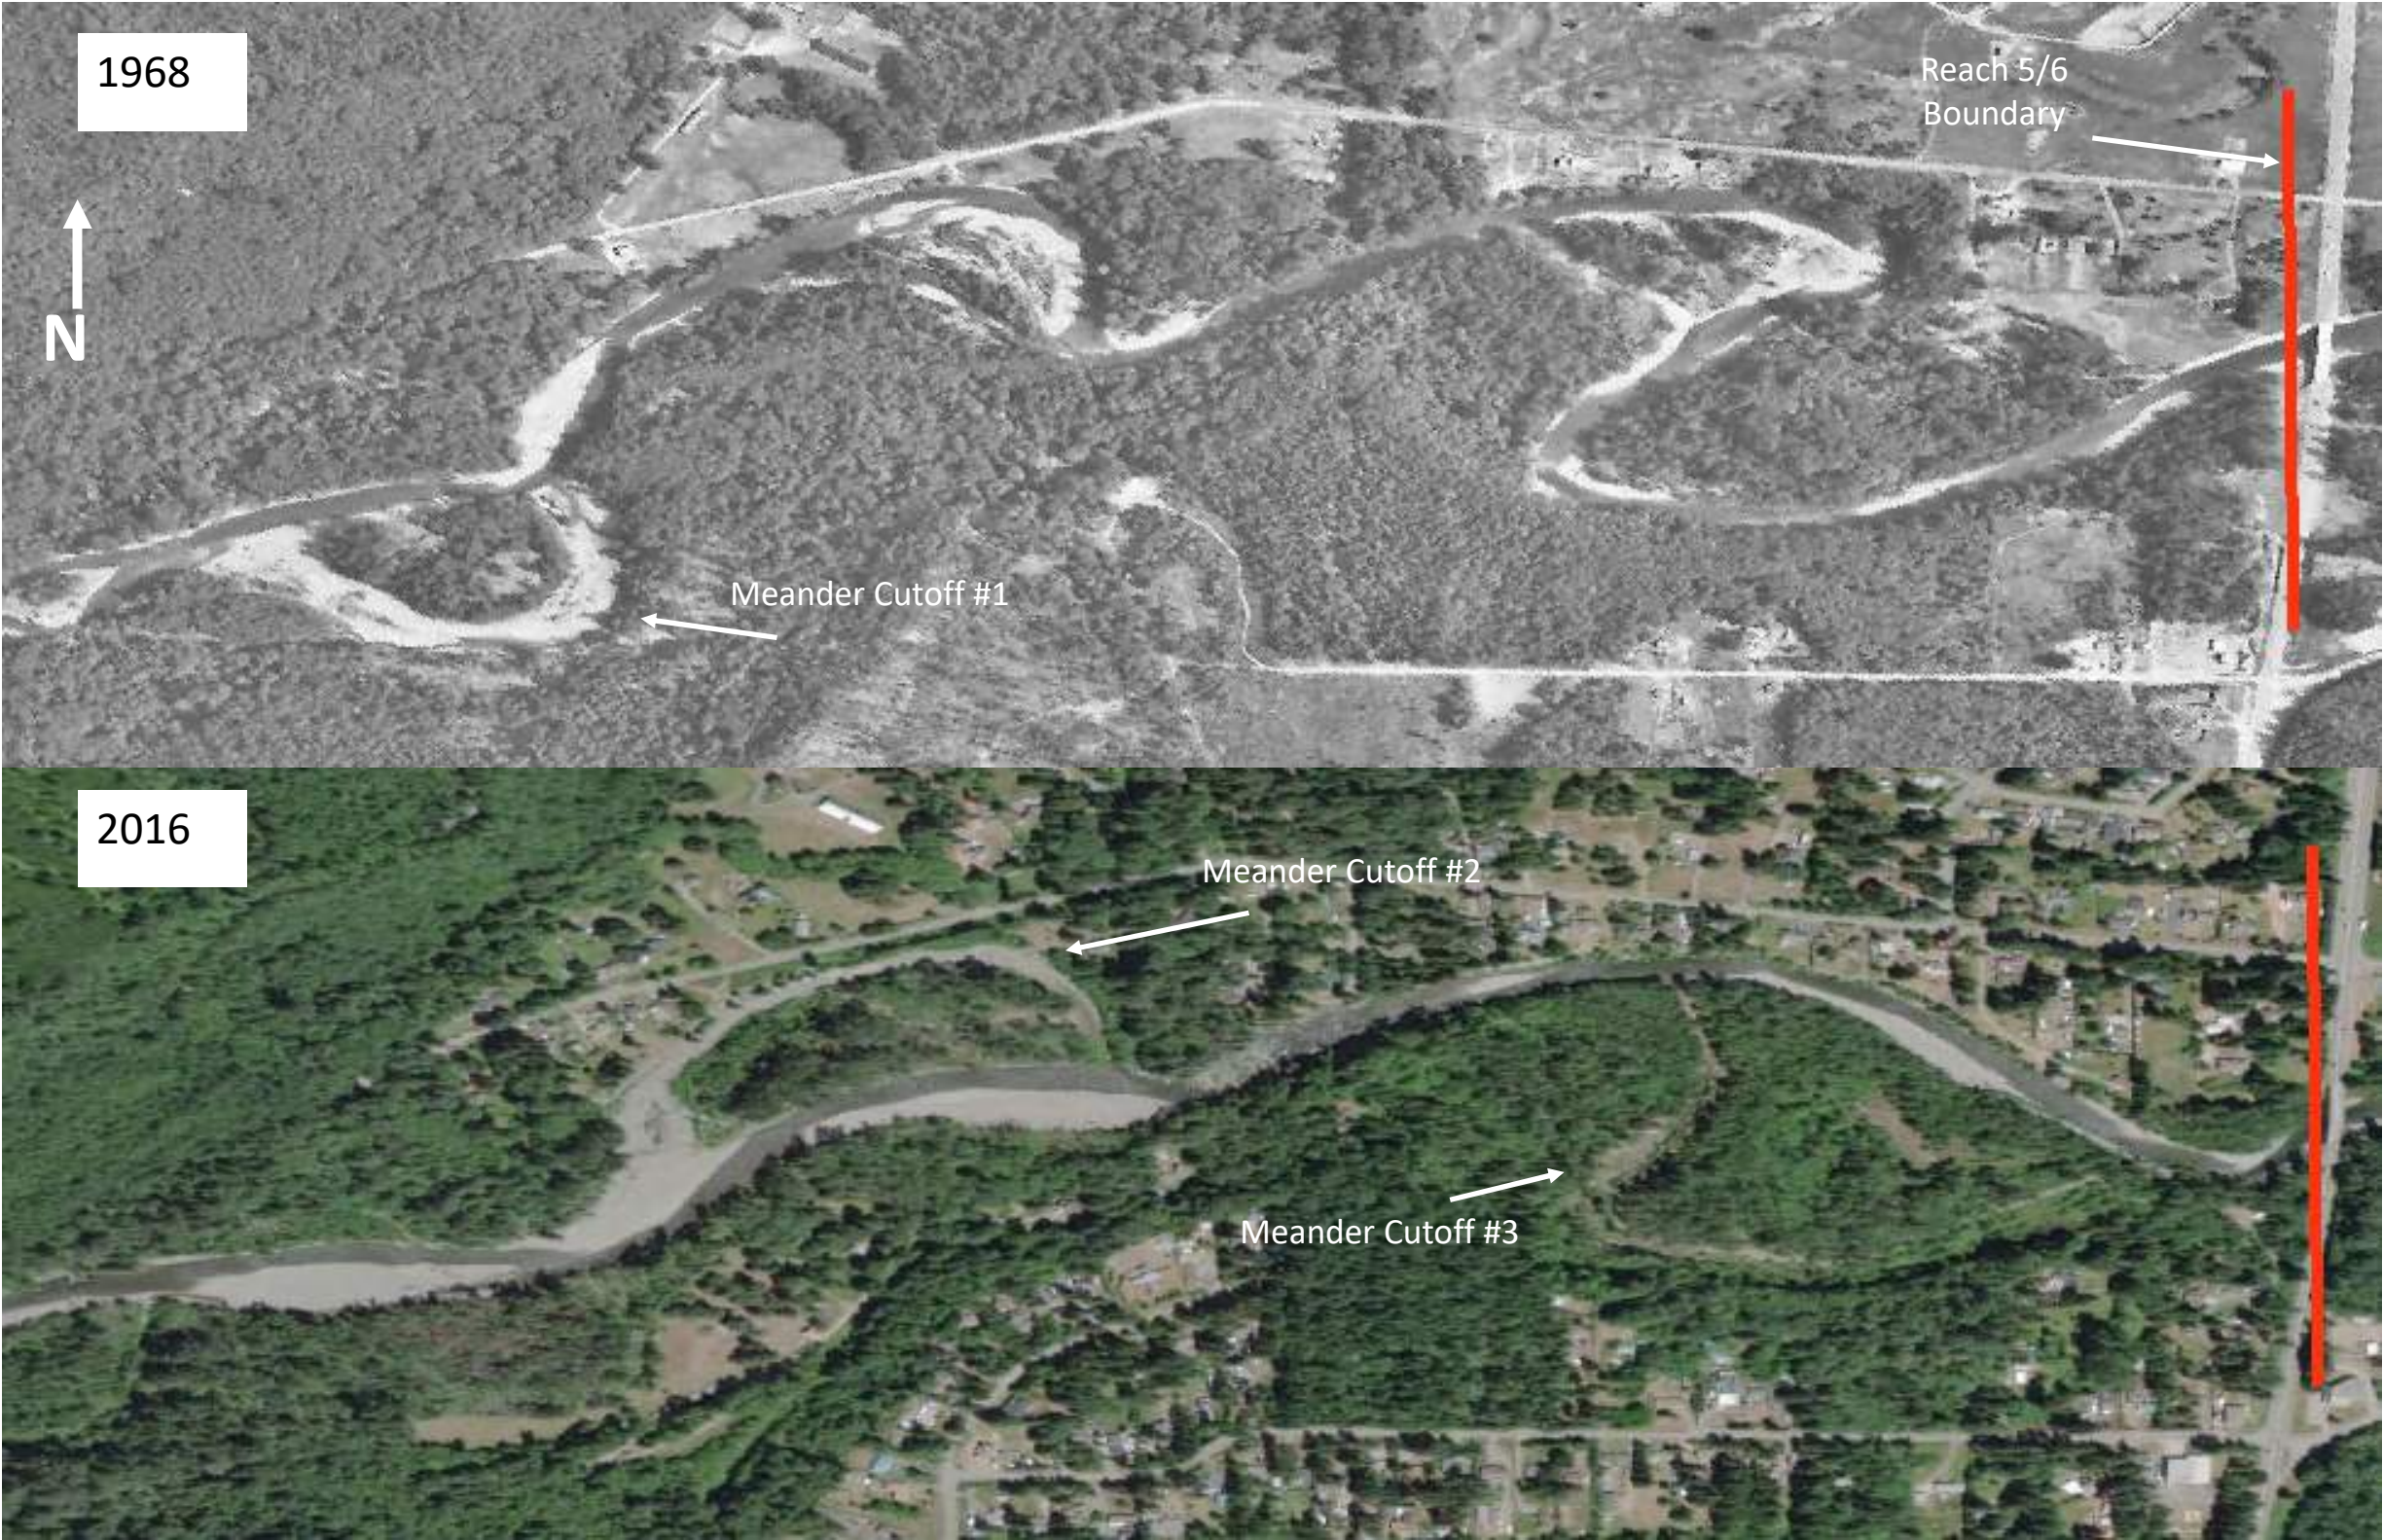
Figure 6

Oyster River Meander Cut-offs (#1 through #3) at the Downstream End of Reach 5

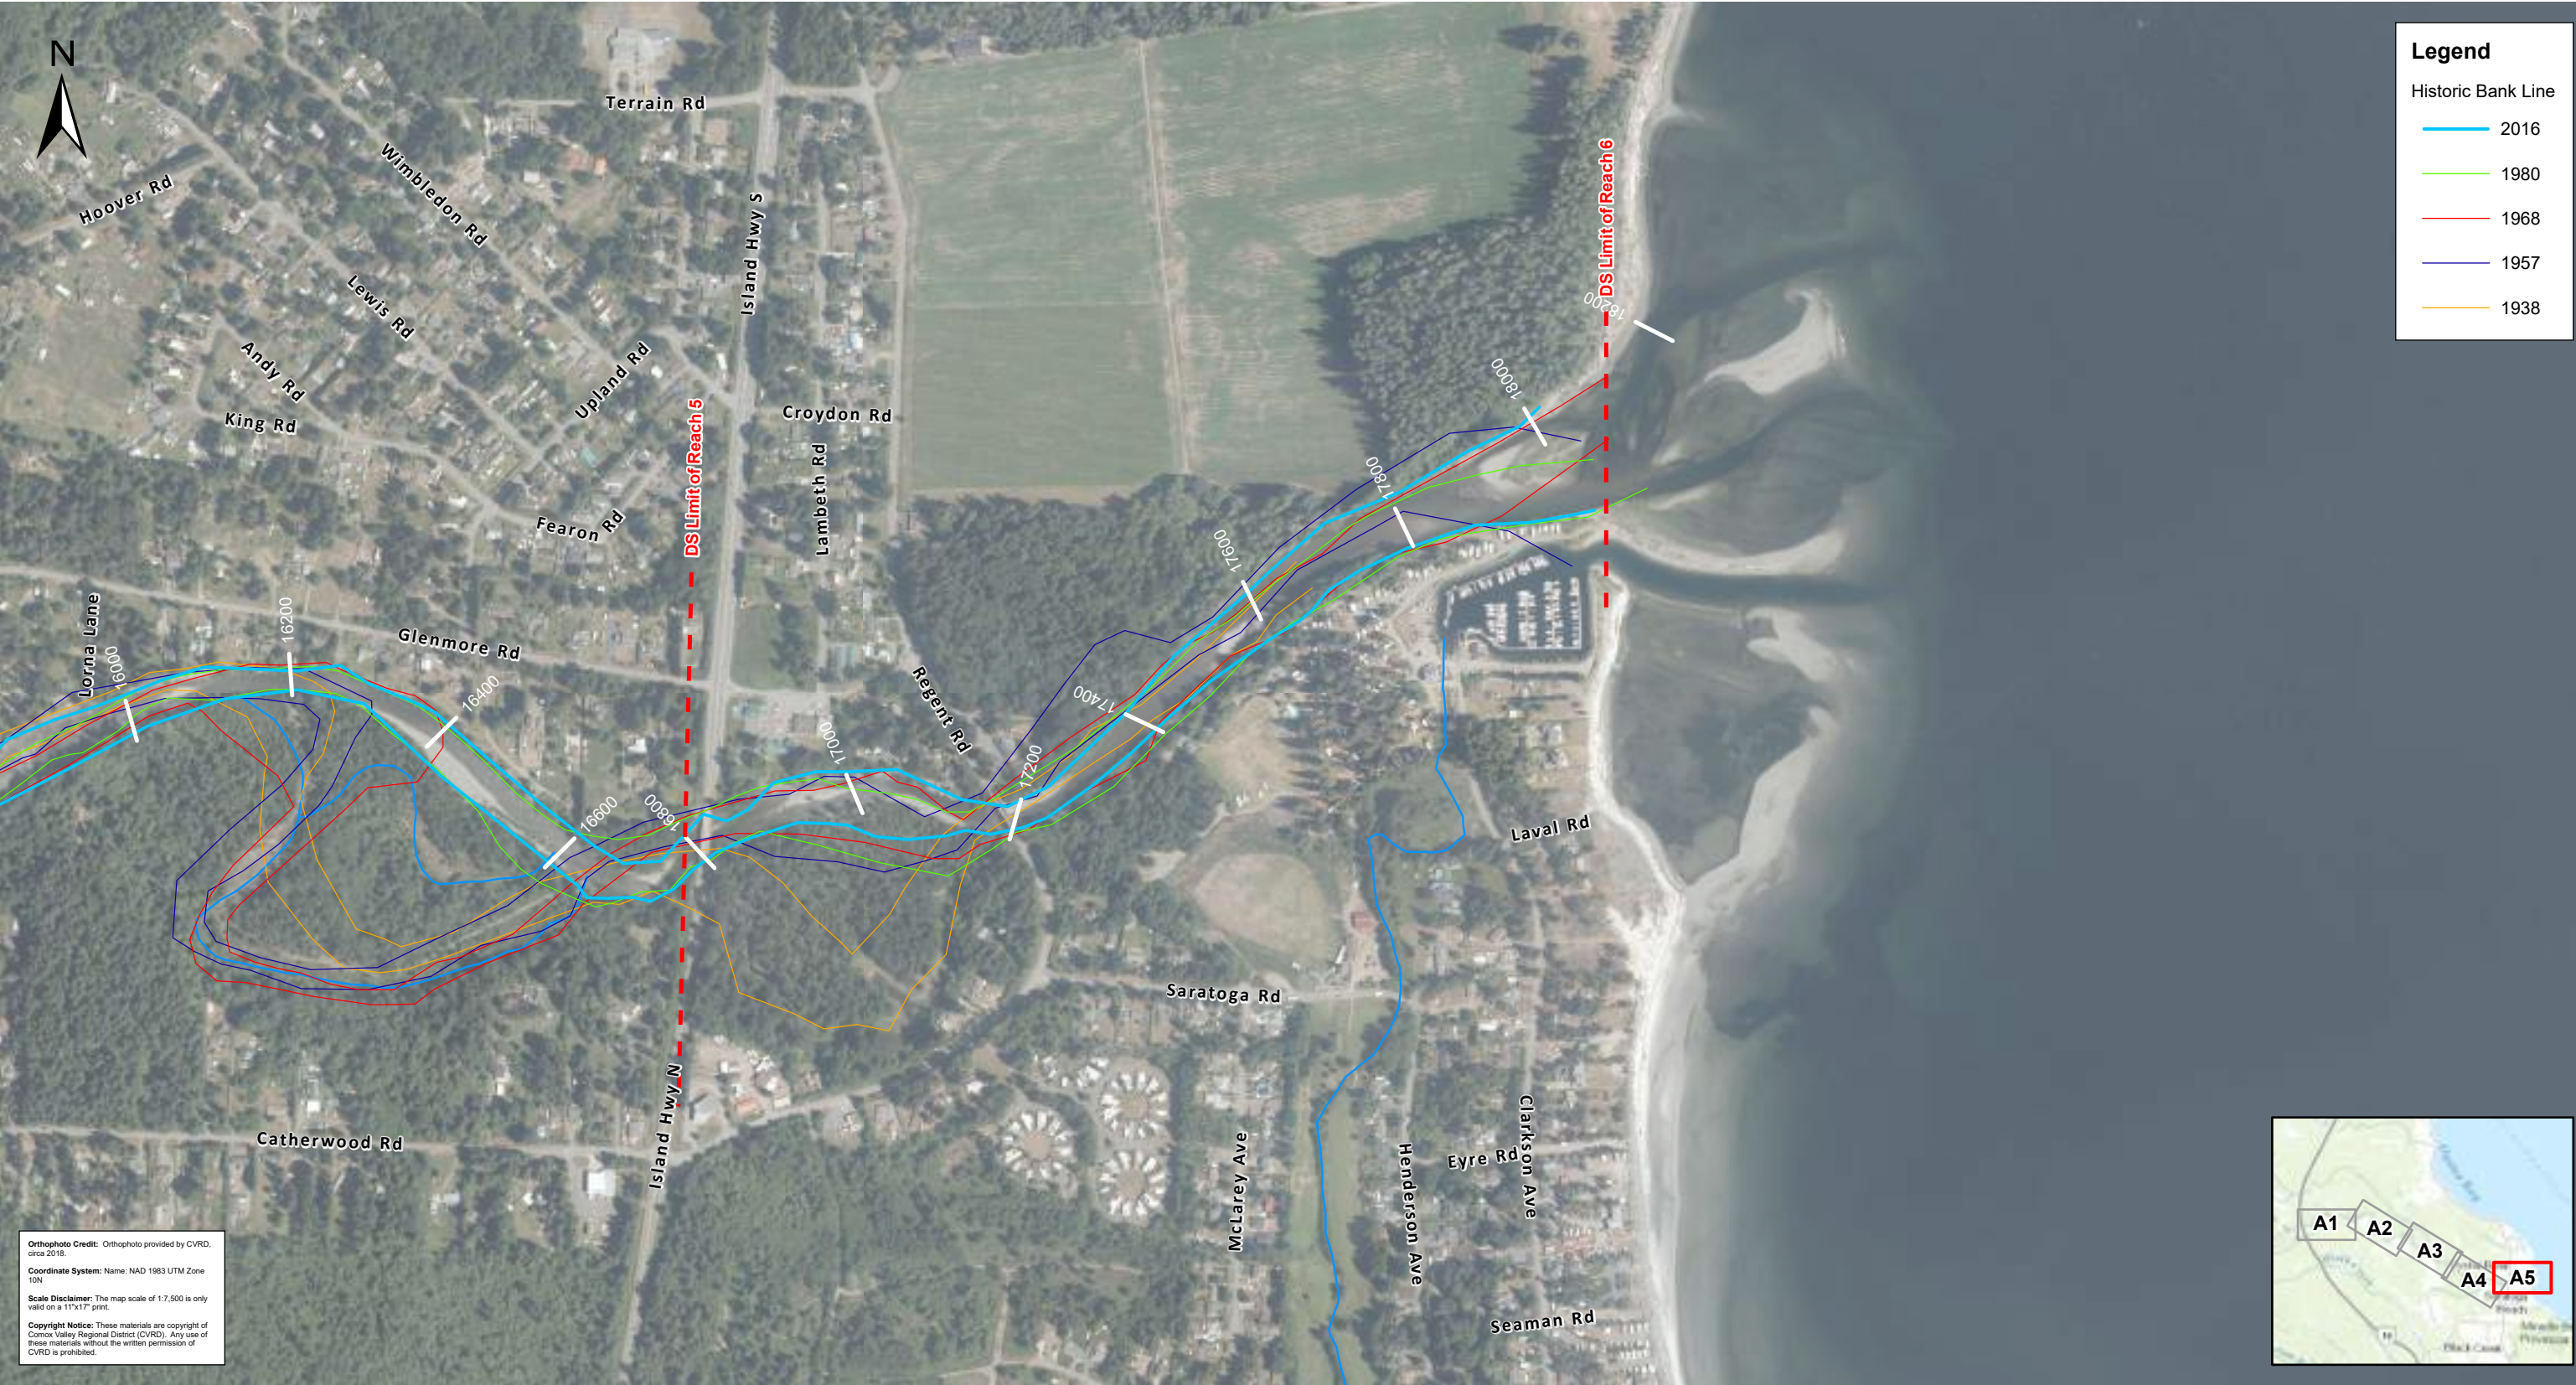
# Historical Bank Line Mapping of Oyster River
