## Technical Memorandum #2

**RE:** Coastal Flood Mapping Project  
Technical Memorandum #2 – Fluvial and Coastal Geomorphology  
Our File 2623.014-300

This technical memorandum (#2) documents the fluvial (river migration corridor) and coastal (shoreline erodibility) geomorphic assessment components of the project. Other technical memoranda will document the remaining project components.

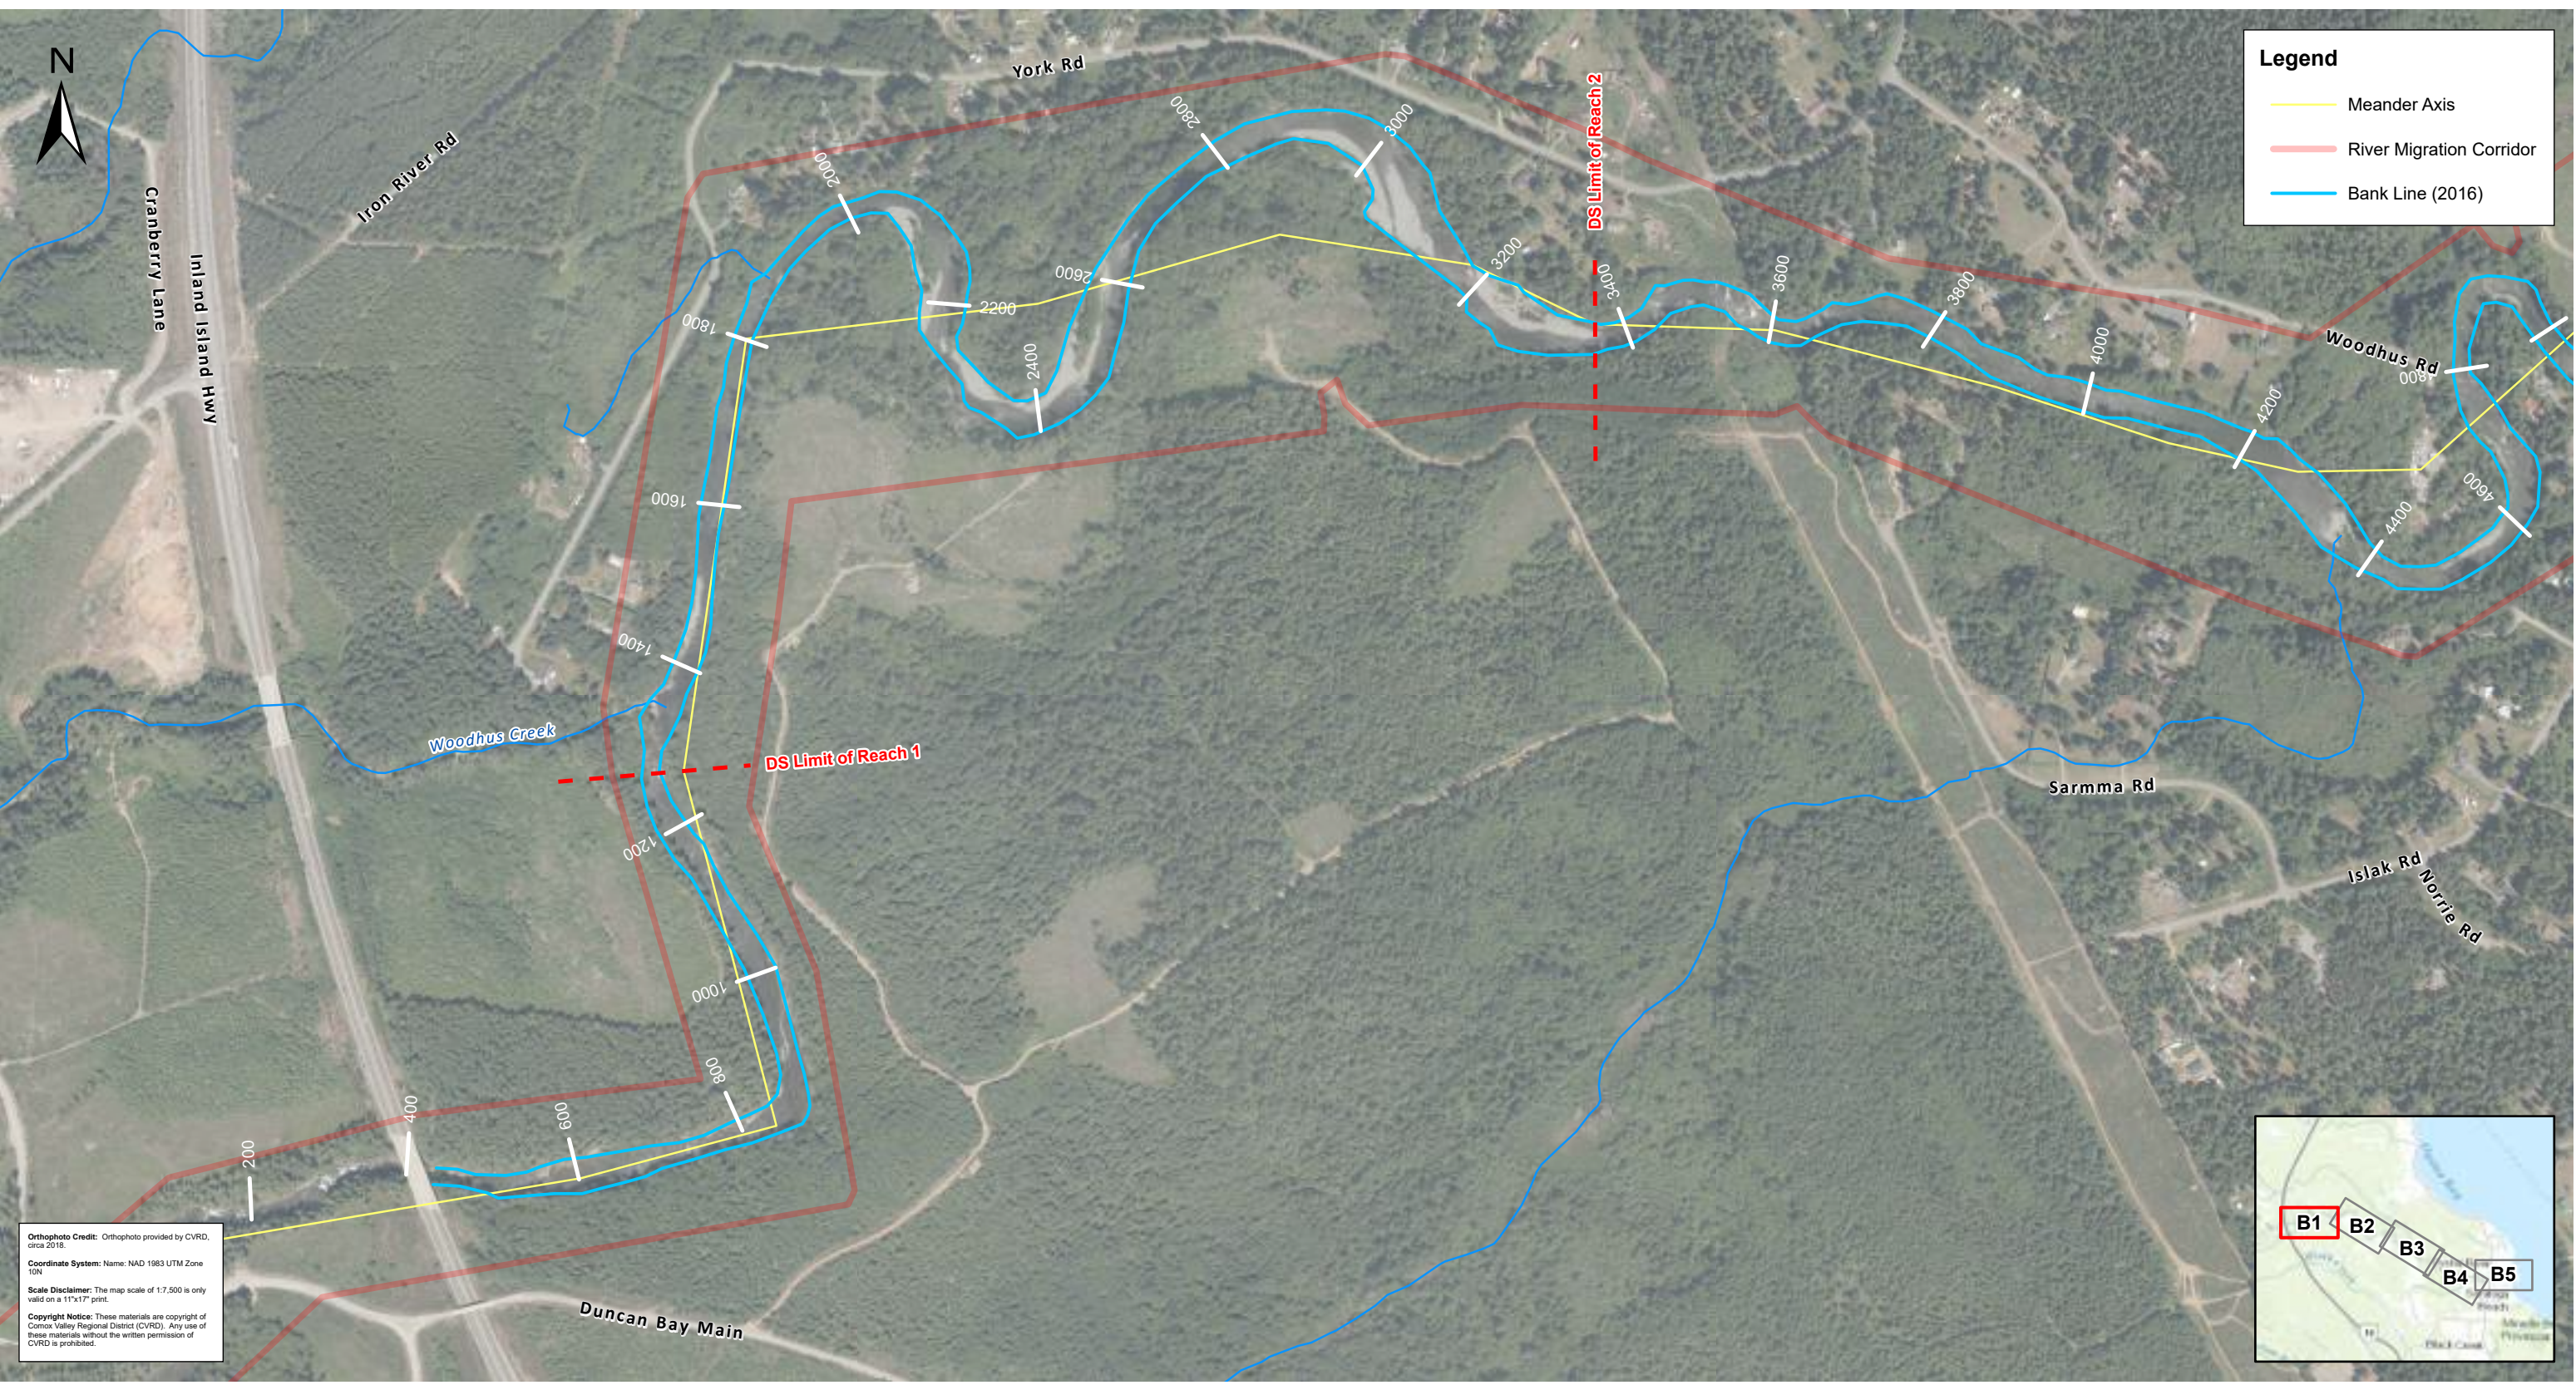
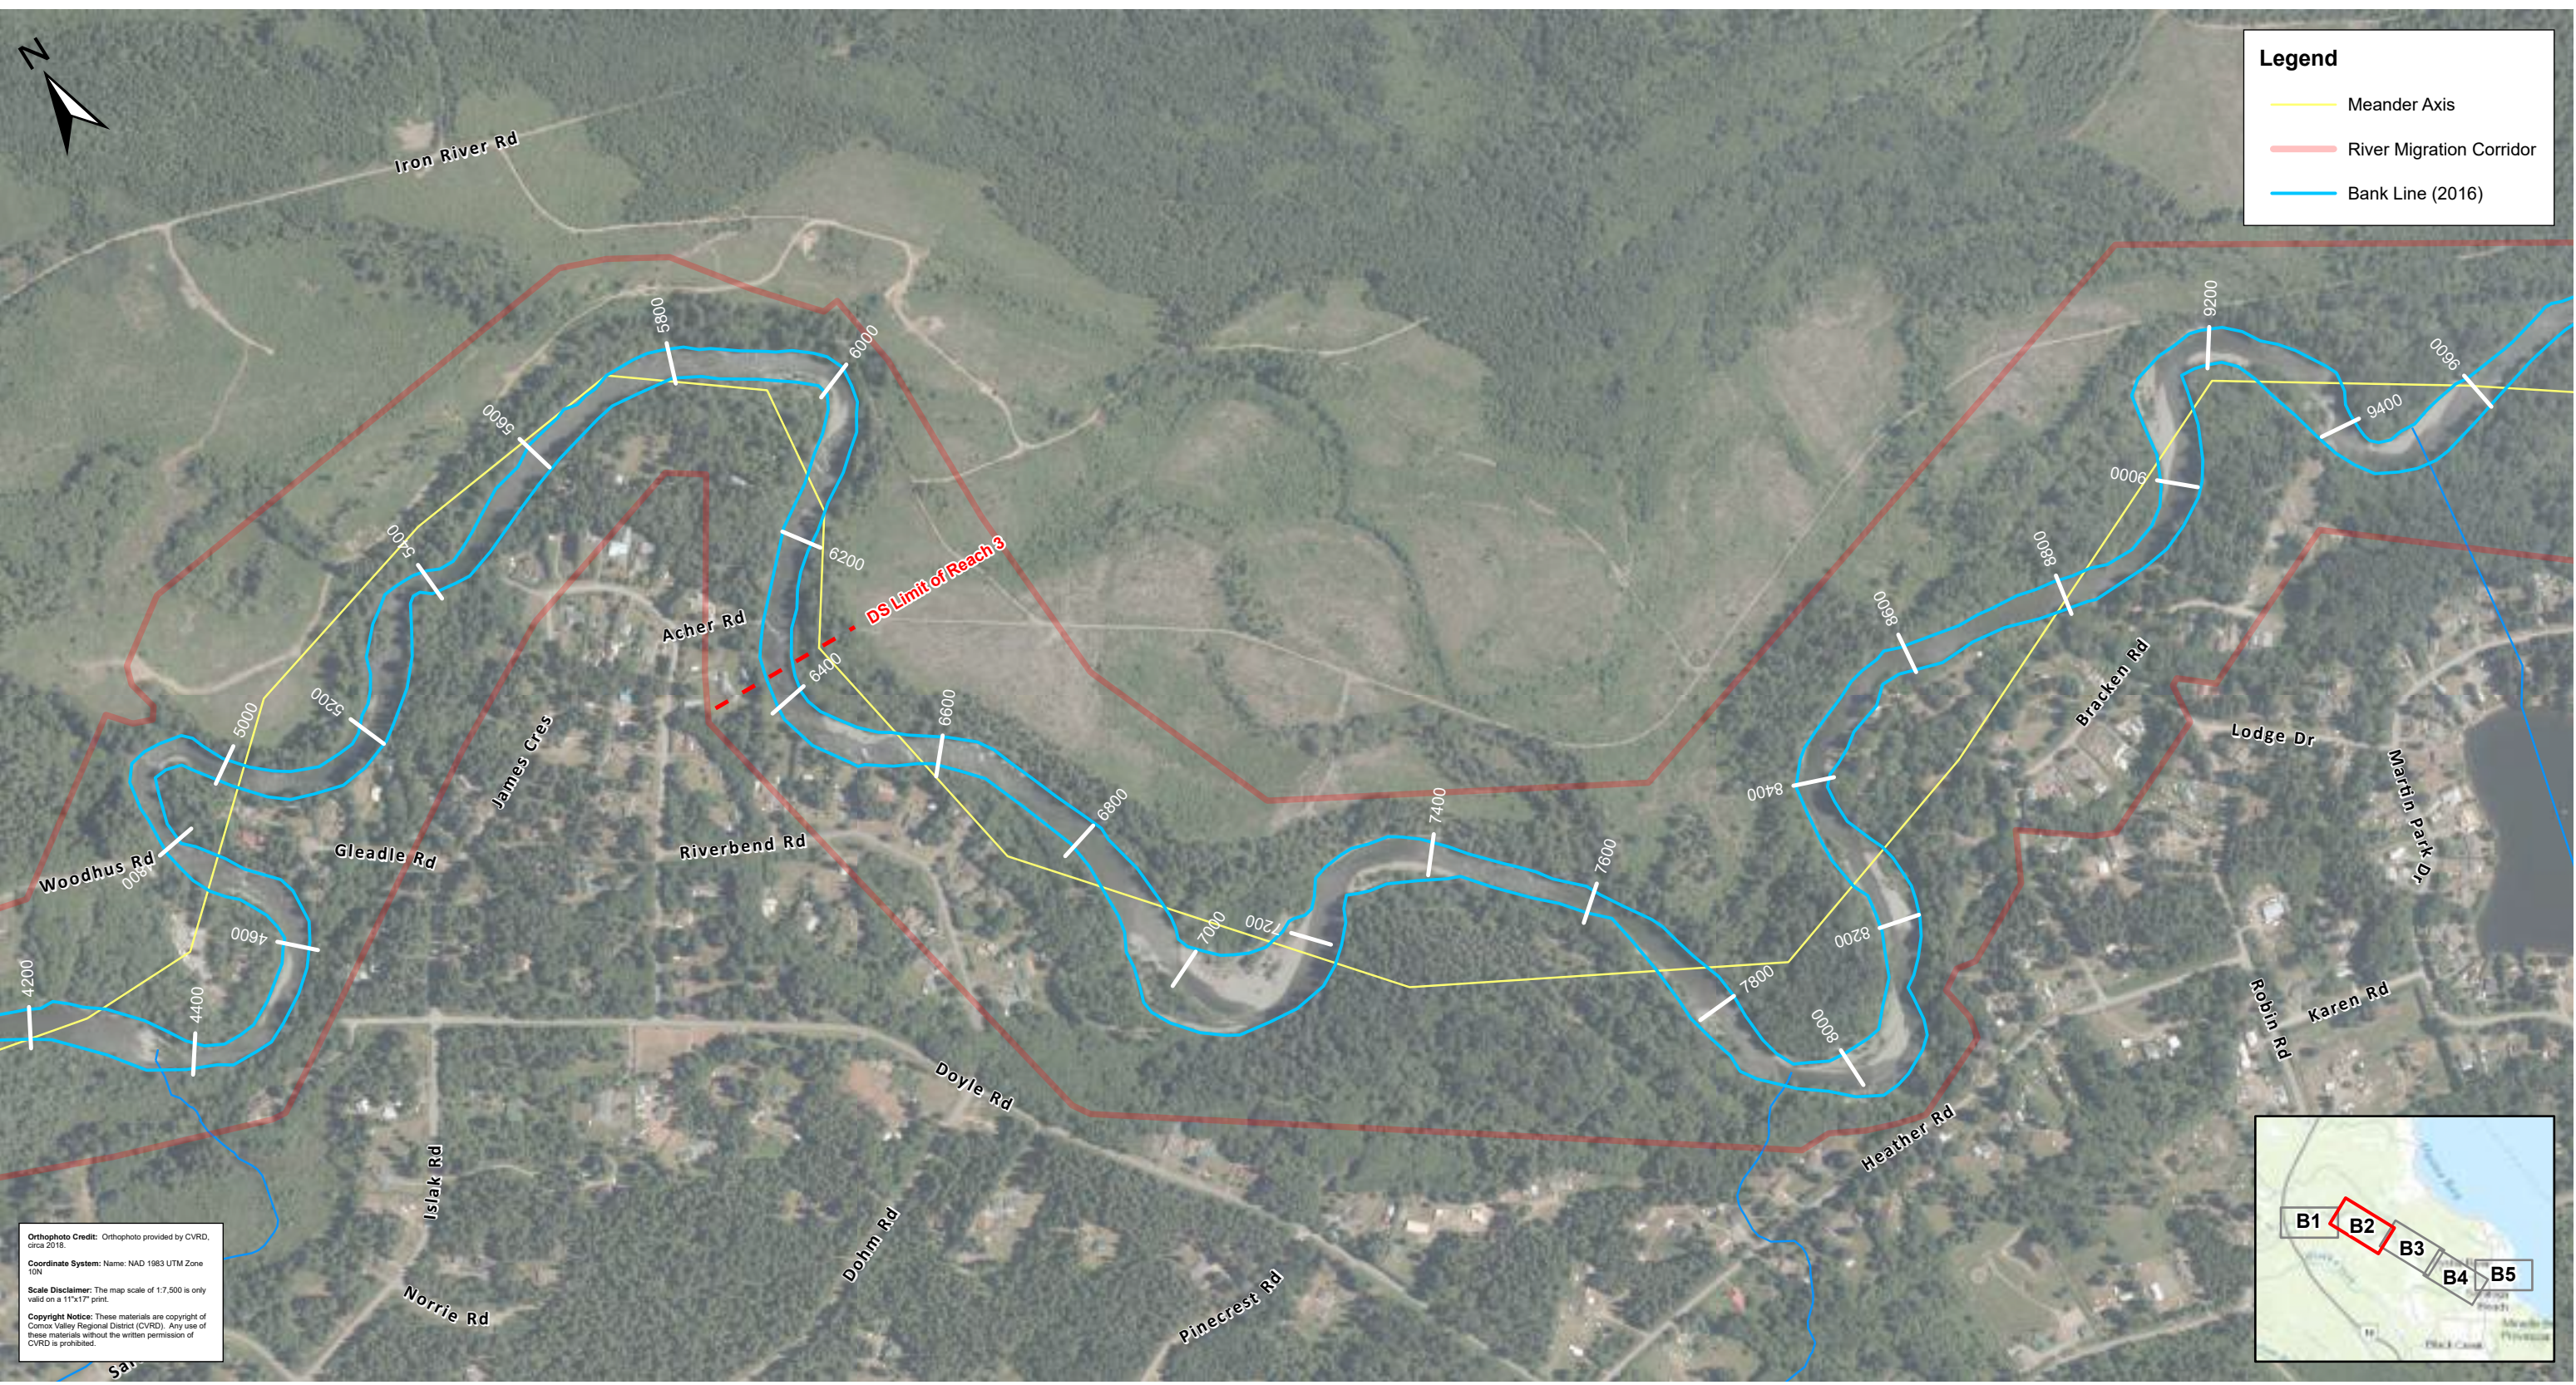
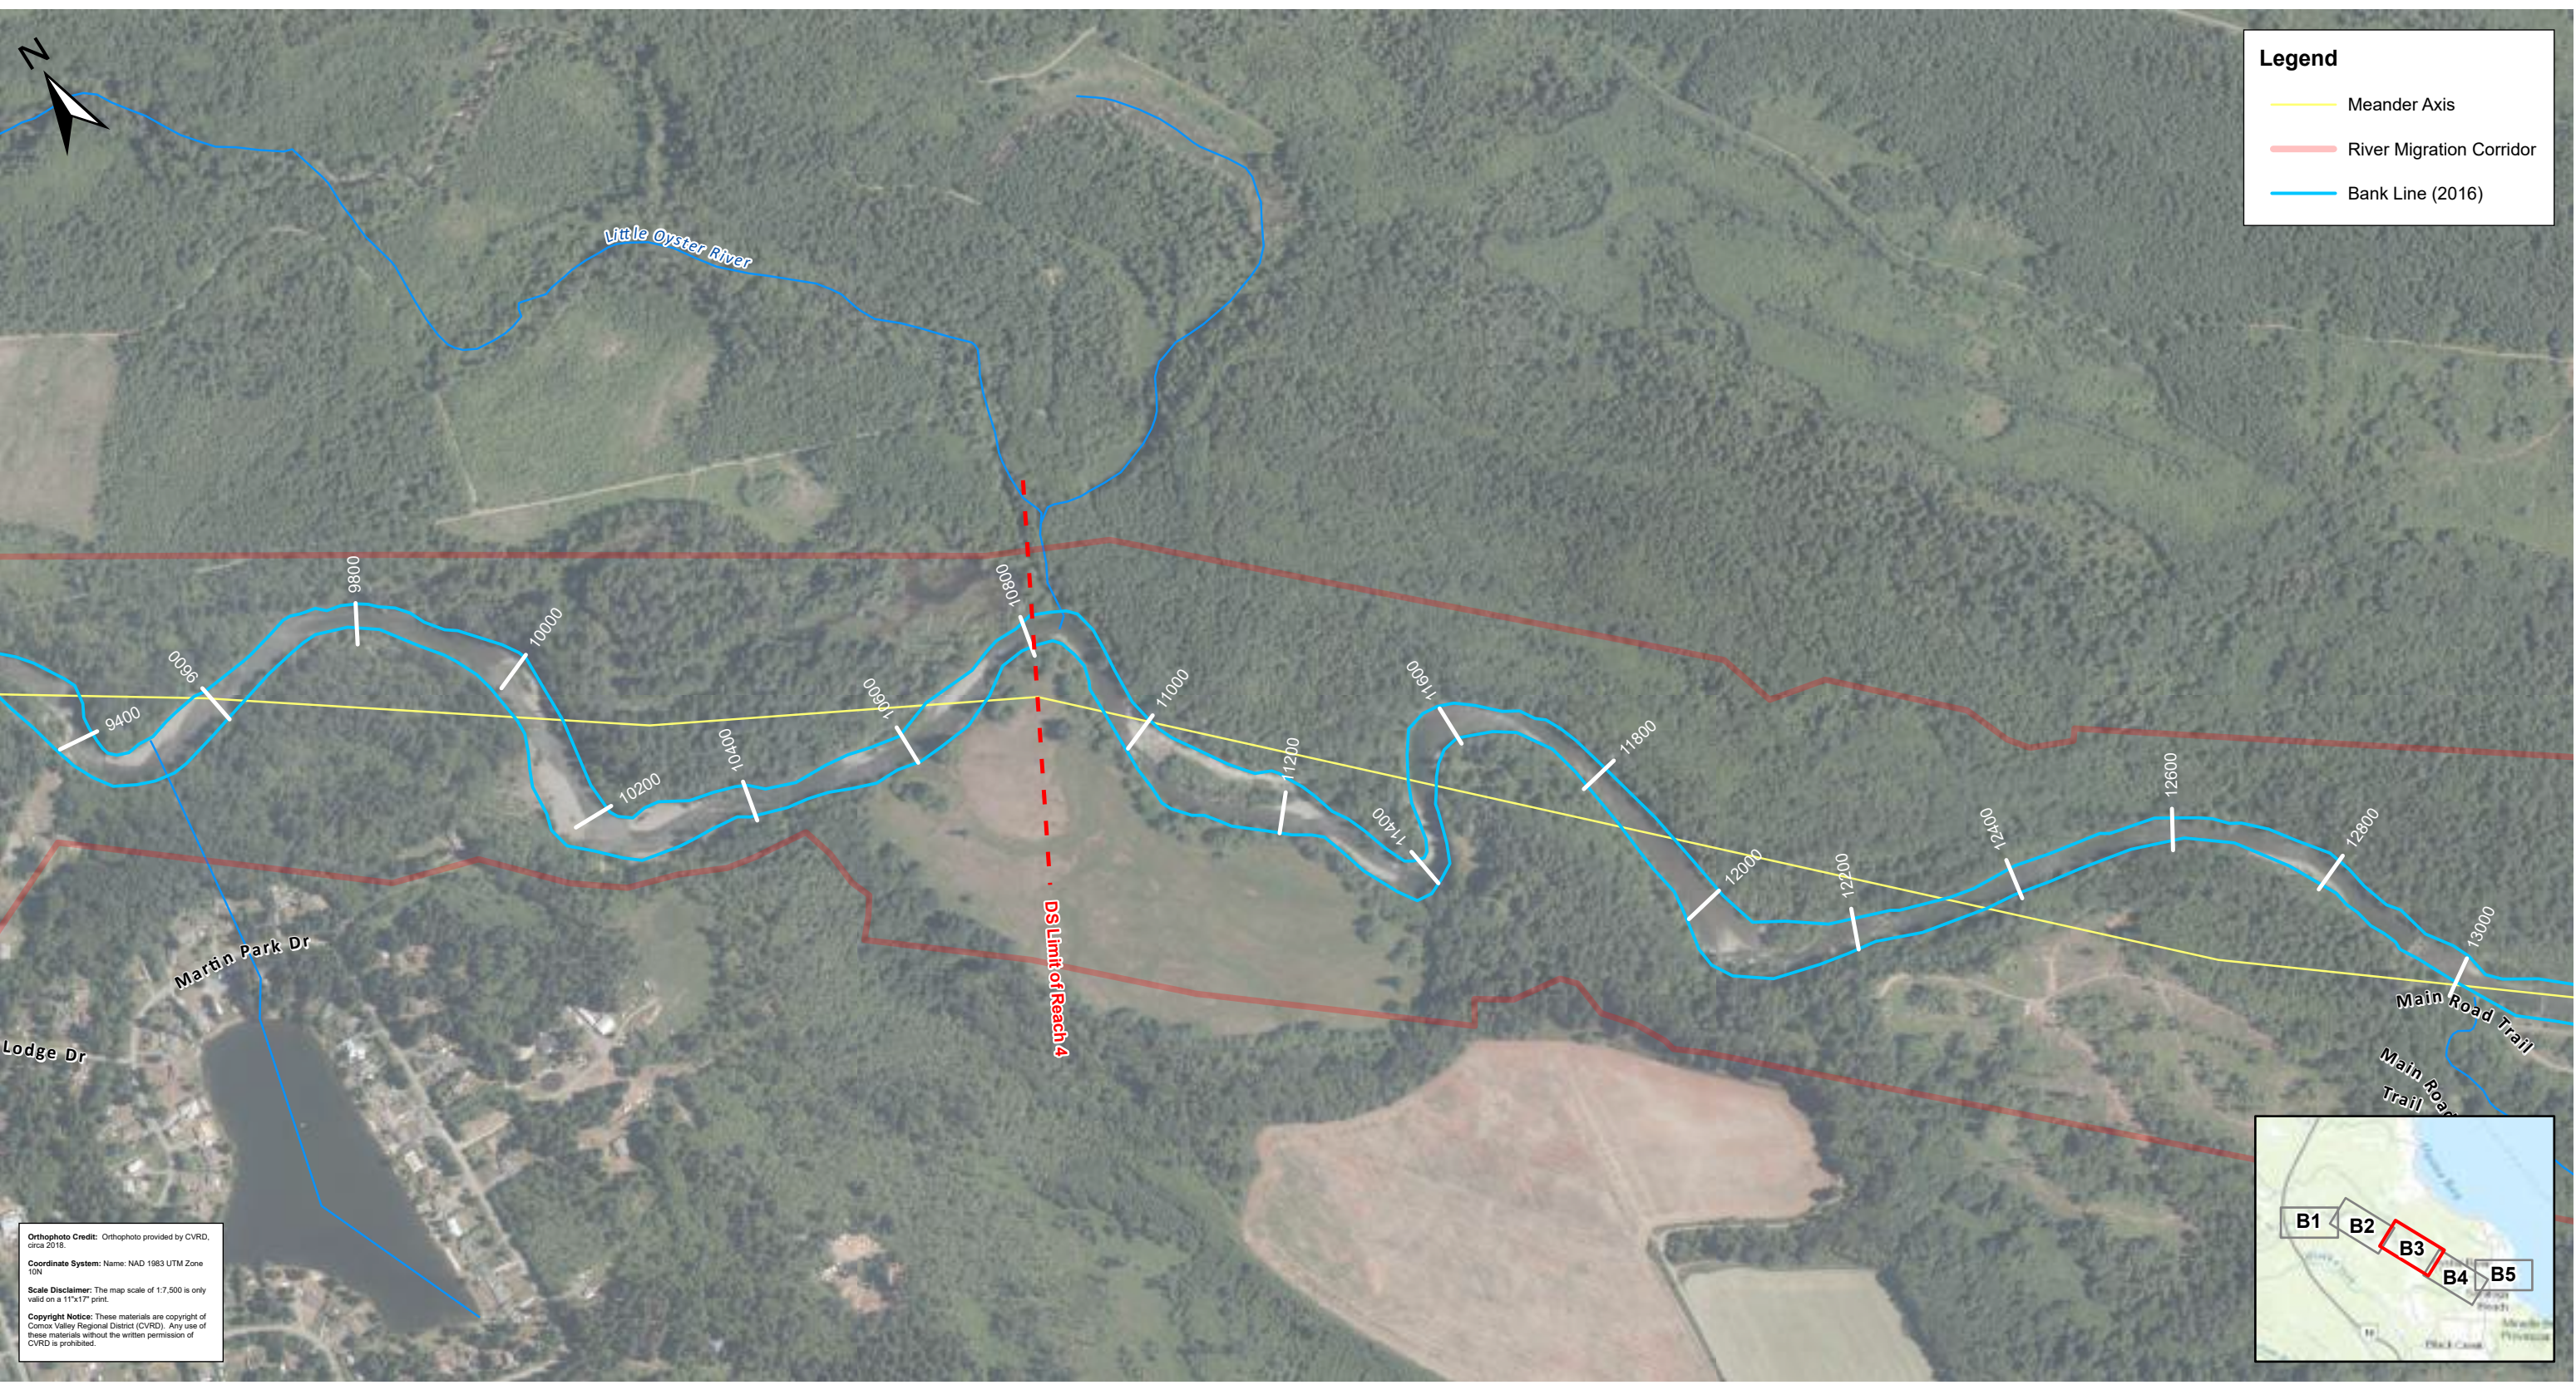
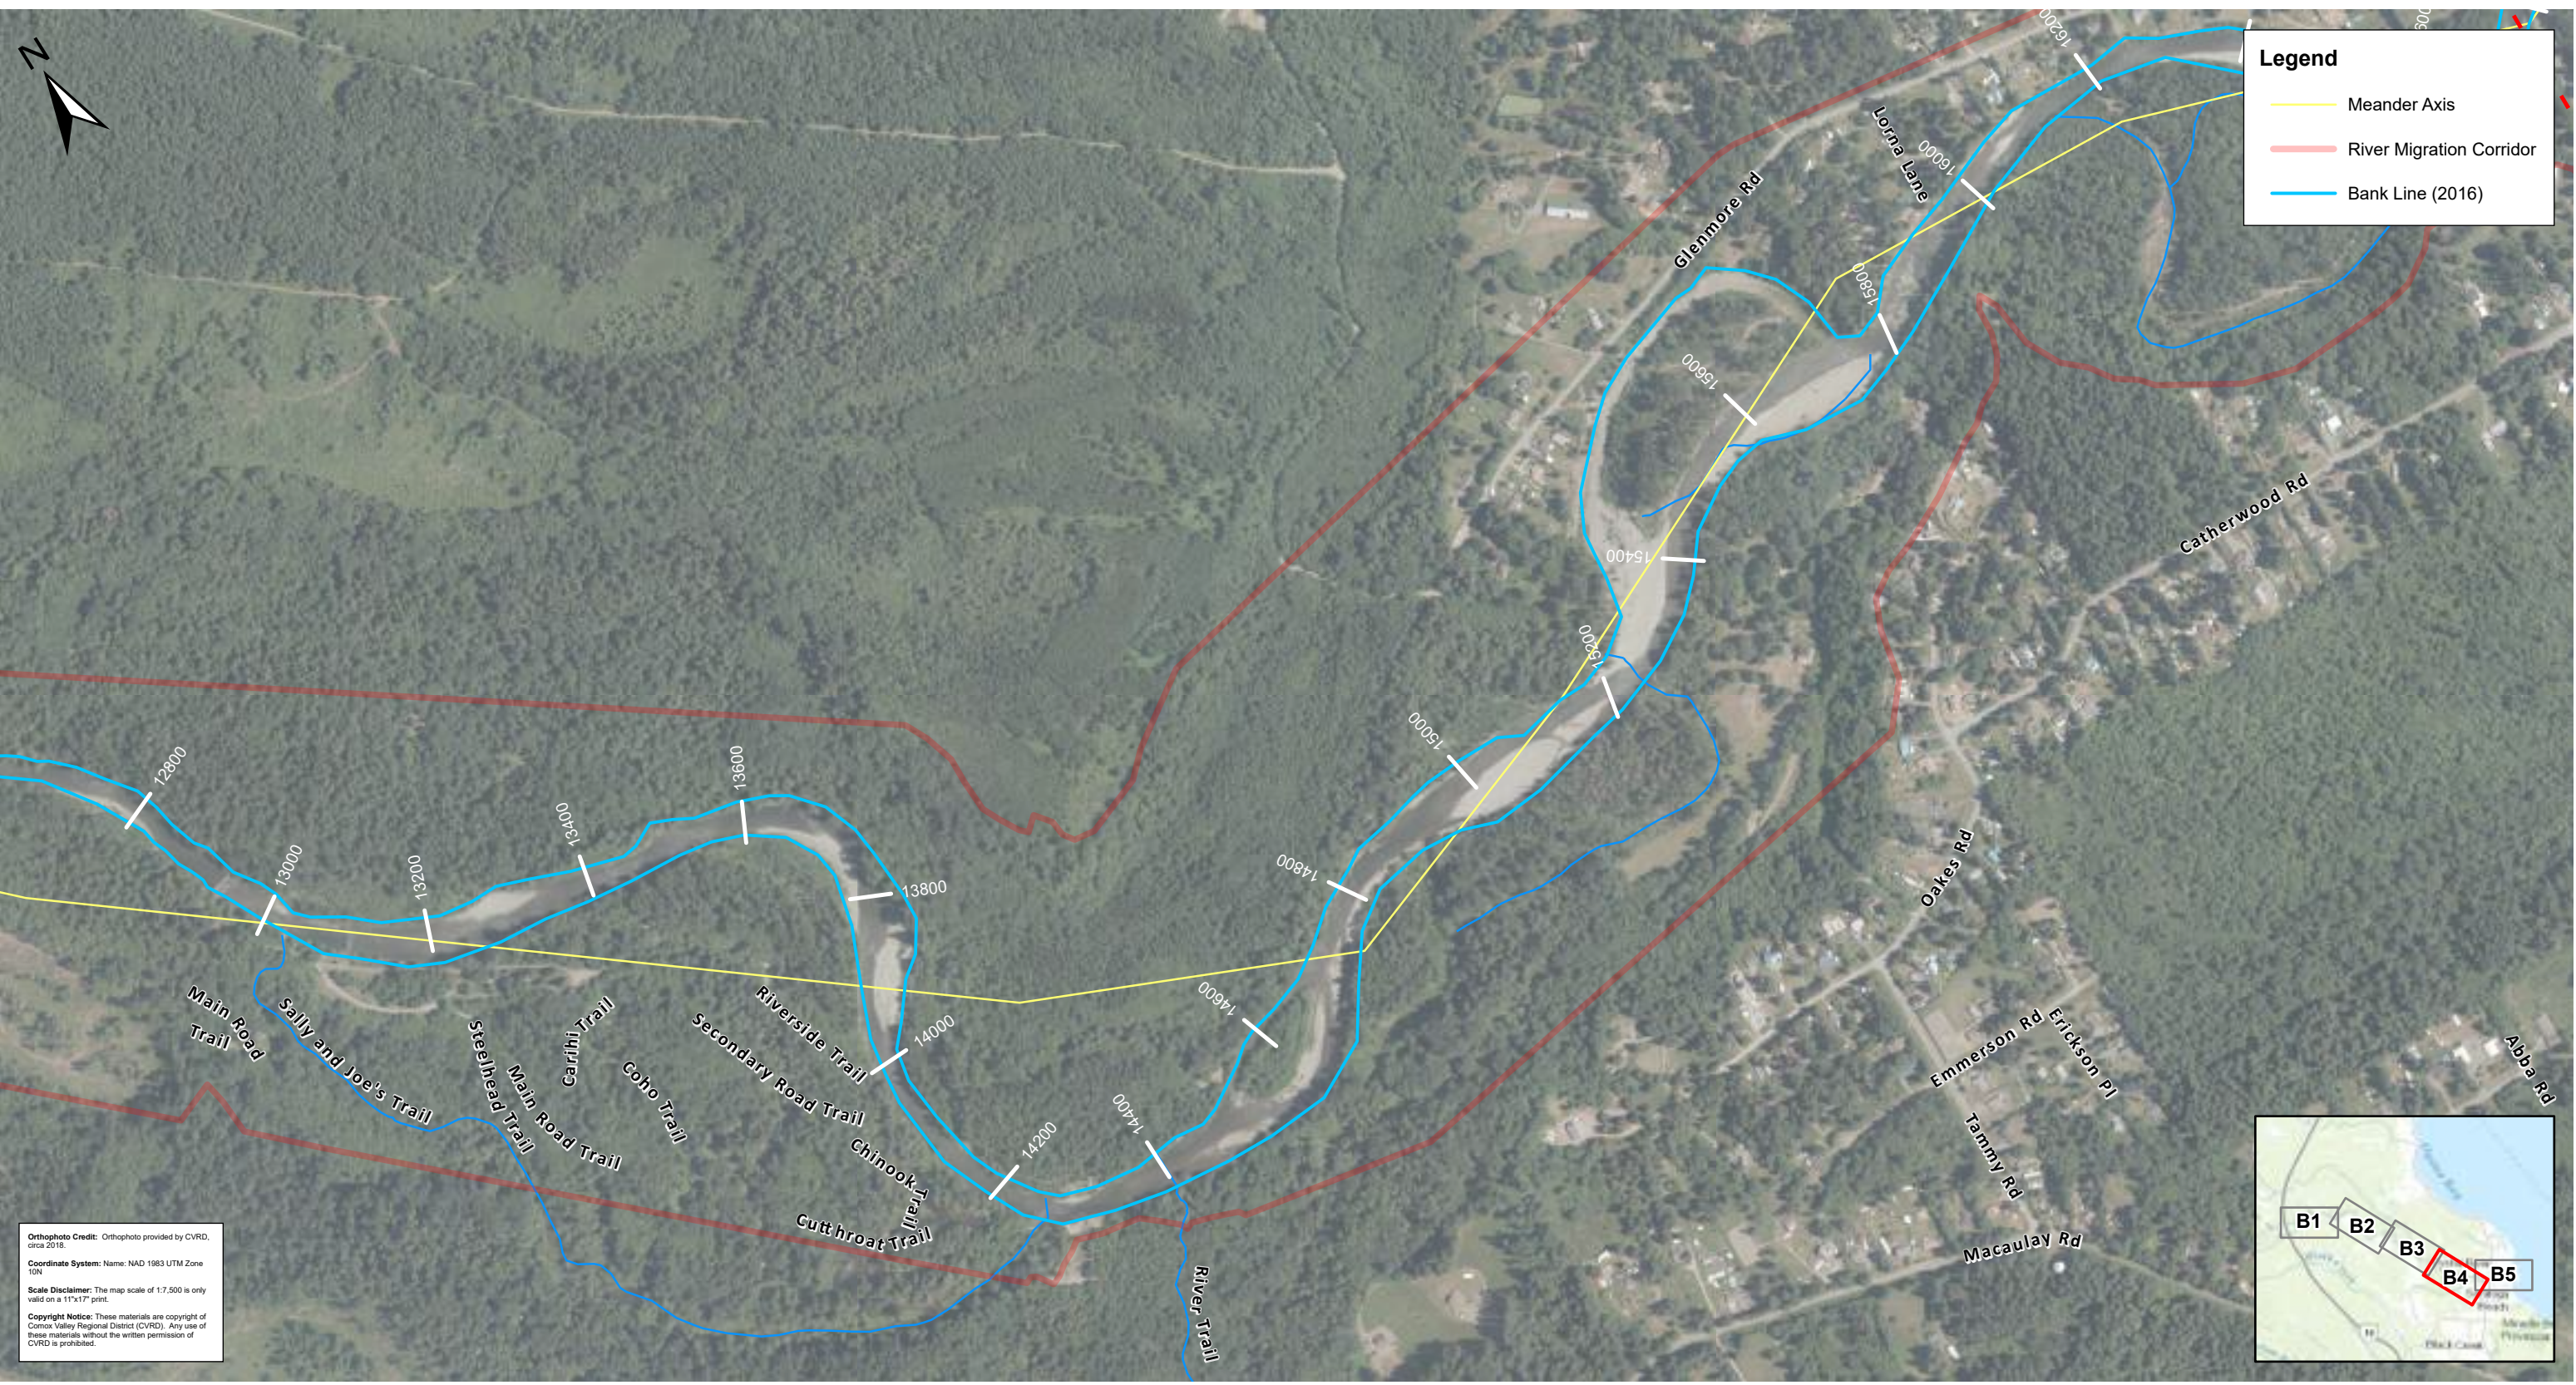
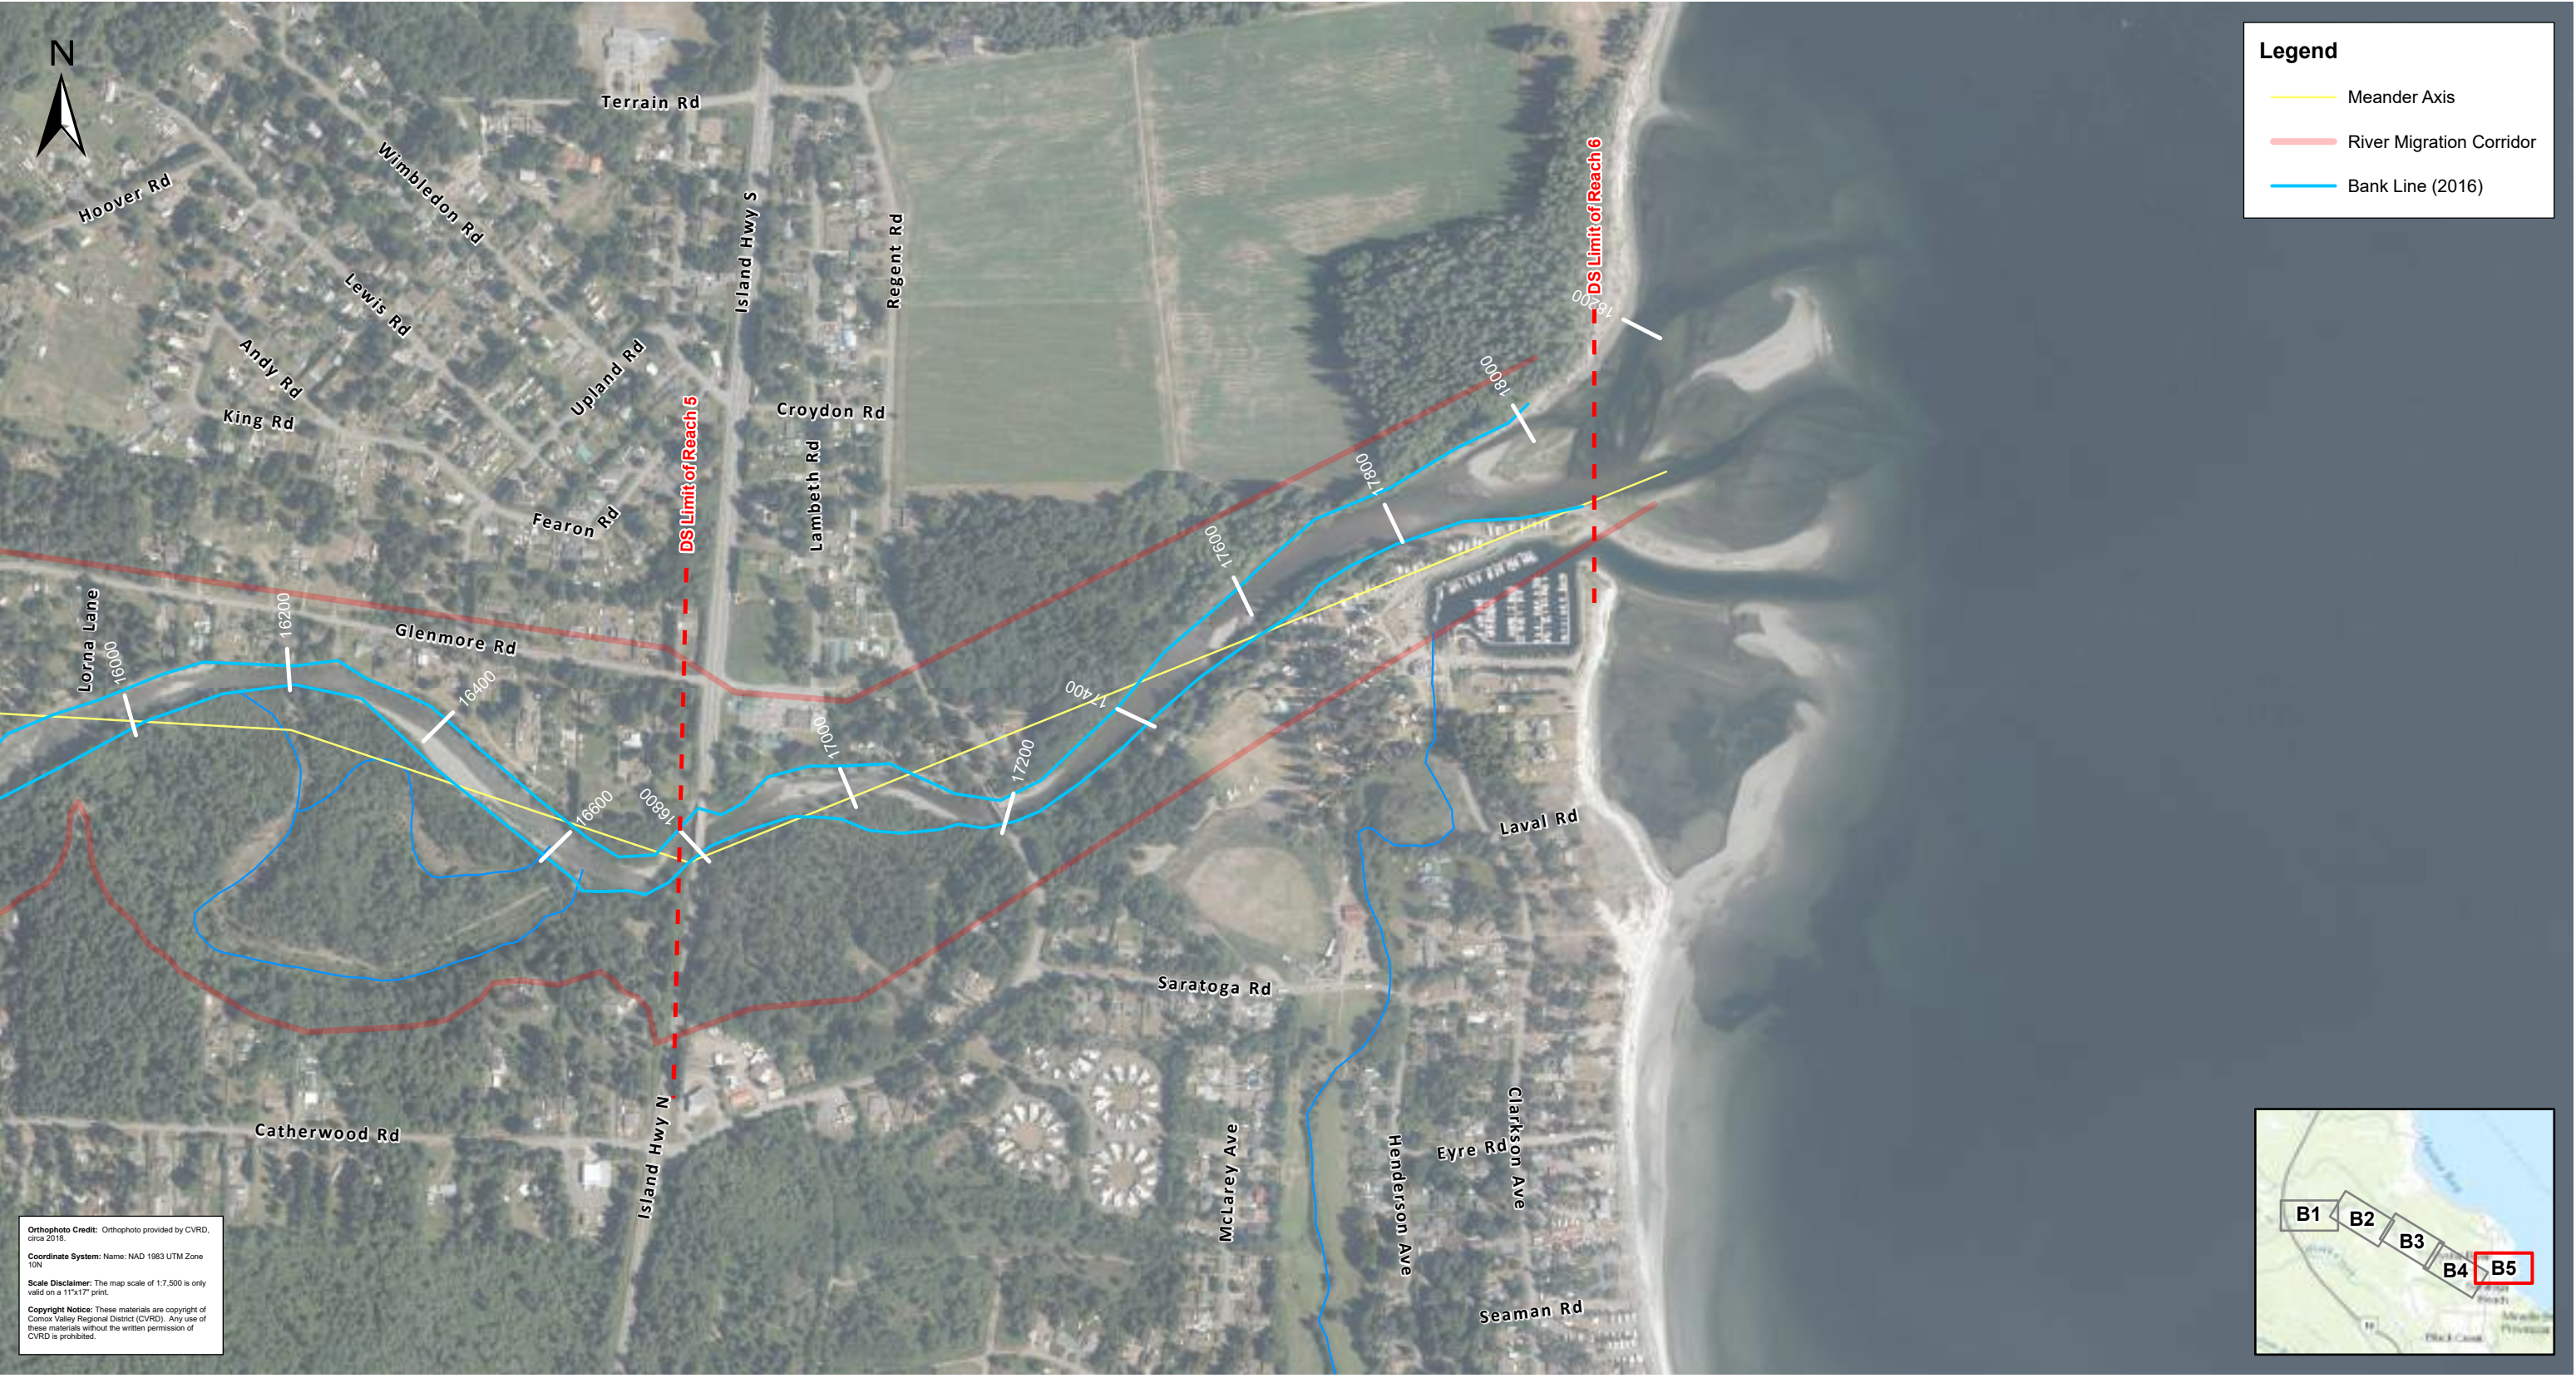
# Migration Corridor of Oyster River

It should be noted that the channel migration corridor in all locations exceeds the 30 m setback recommended by the provincial guidelines (FLNR, 2018).
