# Village of Cumberland Statement of Significance

## Coal Beach and No. 4 Mine Site

Prepared by Becky Thiessen,  
Master of Community Planning Candidate, Vancouver Island University

December 2019

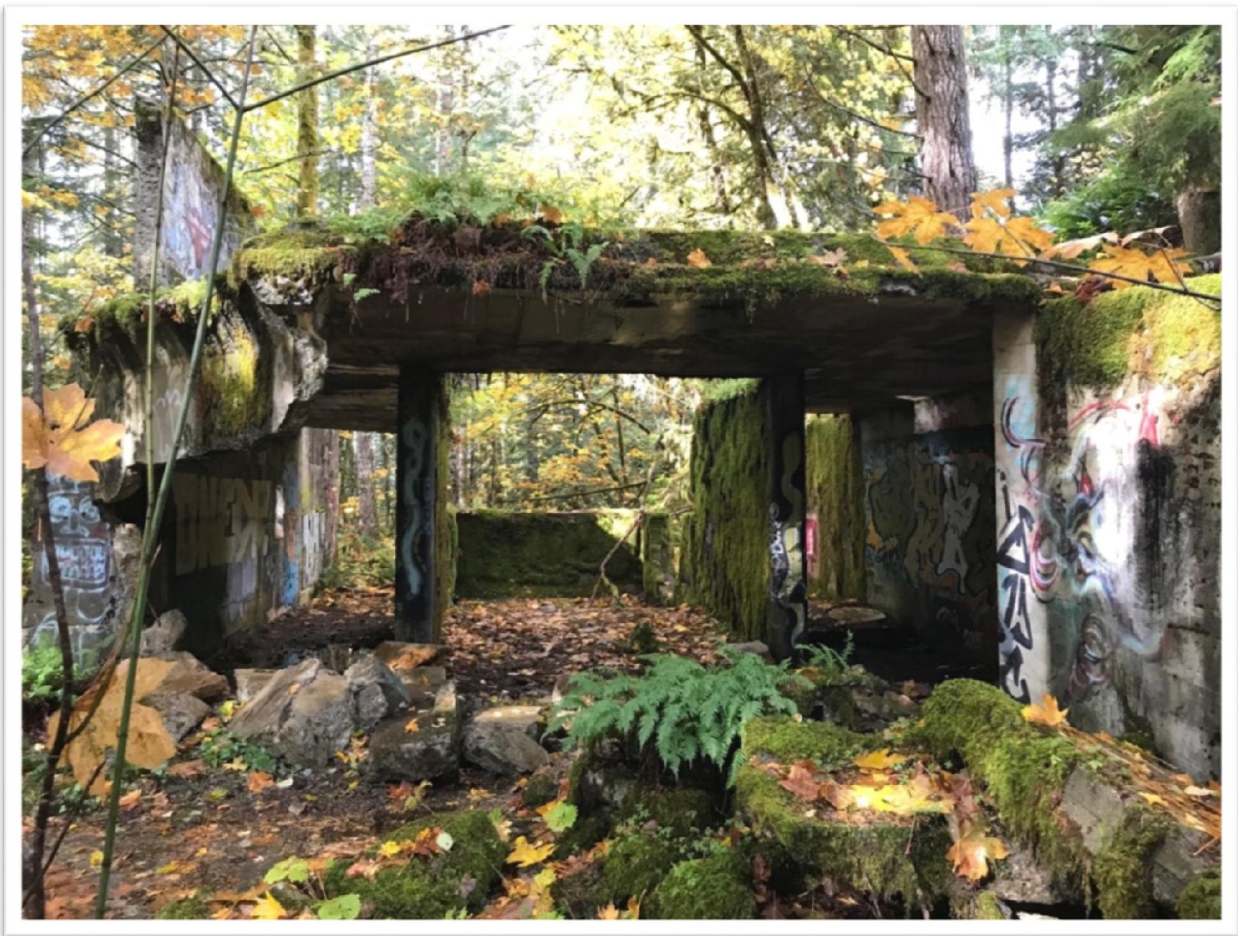
*Figure 1 View of #4 Mine Fan House along the rail to trail path to Coal Beach*

Ventilation of the mines was a considerable problem as the No. 4 Mine Site continued to follow the coal seams deeper underground. Above ground evidence of the No. 4 Mine is the Fan House. The Fan House ventilated the mine to supply oxygen for the miners to breathe and to remove toxic gases such as, methane, hydrogen sulphide and carbon monoxide. The Fan House was critical to the safe operations of the mine.

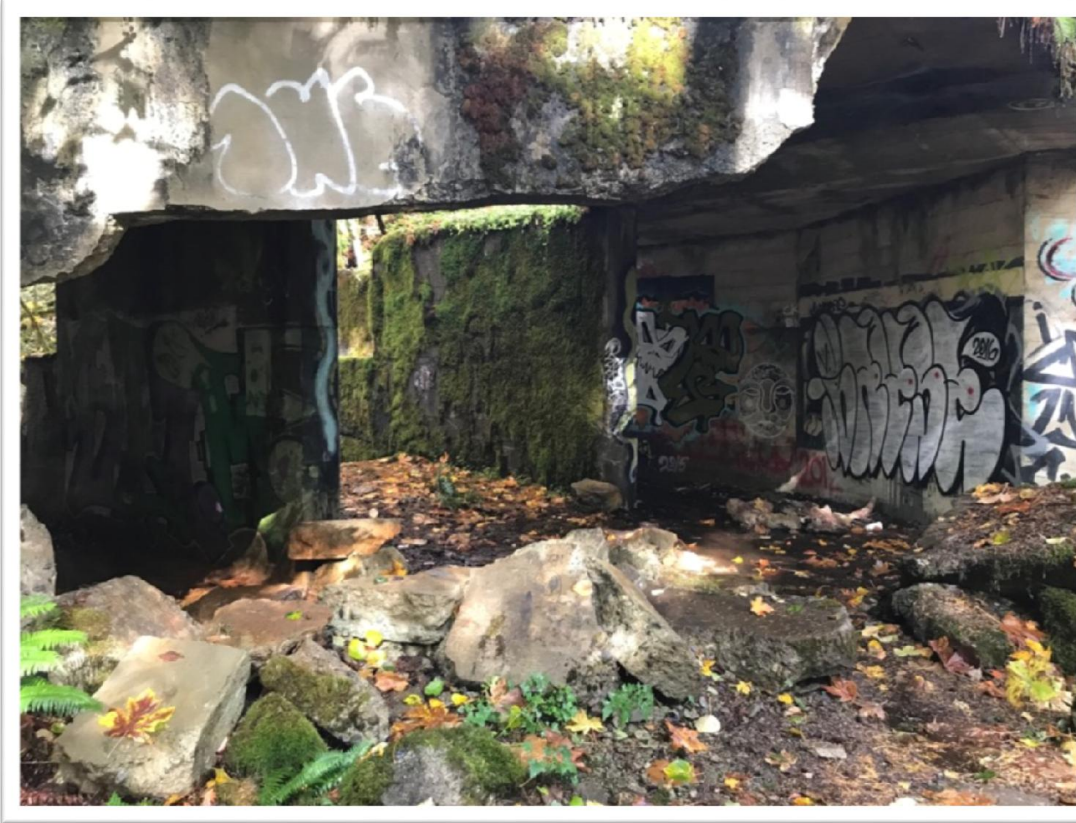
*Figure 3 Concrete Ruins of No.4 Mine Fan House*

- Natural environment of the forest, Perseverance Creek and Comox Lake
- Location of the No. 4 Fan House
  - Concrete slab foundation
  - Remaining curved concrete walls that represent the fan and machinery
  - Remaining concrete slab roof
  - Exhaust tunnels emerging from the hillside
- The concrete foundation of a tipple
- Coal slag berm near the tipple
- The former rail line, currently used as a walking trail
- Rusted relics scattering the forest floors
- Buried brick wall, assumed to be part of the former blacksmith shop
- Linear slag piles leading from the Fan House to Comox Lake
- Coal Beach – the foreshore of the lake scattered with coal overburden.

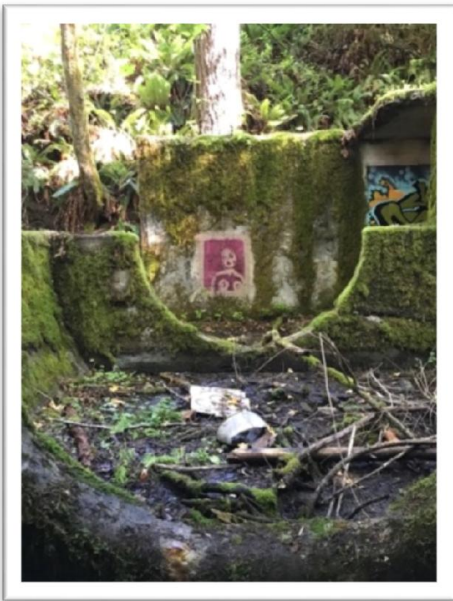
*Figure 2 Concrete Ruin of No.4 Mine Fan House showing curved concrete walls*

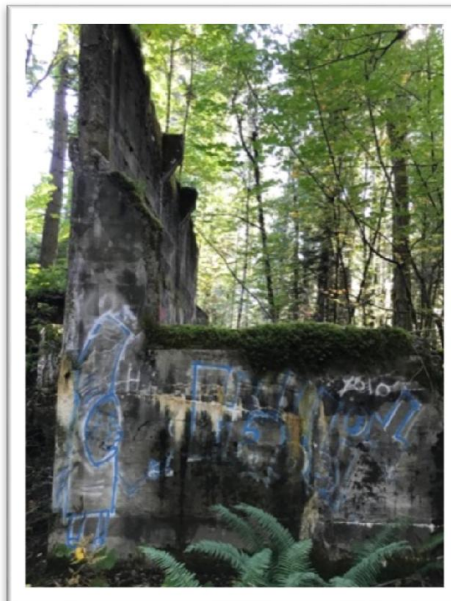
*Figure 4 Concrete ruin of No.4 Mine Fan House showing exterior wall*

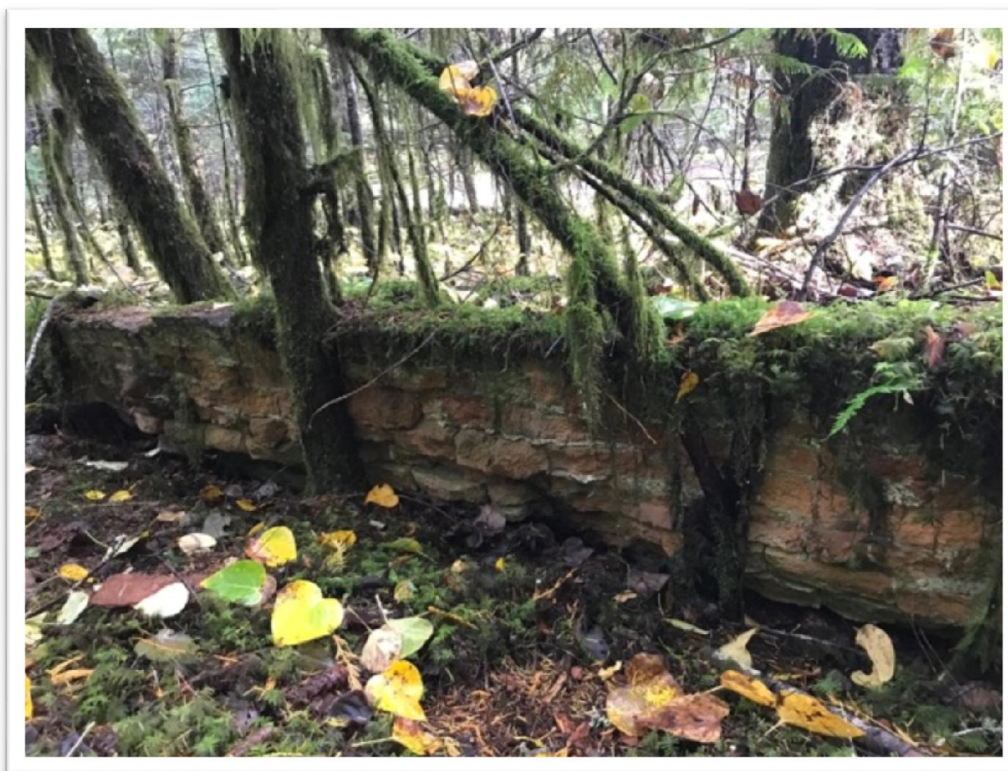
*Figure 7 Brick wall ruin at No.4 Mine Site*

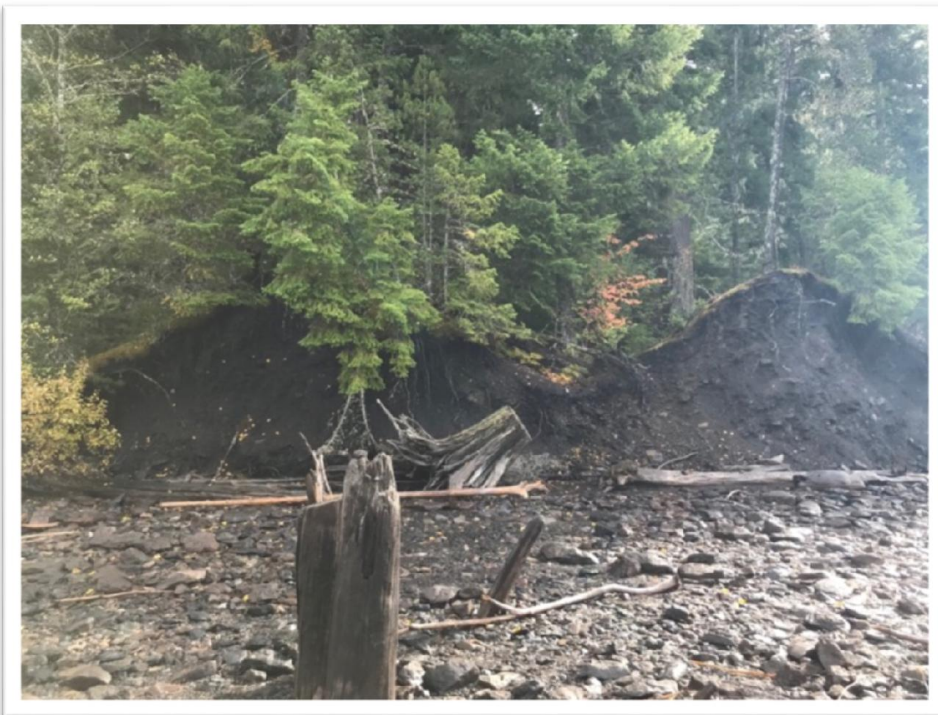
*Figure 8 Coal overburden remains from the mine at Coal Beach, Comox Lake*

As one approaches Coal Beach, linear slag heaps fan out to the shores of Comox Lake. The slag heaps are clearly used for recreational purposes. As the name suggests, Coal Beach is black with coal overburden from the mine. This is a local spot off the beaten path where Cumberland residents continue to enjoy the beauty and wonder of Comox Lake.

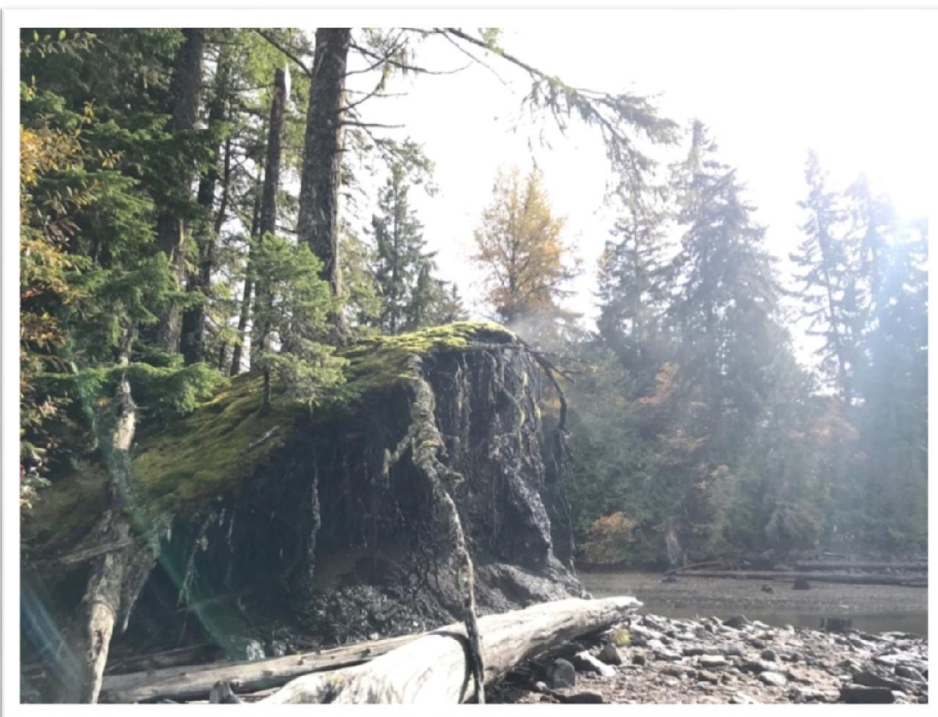
*Figure 9 Coal overburden remains from the mine at Coal Beach, Comox Lake*

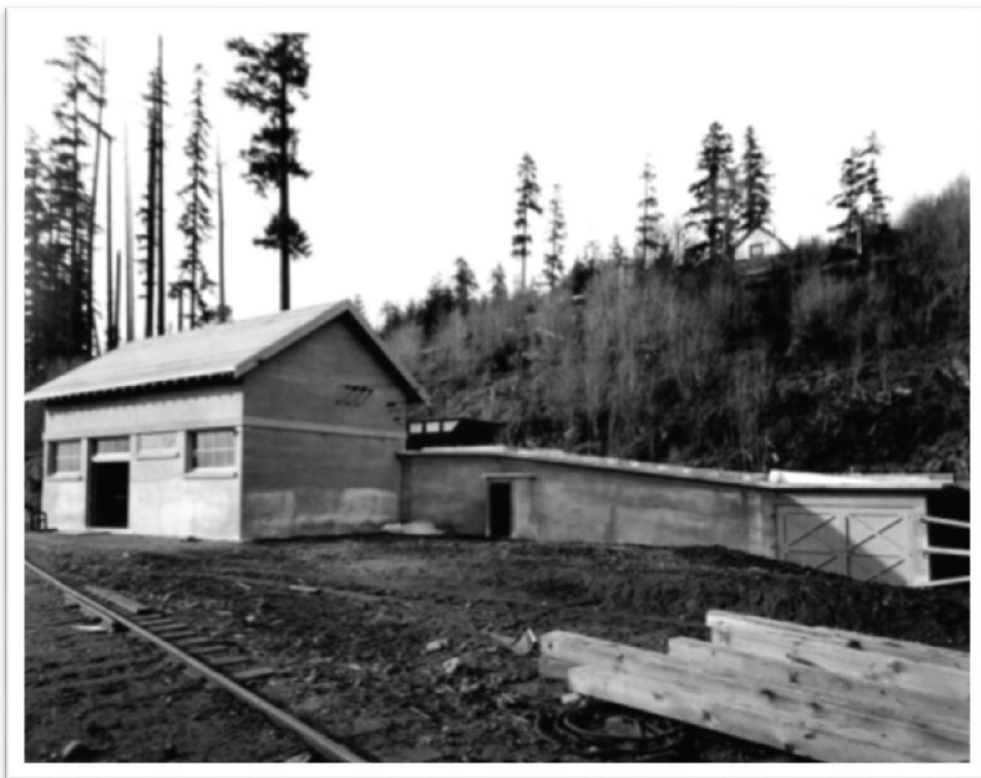
*Figure 14 Sirocco Fan at No. 4 Mine Showing Fan House. Photographed by Leonard Frank, [ca. 192-]. C164-028, Cumberland Museum and Archives.*
