# Perseverance Creek

## Fish Habitat and Proper Functioning Condition Assessment

January 24, 2019

Ecofish Research Ltd.

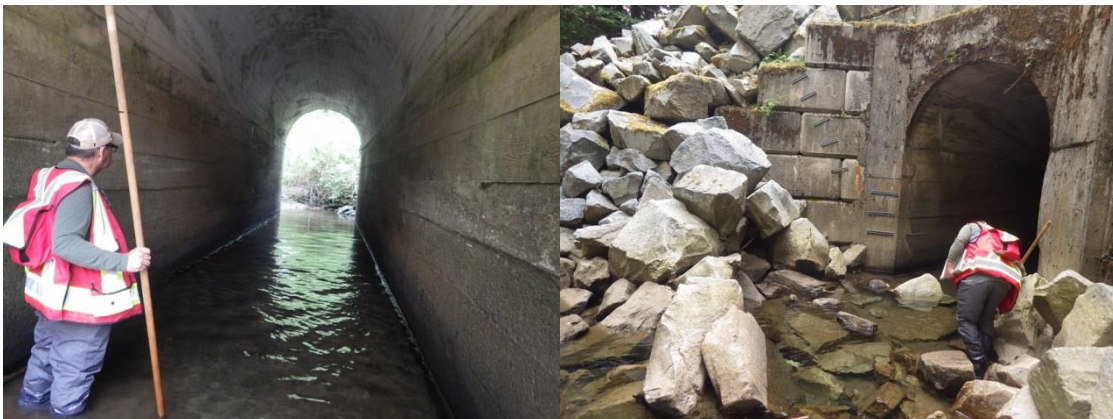
**Figure 12. Culvert under Comox Lake Road, August 22, 2018.**

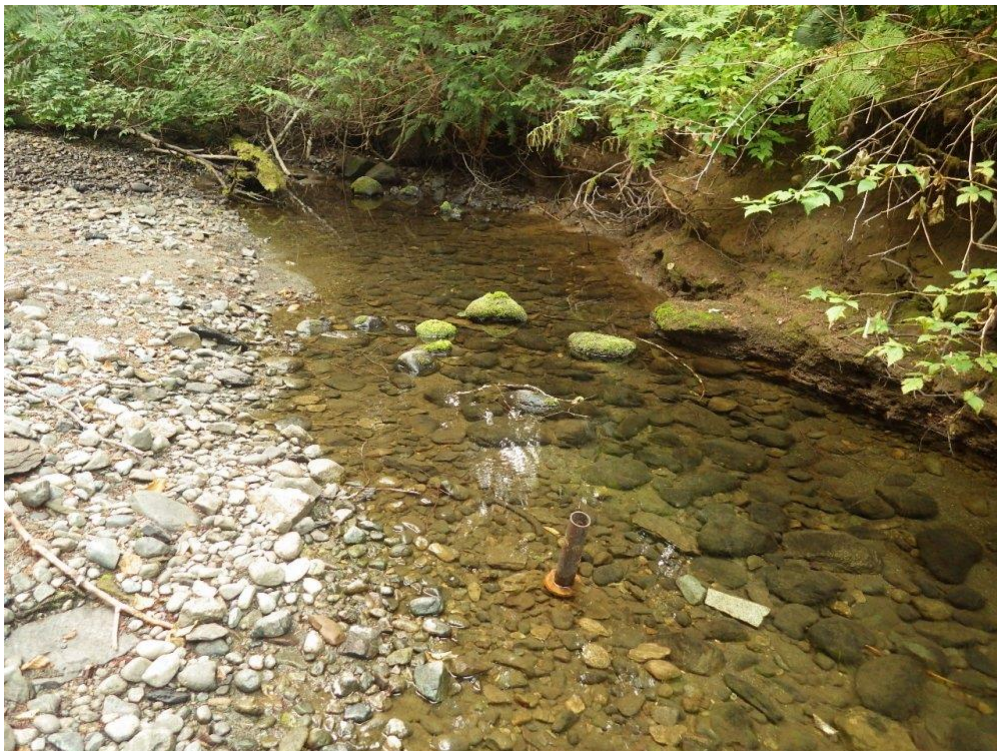
Figure 14. Undercut banks and overhanging vegetation, August 22, 2018

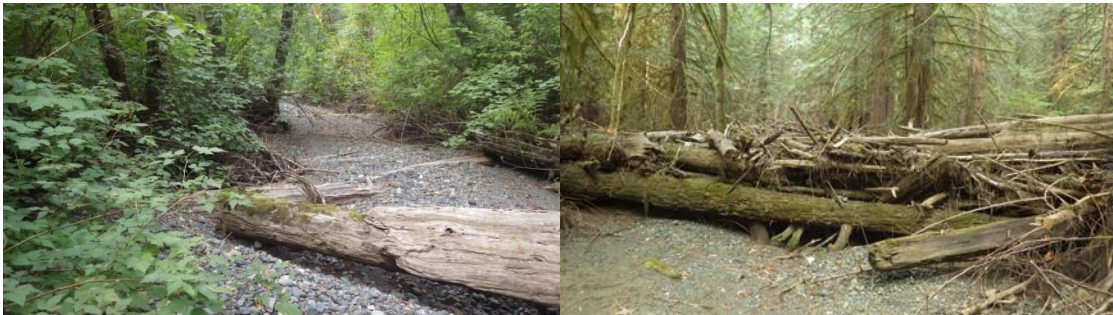
**Figure 22.** Upper section includes more log jams, aggradation, and forest deposition; to Hai Gai bridge, August 22, 2018.

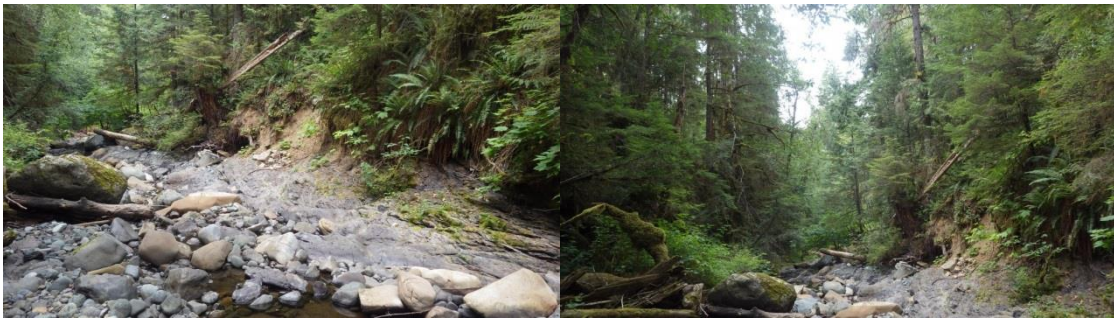
Figure 41. Eroding bank on river left August 23, 2018.

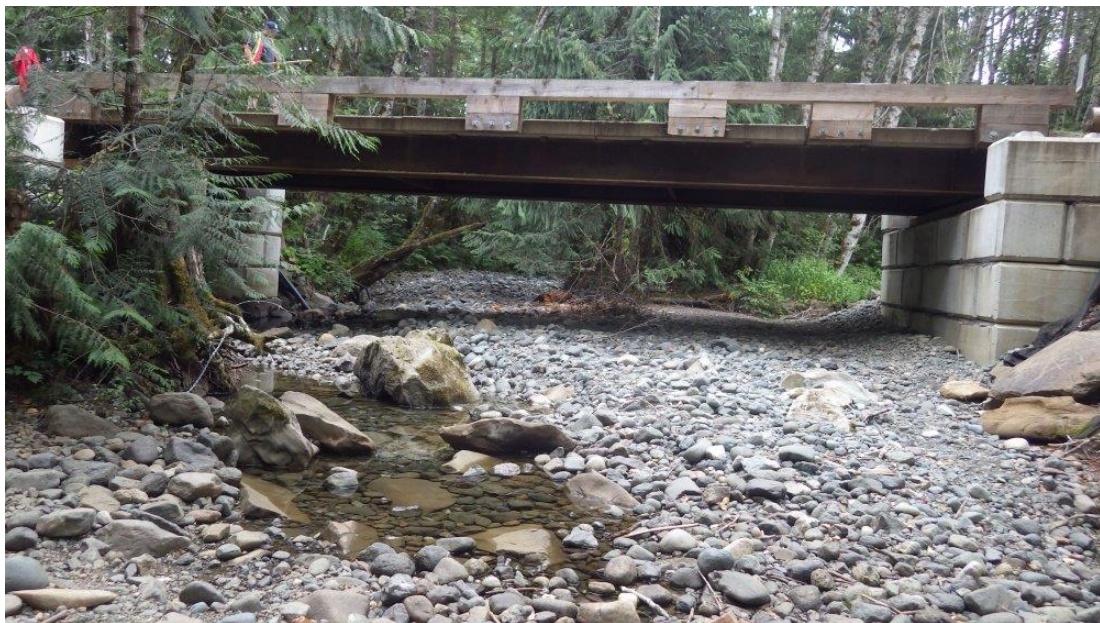
Figure 42. Davis Creek Main bridge, August 23, 2018.

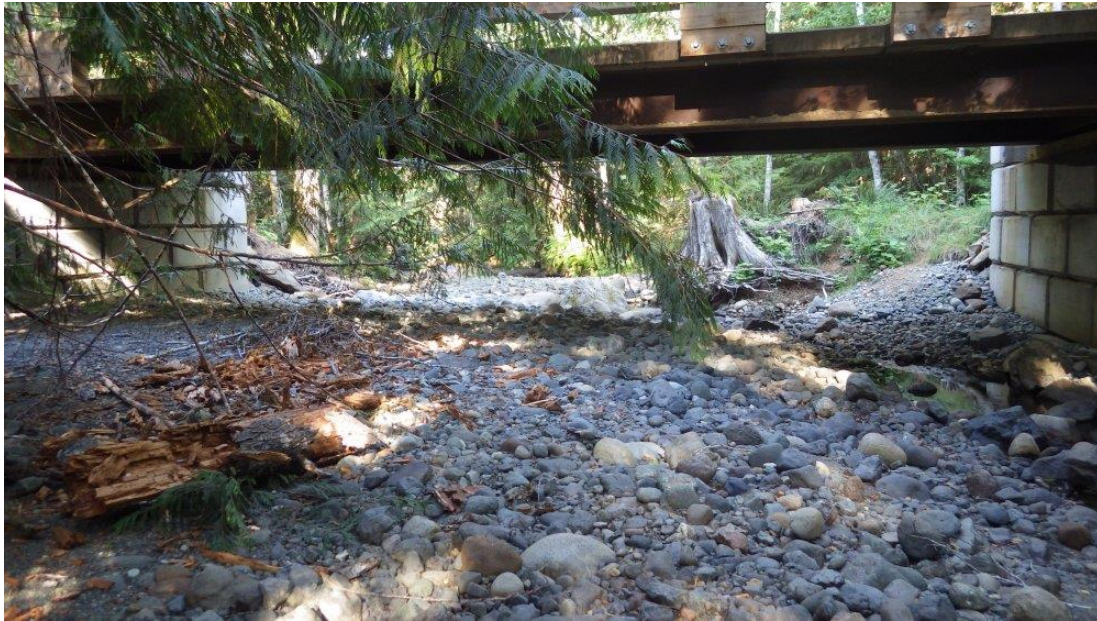
Figure 43. Davis Creek main bridge, August 24, 2018.

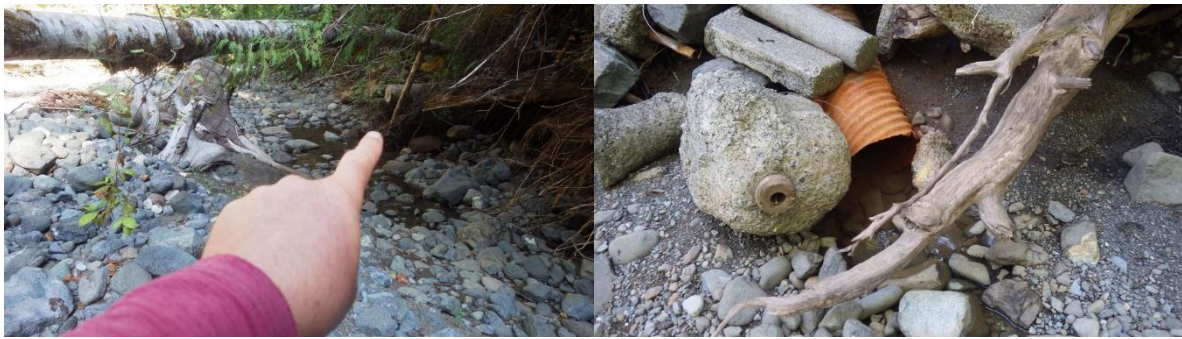
Figure 49. Water main drain, August 24, 2018.

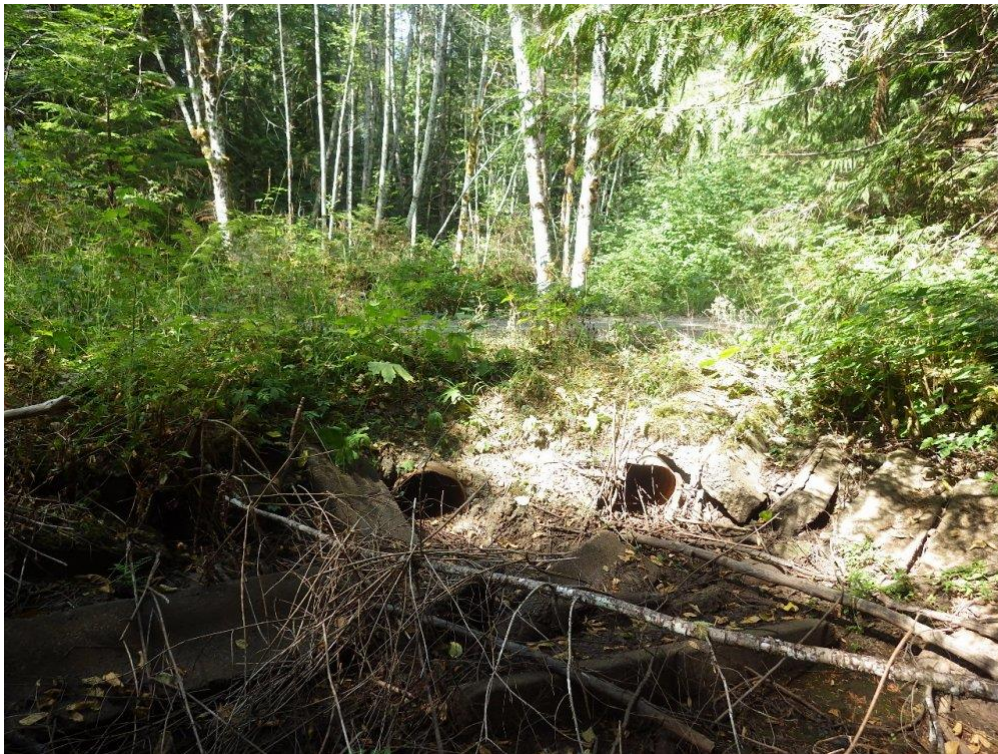
Figure 53. Allen Lake west tributary outlet beneath access road, August 24, 2018.

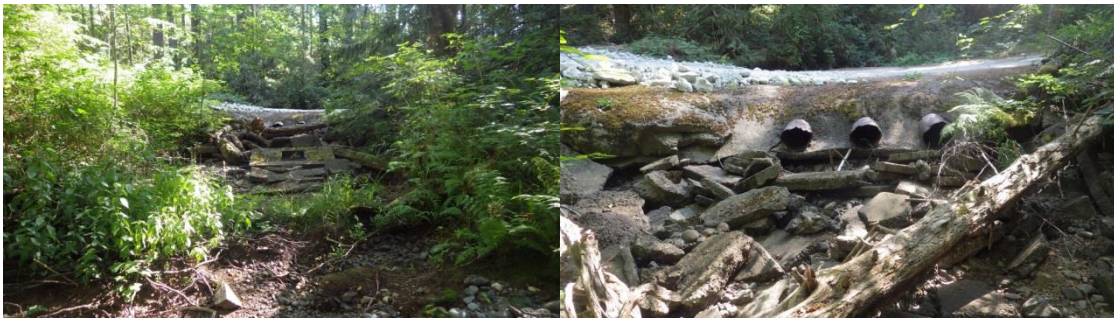
**Figure 58.** Allen Lake overflow beneath access road, on August 24, 2018.

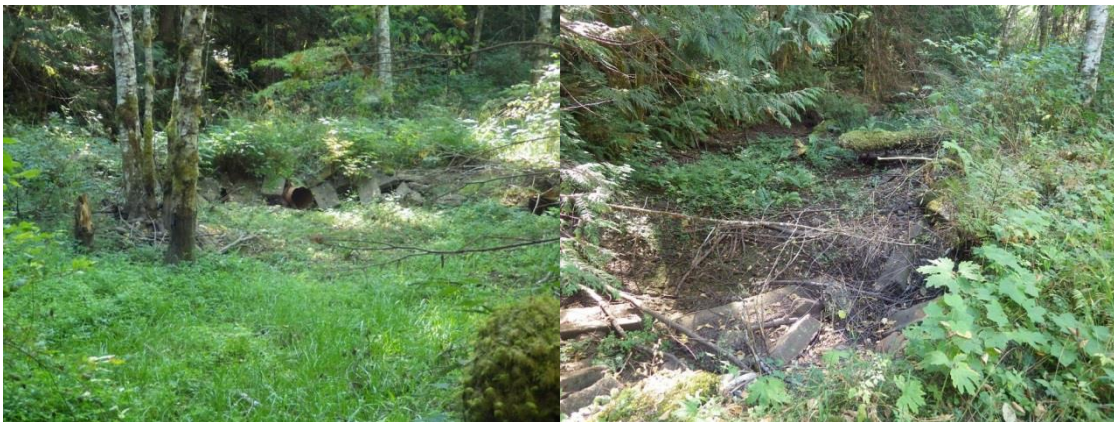
**Figure 59.** Seepage from Allen Lake middle dam tributary, August 24, 2018.
