# Perseverance Creek

## Fish Habitat and Proper Functioning Condition Assessment

January 24, 2019

Ecofish Research Ltd.

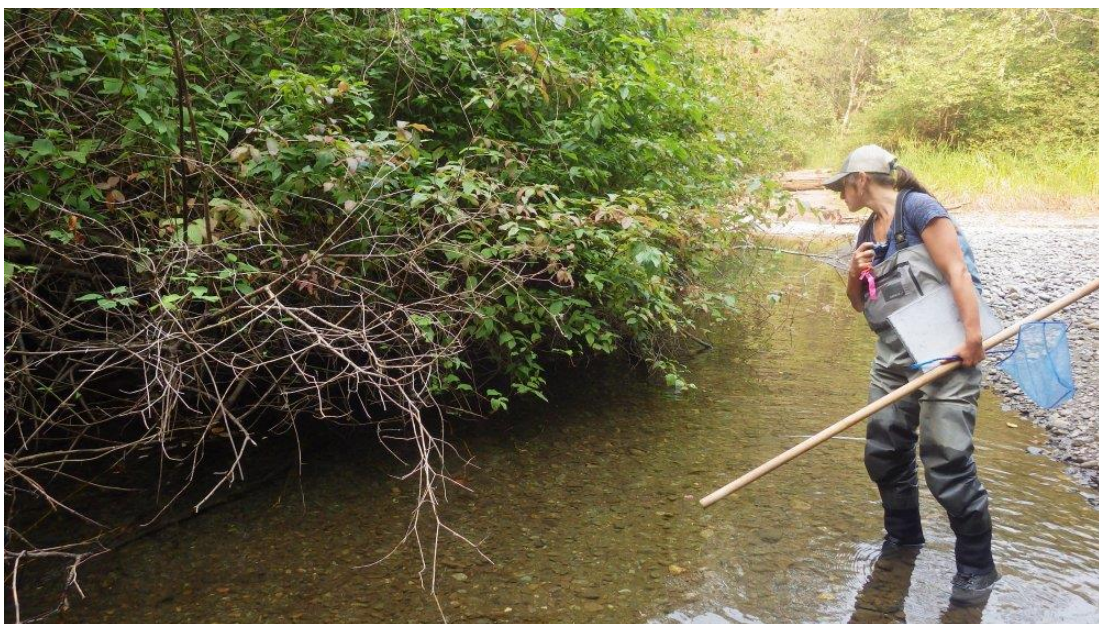
**Figure 8.** Overhanging vegetation and deep pool, August 21, 2018.

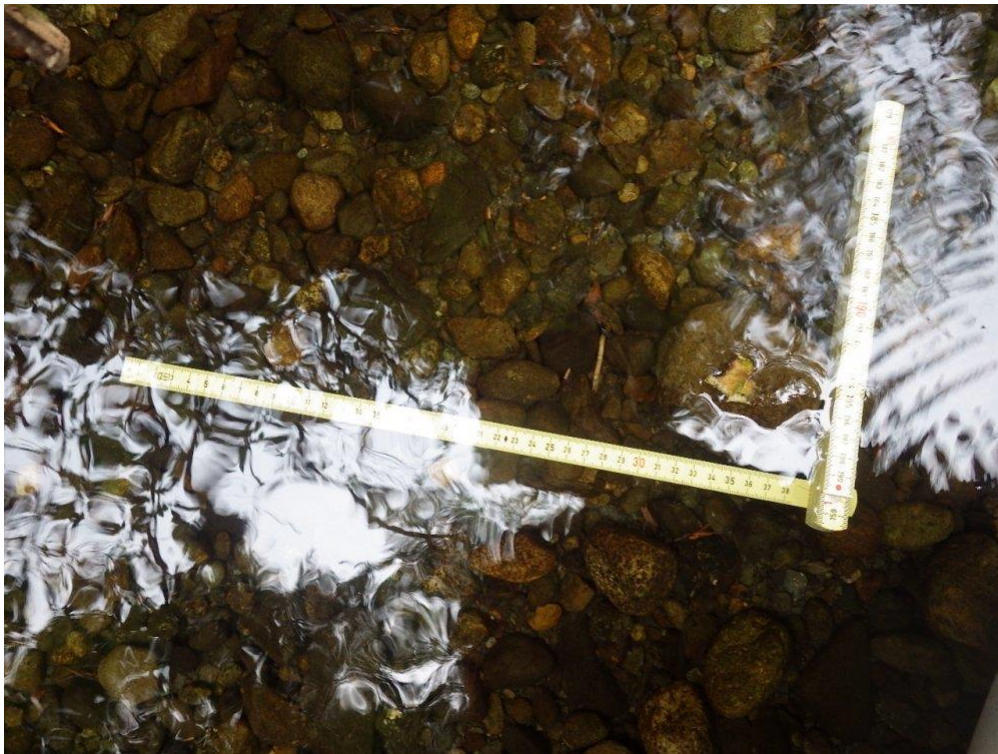
**Figure 9.** Channel substrate; spawning gravels, August 21, 2018.

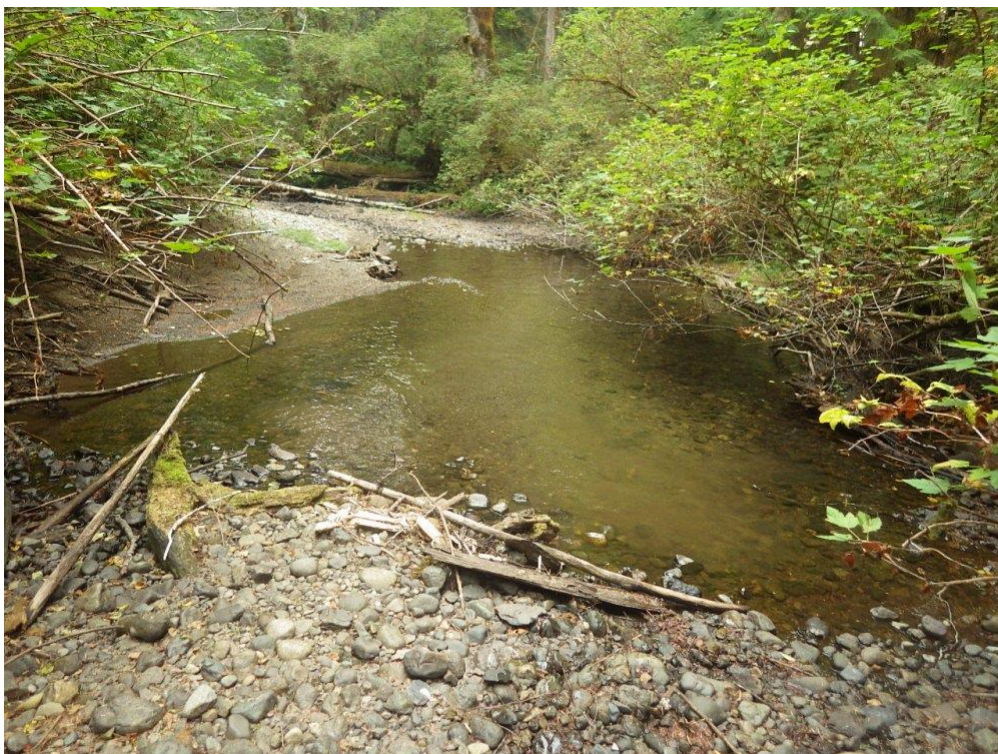
**Figure 10.** Back channel with overhanging vegetation and isolated pools, August 21, 2018.

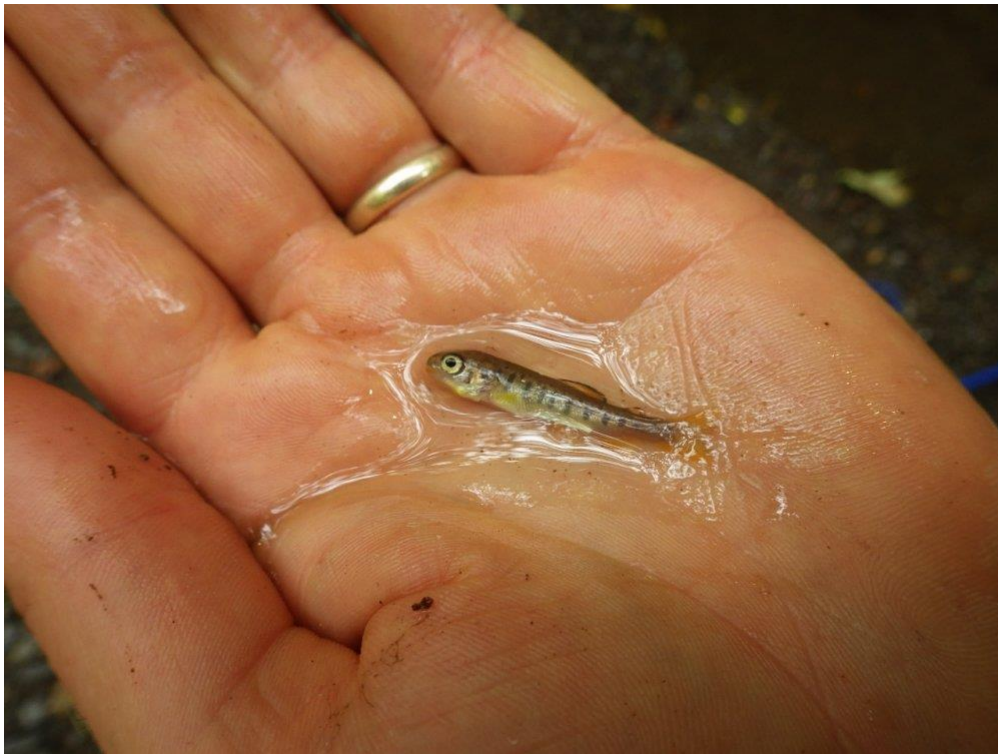
**Figure 17. Fish presence; fry, August 22, 2018.**

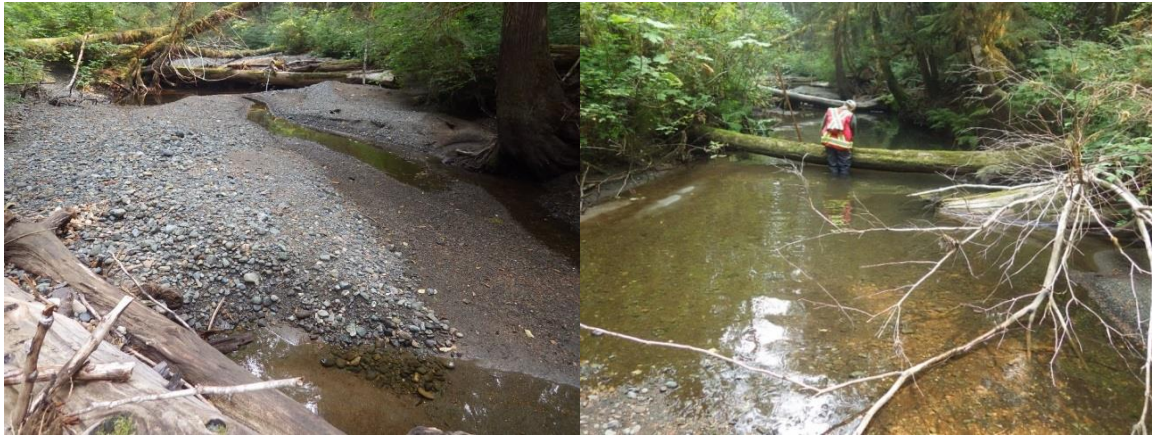
Figure 19. Good fish habitat in pools; LWD and overhanging vegetation; fish presence confirmed in lower section, August 22, 2018.

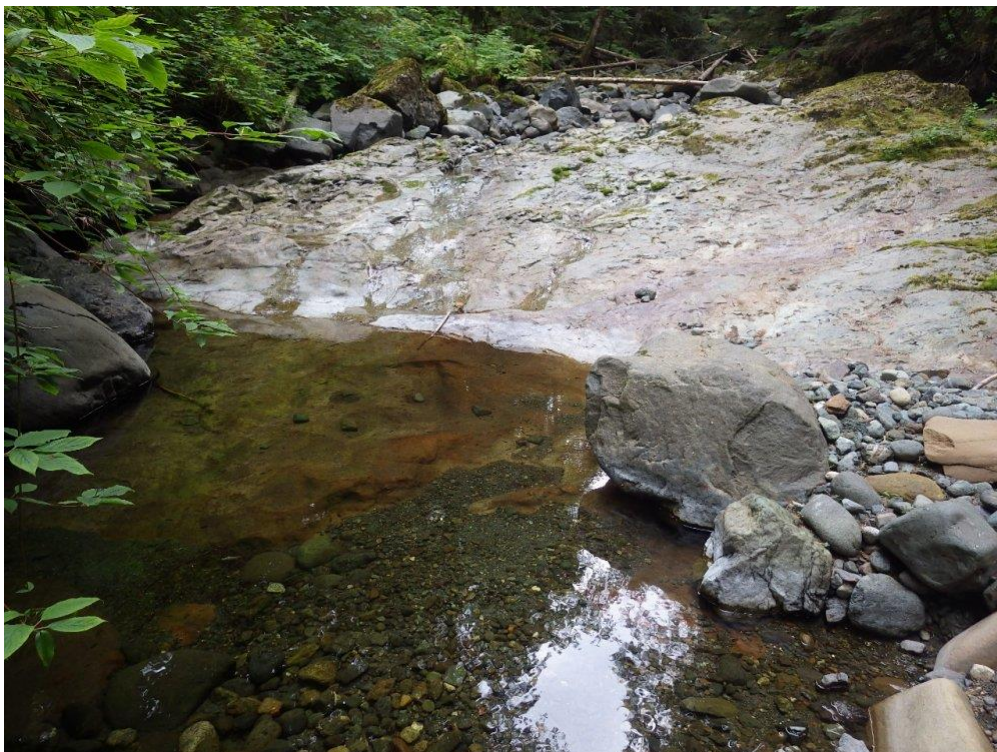
**Figure 24. Deep pool with Coho observed below chute, August 23, 2018.**

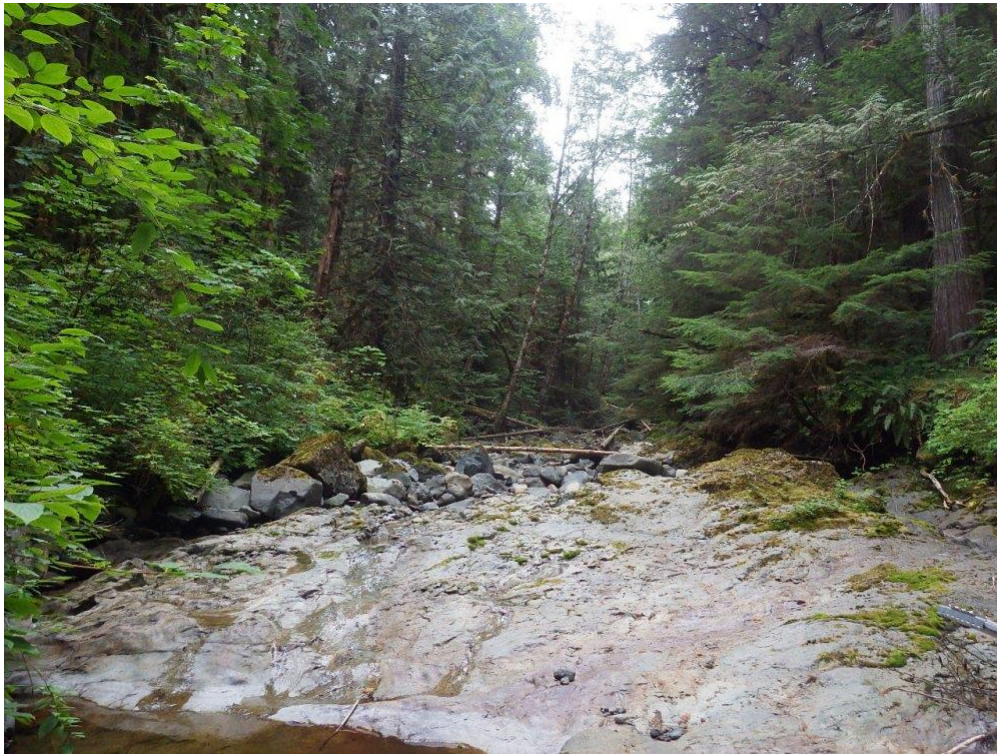
Figure 27. Wide and moderately steep chute (6m long, 11% gradient), August 23, 2018.

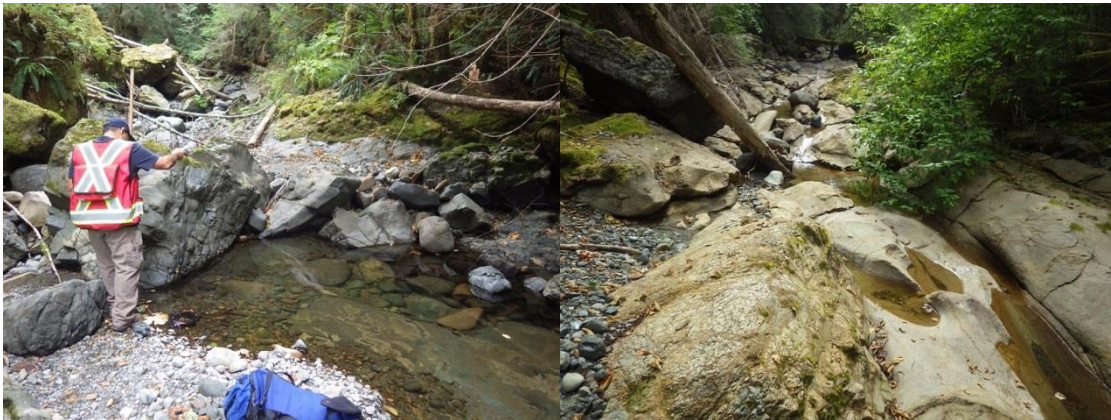
Figure 28. Bedrock pools with Coho fry and trout observed, August 23, 2018.

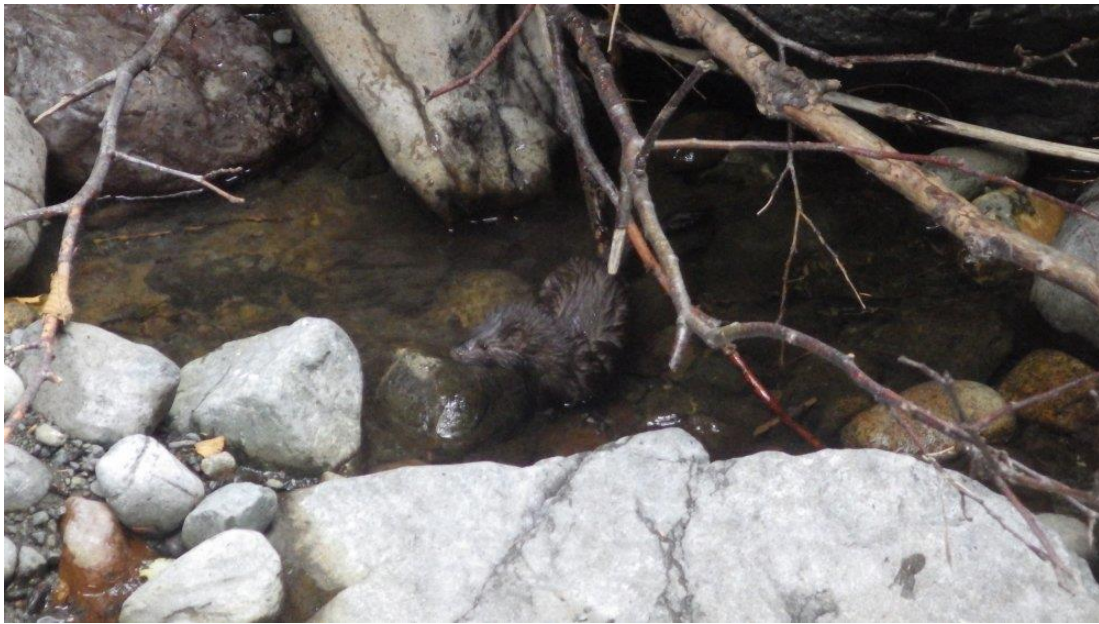
Figure 31. Mink fishing in pools, August 23, 2018.

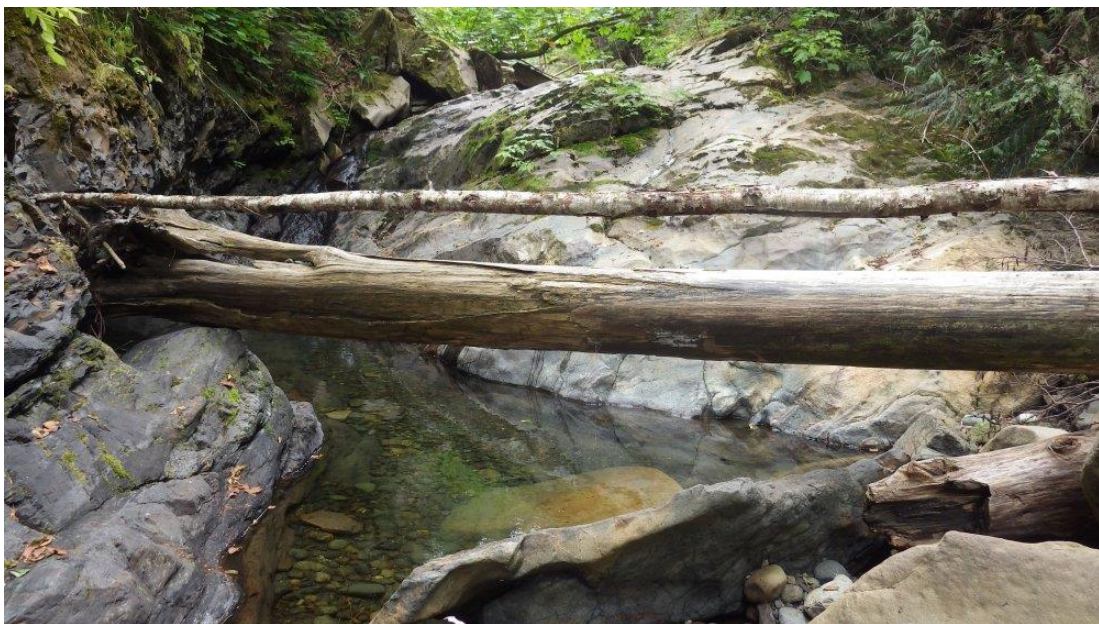
Figure 32. Pools in bedrock canyon, August 23, 2018.

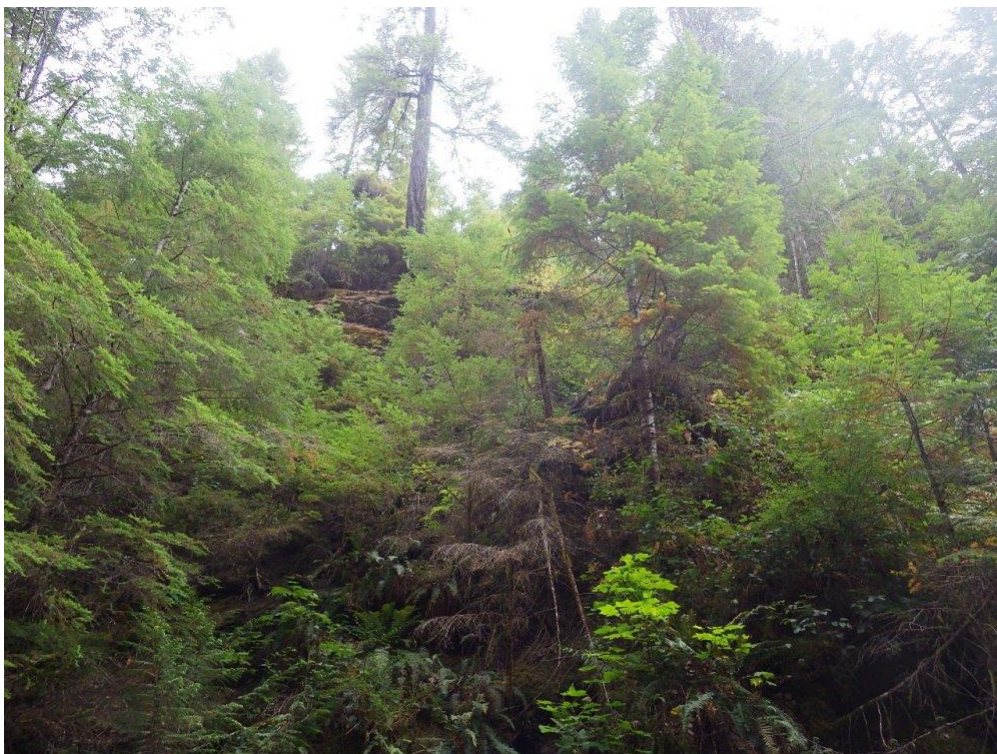
Figure 34. Riparian vegetation covering canyon wall, August 23, 2018.

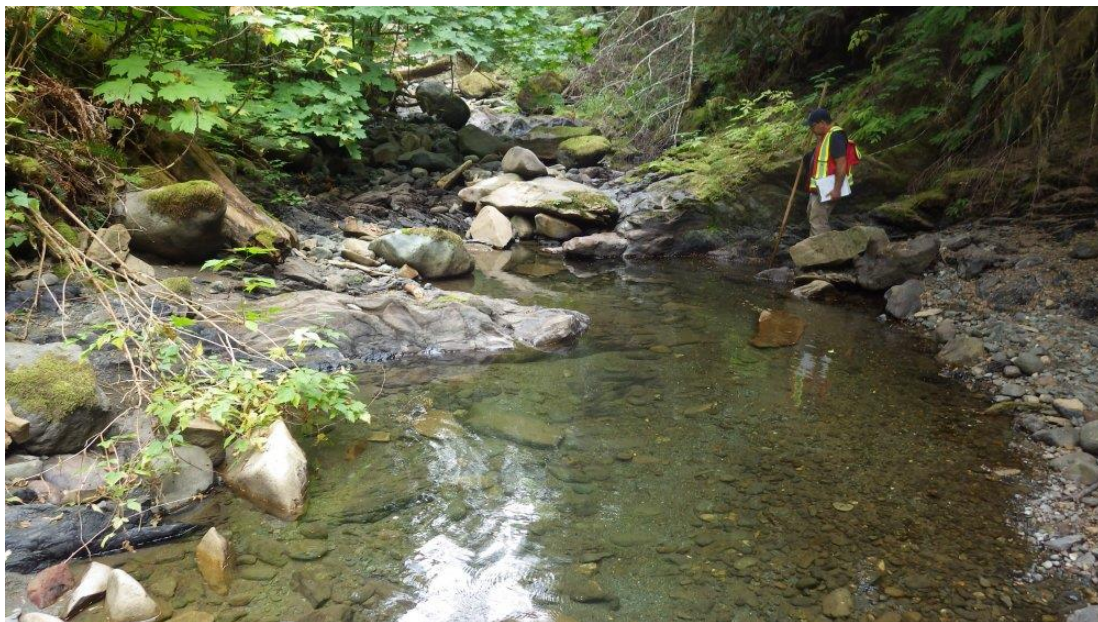
Figure 36. Residual pools, August 23, 2018.

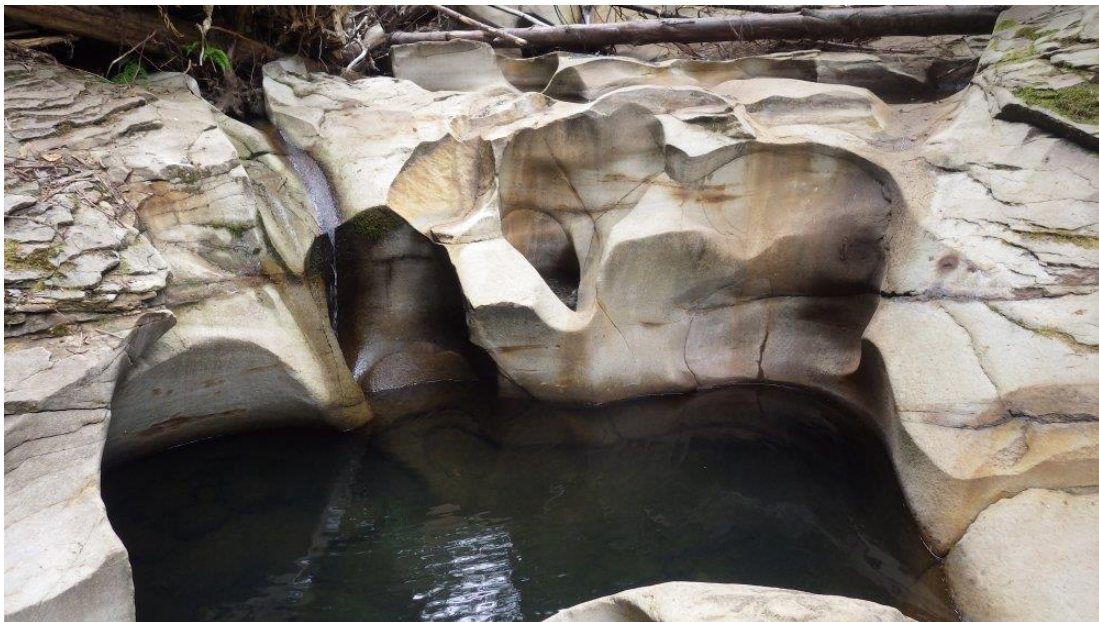
Figure 40. Scour pools above falls with trout observed, August 23, 2018.

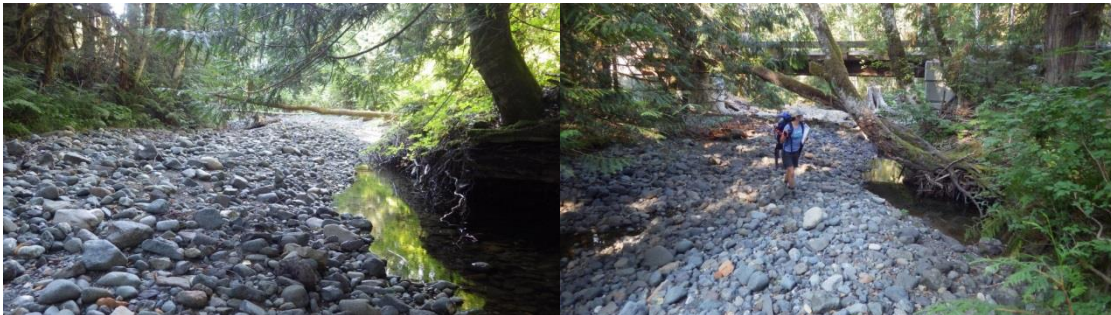
Figure 44. Isolated pools with trout fry, August 24, 2018.

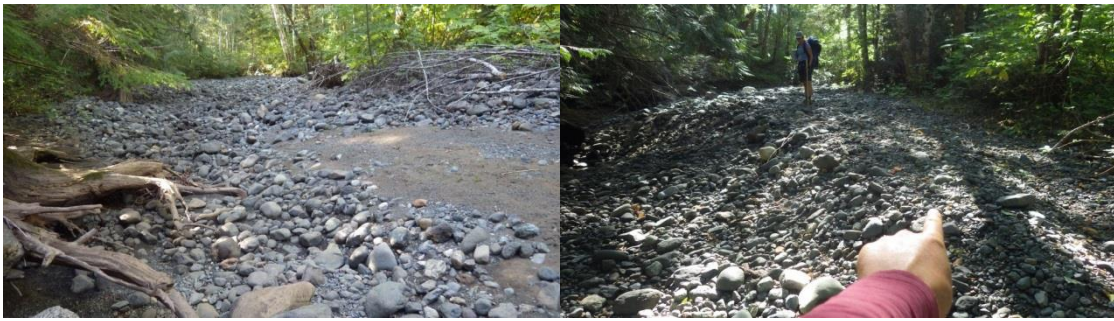
Figure 45. Extensive bedload filled channel, August 24, 2018.

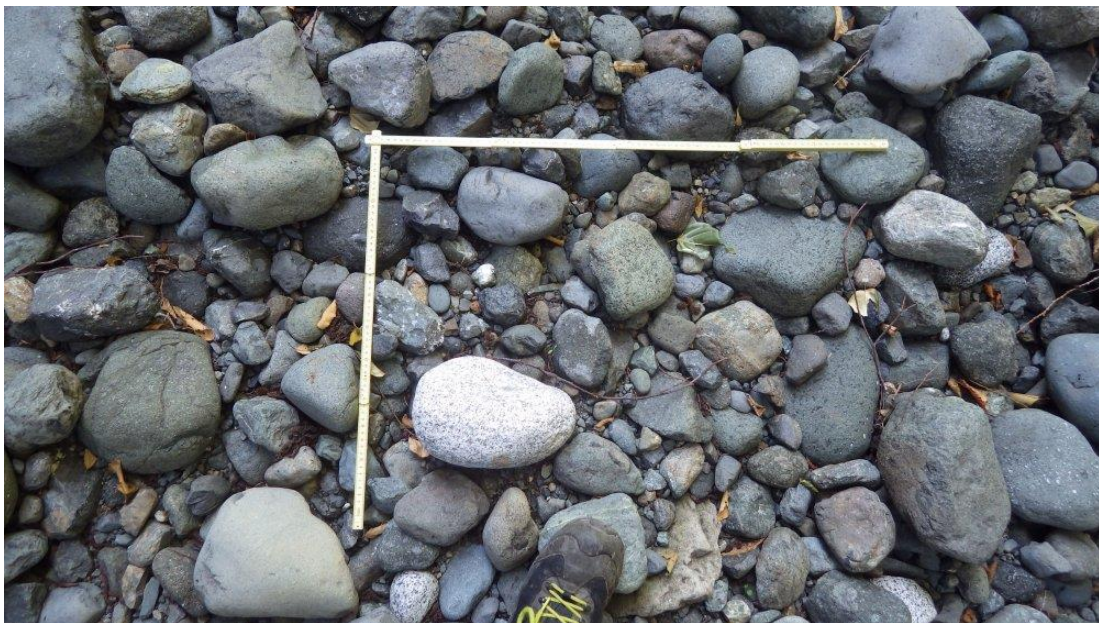
Figure 46. Coarse cobble and large gravel substrate, August 24, 2018.

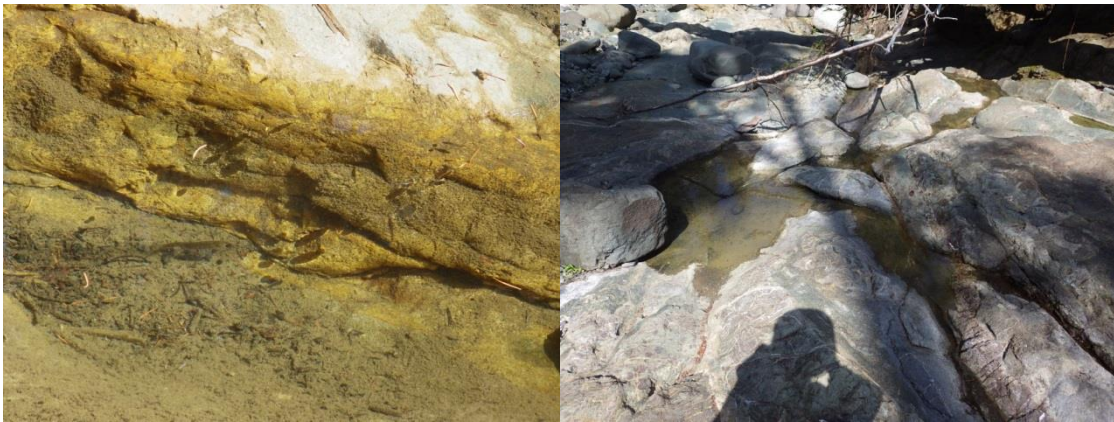
Figure 52. Trout and stickleback in residual pools, August 24, 2018.

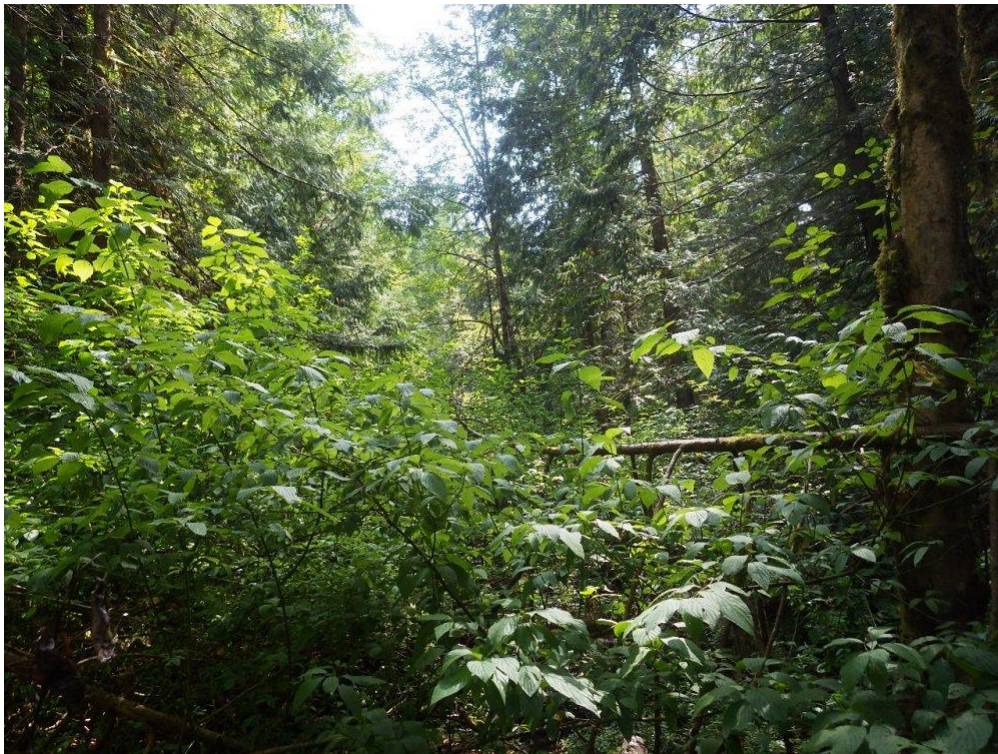
Figure 54. Thick riparian canopy, August 24, 2018.

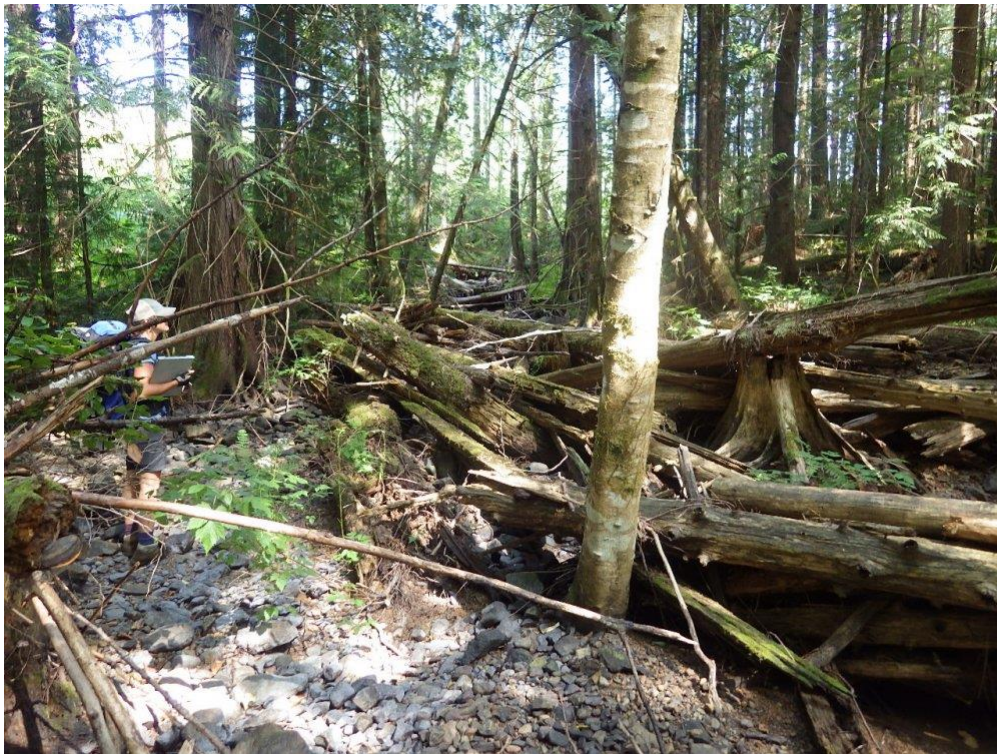
Figure 56. Log jam, August 24, 2018.

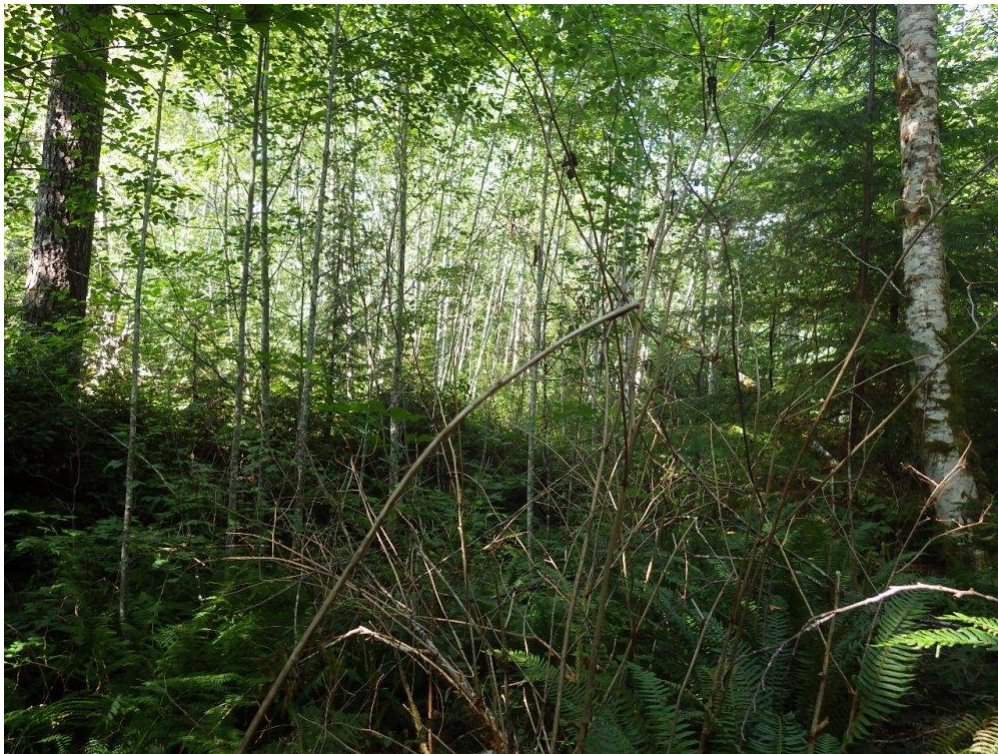
Figure 61. Pole-sapling riparian stage at East Tributary, August 24, 2018.
